Report on CRDCS Breaker Cabinet Seismic Qualification

This report, pursuant to 10 CFR 50.53(e) on Significant Deficiencies, is to document the investigation of the significant deficiency in the seismic qualification on the Control Rod Drive Control System Trip Breaker Cabinets.

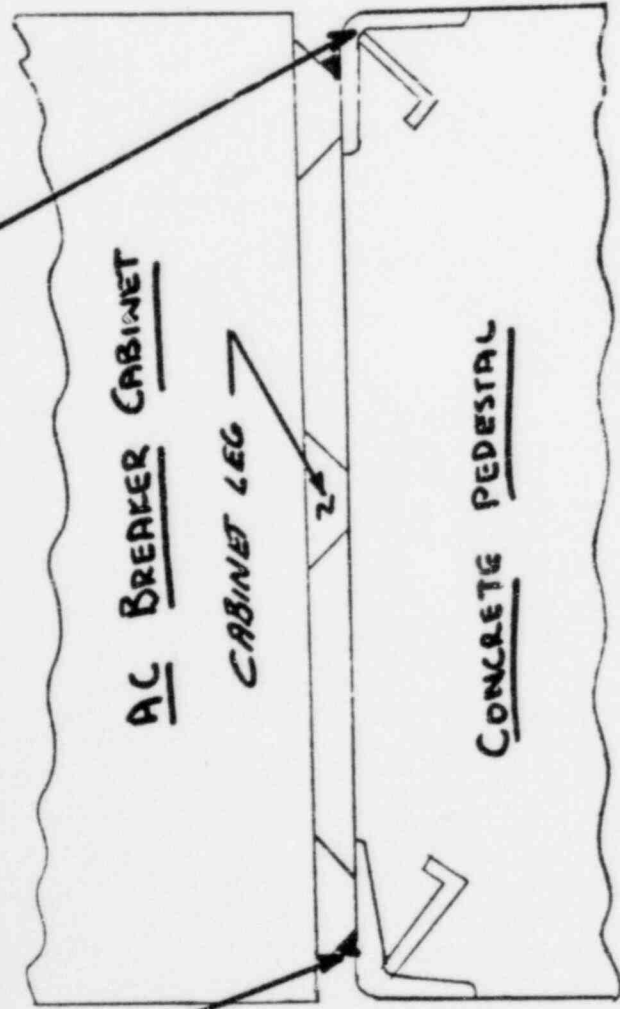
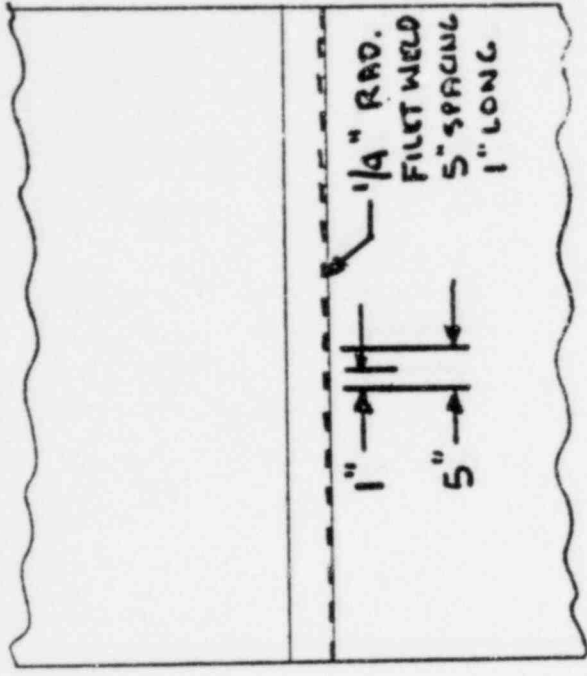
AC BREAKER CABINET
ATTACHMENT MODIFICATION

A reevaluation of the seismic qualification of the control rod drive control system AC breaker cabinets has found that the recommended attachment of the cabinet to the floor is inadequate to withstand the SSE acceleration levels.

In the event of an SSE, the AC Breaker Cabinets could, as per the finite element stress analysis, break loose from the floor mounting. With the cabinets unattached, the random motion or even falling over could cause accelerations of the breakers that have not been analyzed or damage to the breakers, wiring, or connections which could compromise the ability of the breakers to trip the control rods. Analyses cannot show that the failure will always be fail safe. Therefore, the deficiency in the design of the structural attachment of the AC Breakers Cabinets to the floor could adversely affect safety. This problem is thus considered to be a Significant Deficiency as per 10 CFR 50.55 (e).

The attachment of the AC Breaker Cabinet to the floor has been redesigned (see attached figure). Depending upon the arrangement at the particular site, either additional bolts will be included or a series fillet welds will be added to increase the attachment strength. Each plant with a construction permit or operating license is being evaluated on an individual basis. Newer plants are employing cabinet holddown designs which will assure the ability to withstand SSE loadings.
