DOCKET NO: 50-346

APPLICANT: Toledo Edison Company (TECO)

FACILITY: Davis Besse, Unit 1 (DB-1)

SUMMARY OF NRC SITE VISIT TO THE DAVIS BESSE NUCLEAR POWER STATION, UNIT 1

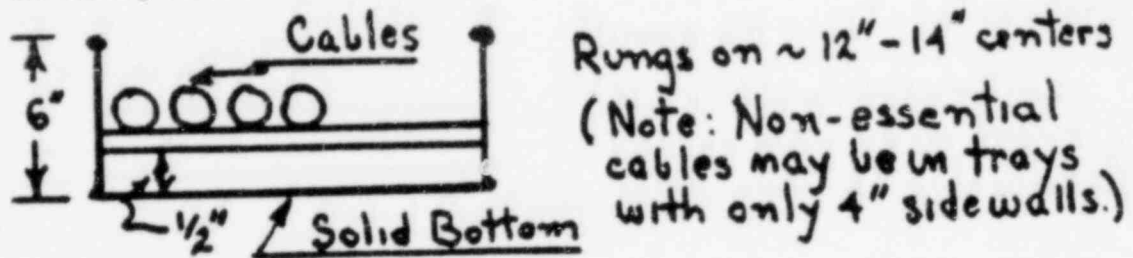
6. Cable tray cross sections as observed for DB-1 are shown in the following sketch.

The staff indicated that the cable tray design as indicated above was a good design.

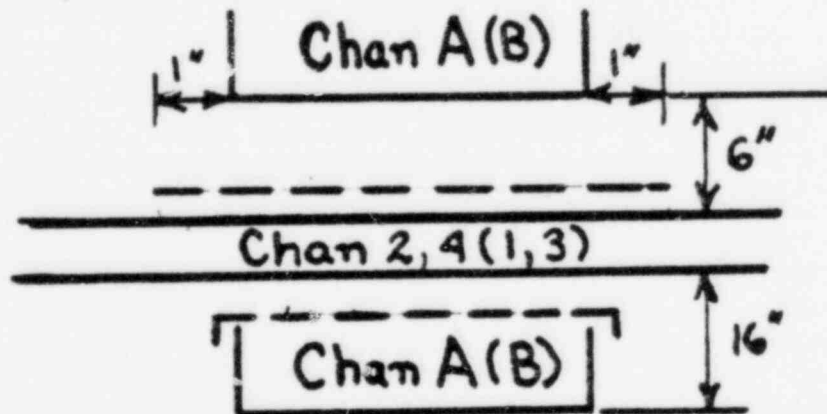
7. TECO stated that the minimum separation distance between redundant cable trays was 4 feet vertical and 18 inches horizontal (bottom to bottom). Less separation would require installation of a barrier. The staff indicated the above provisions were acceptable.
8. Non essential cable trays (Channels A, B, or C) are permitted between redundant essential cable trays. The staff concluded that this was acceptable provided the following minimum separations were maintained. Less separation would require fire barriers as shown by dotted lines.

TECO stated that the above criteria was acceptable to them.

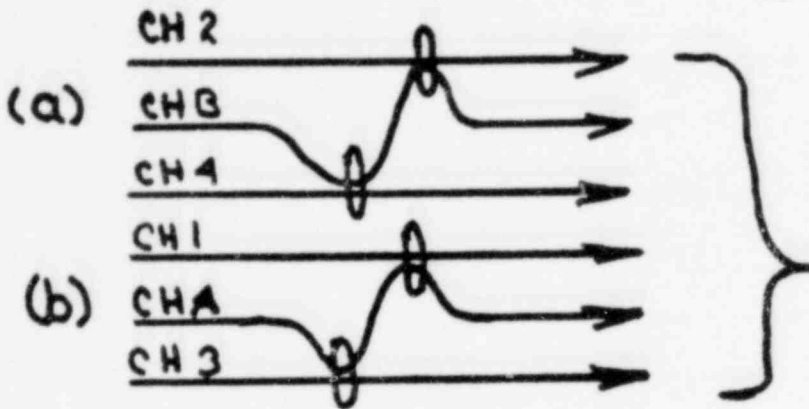
Unacceptable

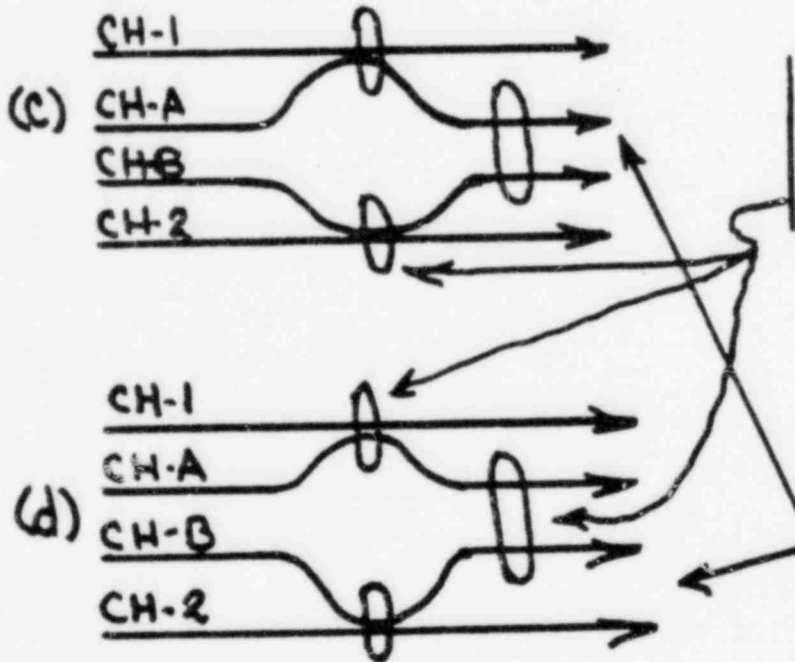
Areas where cables are bundled together (with no separation or barriers provided)

Unacceptable unless it can be demonstrated by test that flame propagation from one safety channel to a redundant safety channel will not occur for these configurations.

TECO stated that flame test data would be documented to substantiate the acceptability of arrangements 9-c) and 9-d) above.

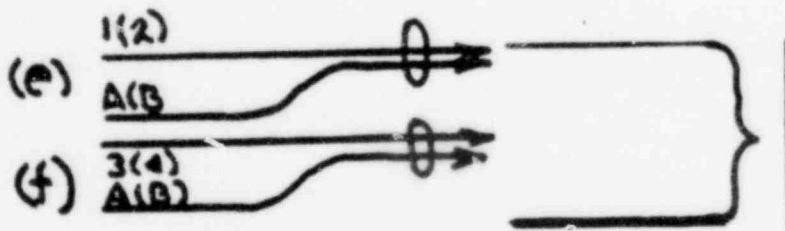
Acceptable provided verification that cable A(B) is not also bundled, routed, or formed with any cable at another essential channel.
