Docket No. 50-~~256~~

Applicant: Florida Power Corporation

Facility: Crystal River, Unit 3

SUMMARY OF STATUS REPORT BY FLORIDA POWER CORPORATION ON THE CONCRETE SEPARATION IN THE CRYSTAL RIVER, UNIT 3 REACTOR BUILDING DOME

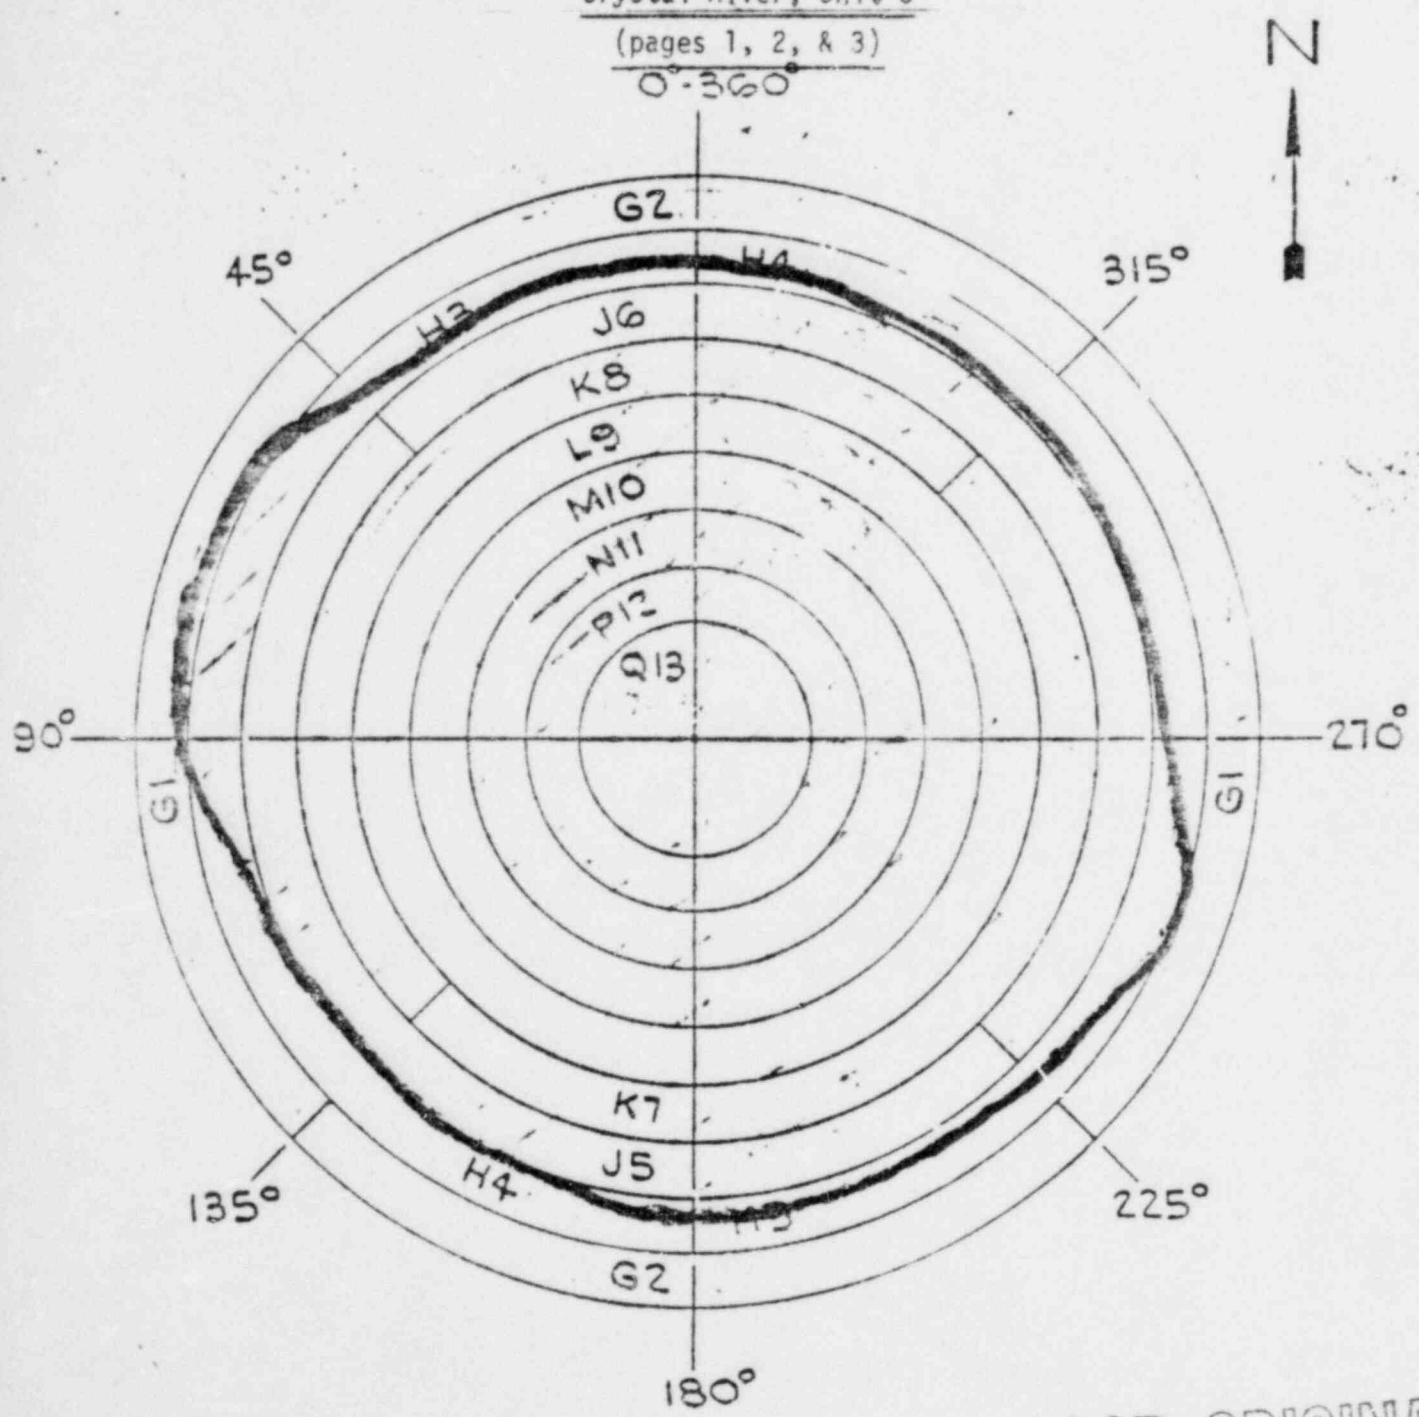
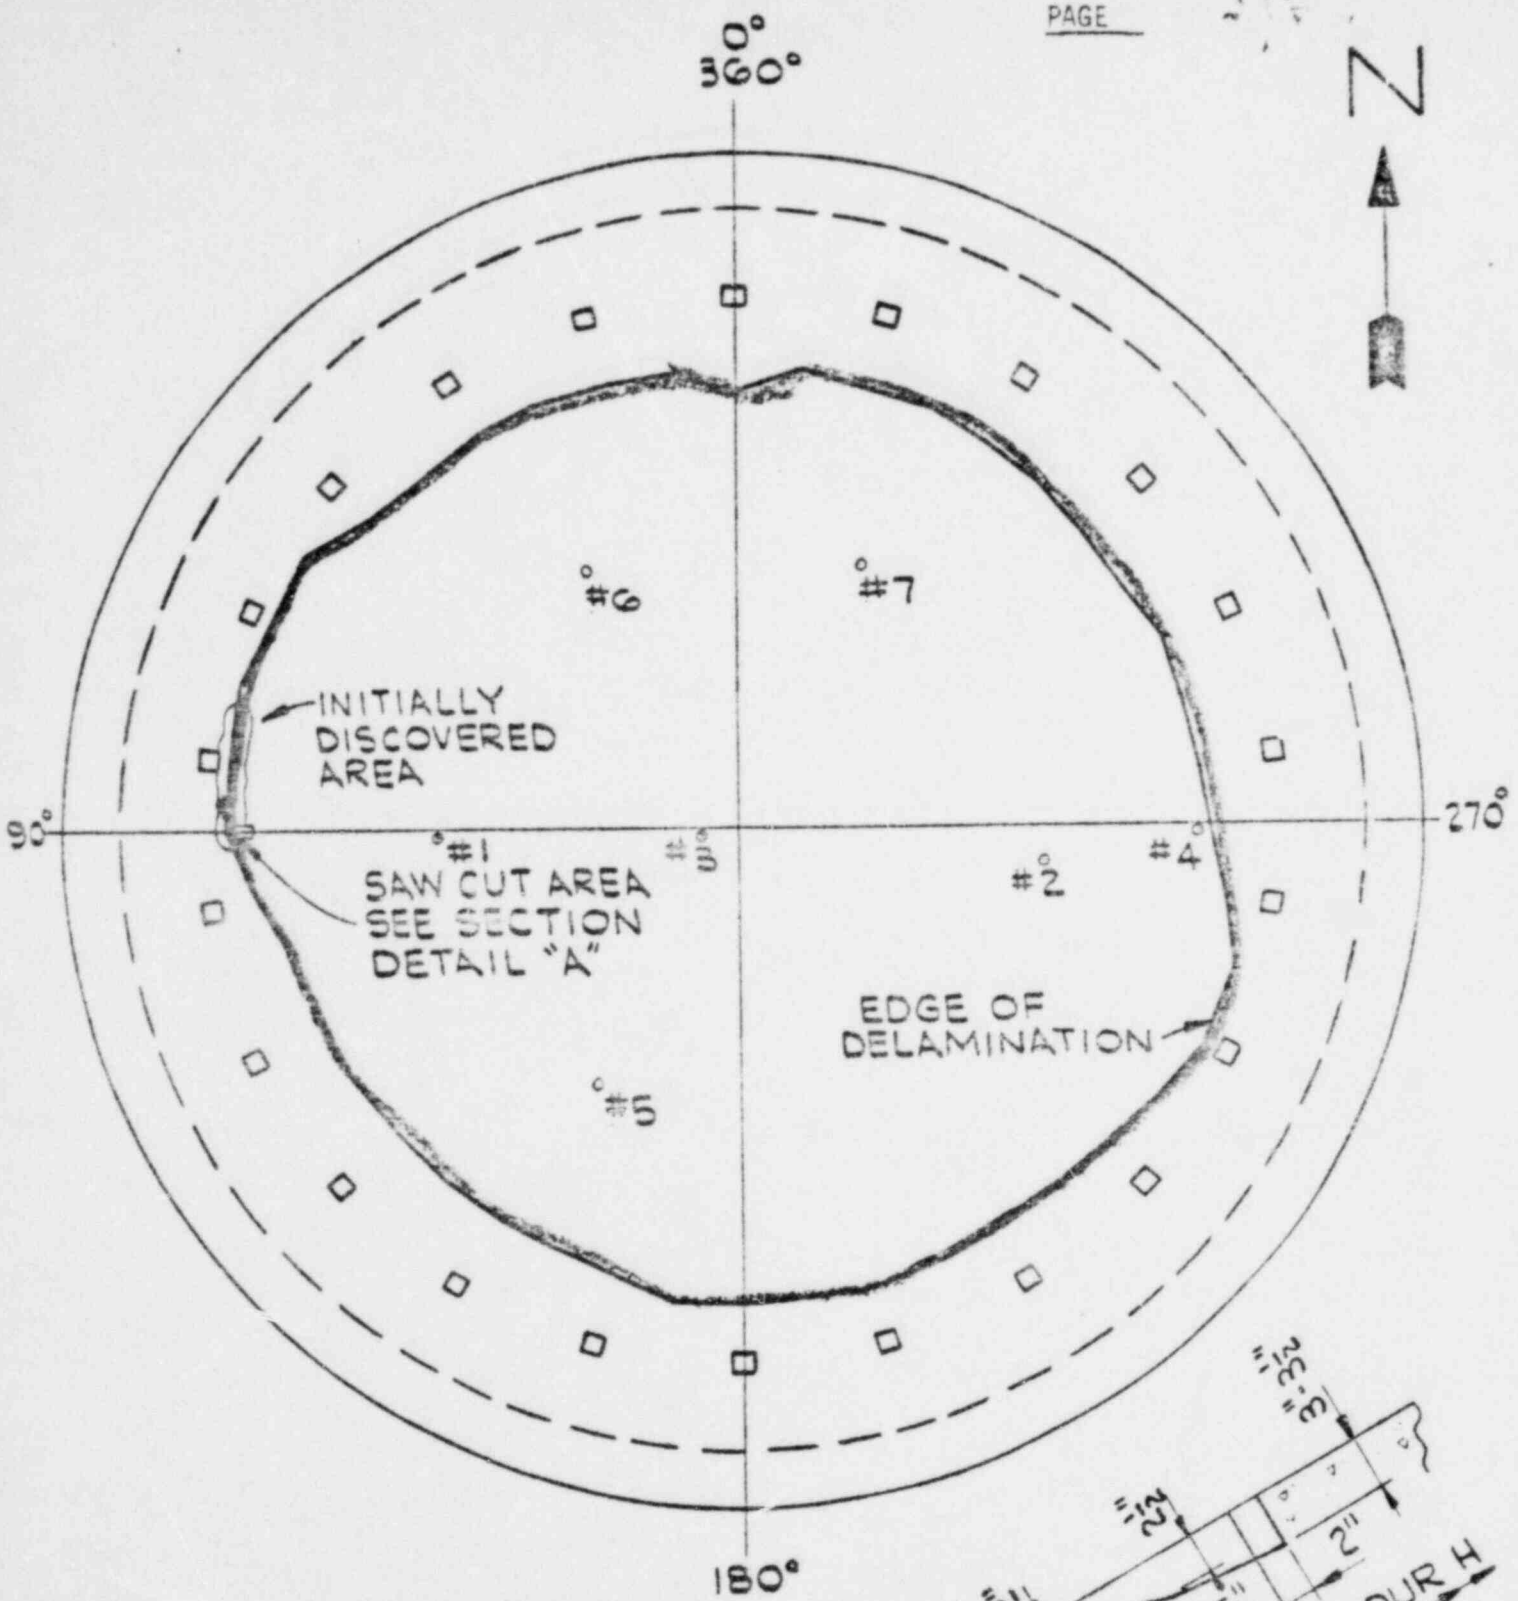
ATTACHMENT 2  
Delaminated Dome Area  
for  
Crystal River, Unit 3  
(pages 1, 2, & 3)  
0-360

On April 14, 1976, while installing lightning arrestors on the CR-3 reactor building dome, the FPC observed that there appeared to be a void about one inch below the surface of the concrete dome. Investigations on April 16, 1976 involved the cutting and removal of a one by three foot concrete sample in the area where the void was first observed. It was found that the void increased in depth in the direction of the dome apex. Further core drilling on April 17 and 18 determined that the concrete separation continued on across the dome and went as deep as 15 inches with a maximum separation of about 2 inches. Acoustic sounding determined that the outer periphery of the separated area extended all around the dome in Pours G and H (See attachment 2).

DELAMINATED AREA

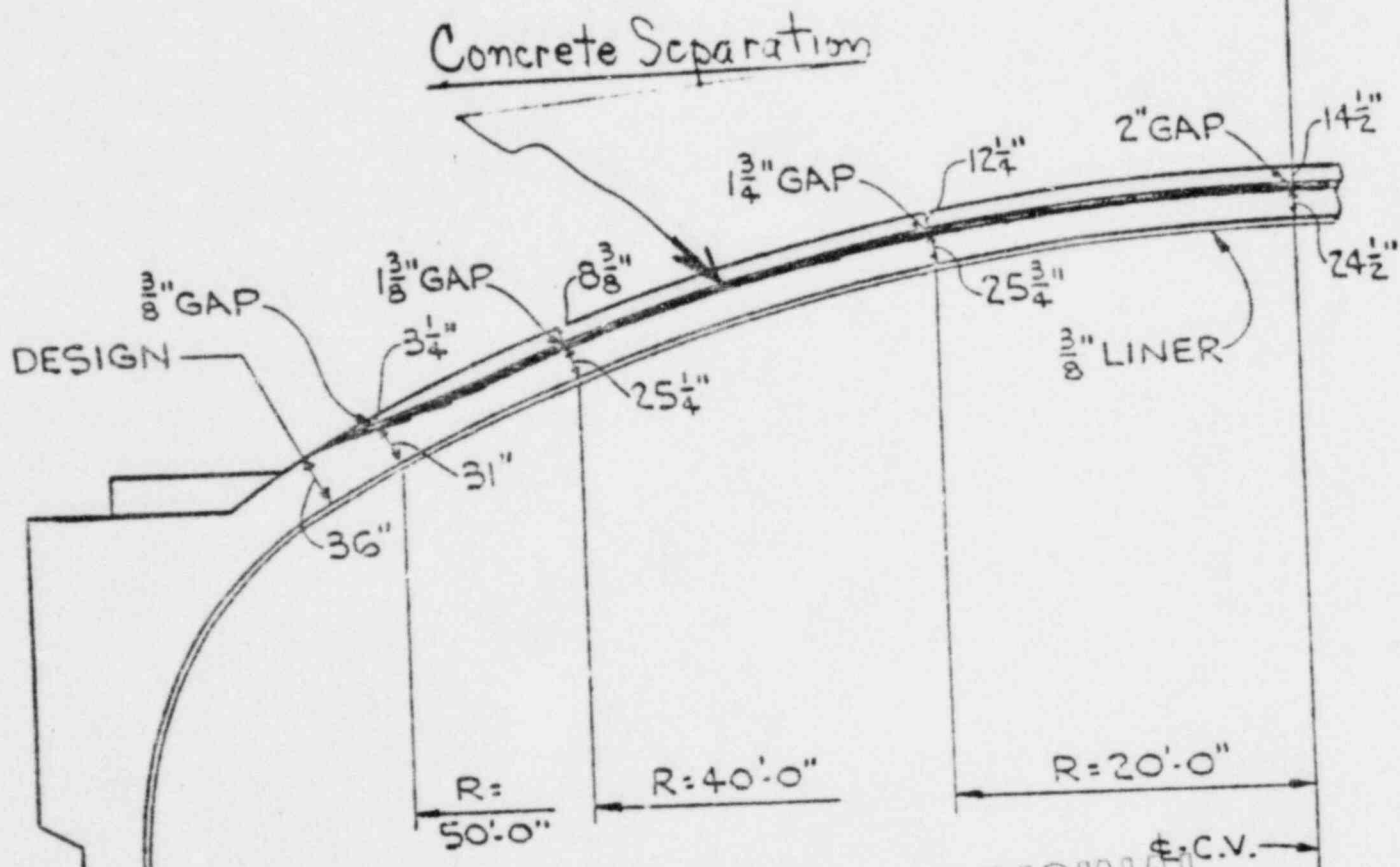
DOME SECTION - 90° AZIMUTH  
(GOVERNING AS IS DOME THICKNESS)

Analytical studies are being conducted on both 2 and 3 foot domes to determine if the 2 foot dome (the concrete thickness below the concrete separation) can adequately perform the intended functions of the three foot dome.

Therefore, the use of a 24" thick concrete dome section for the 2 foot analytical model does not represent the actual conditions.

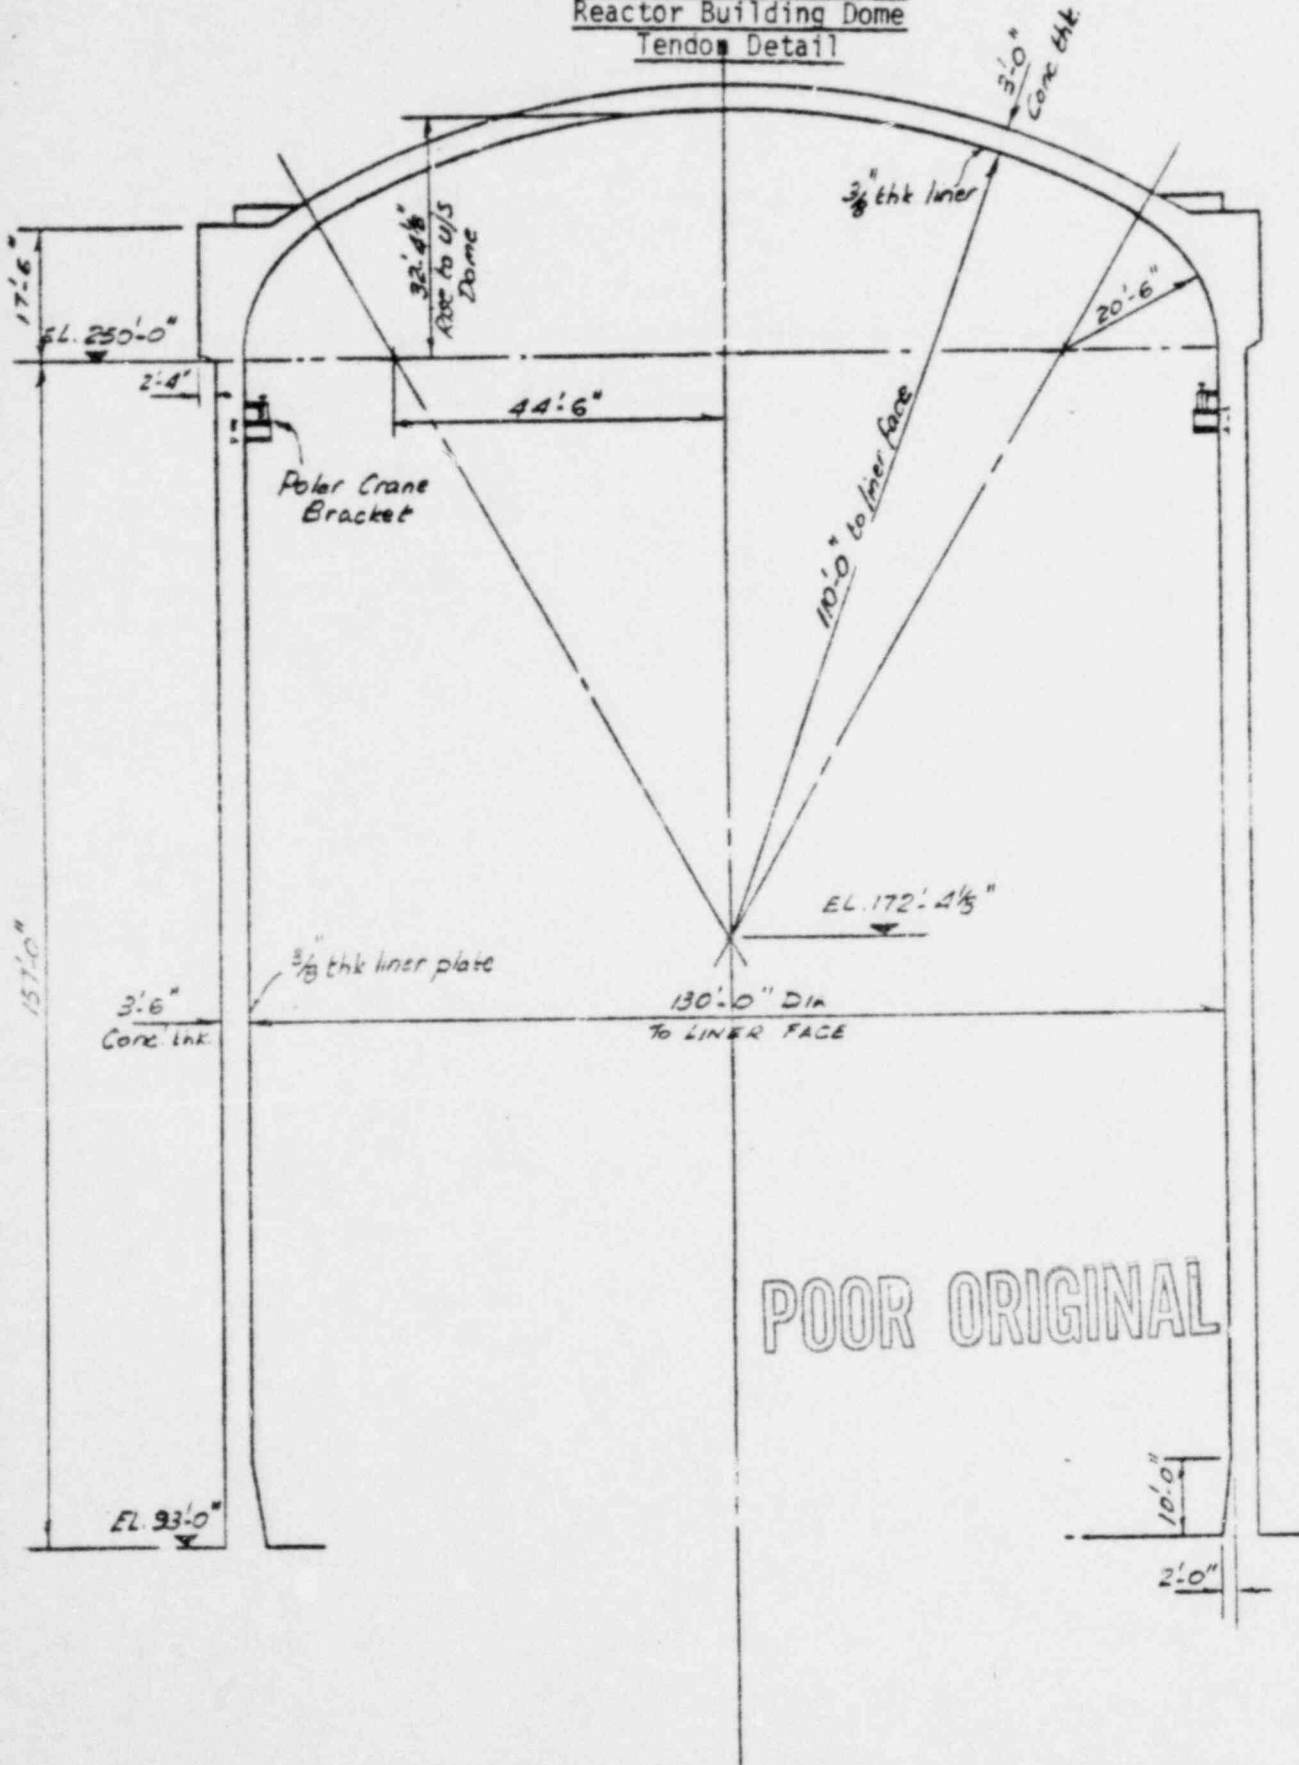
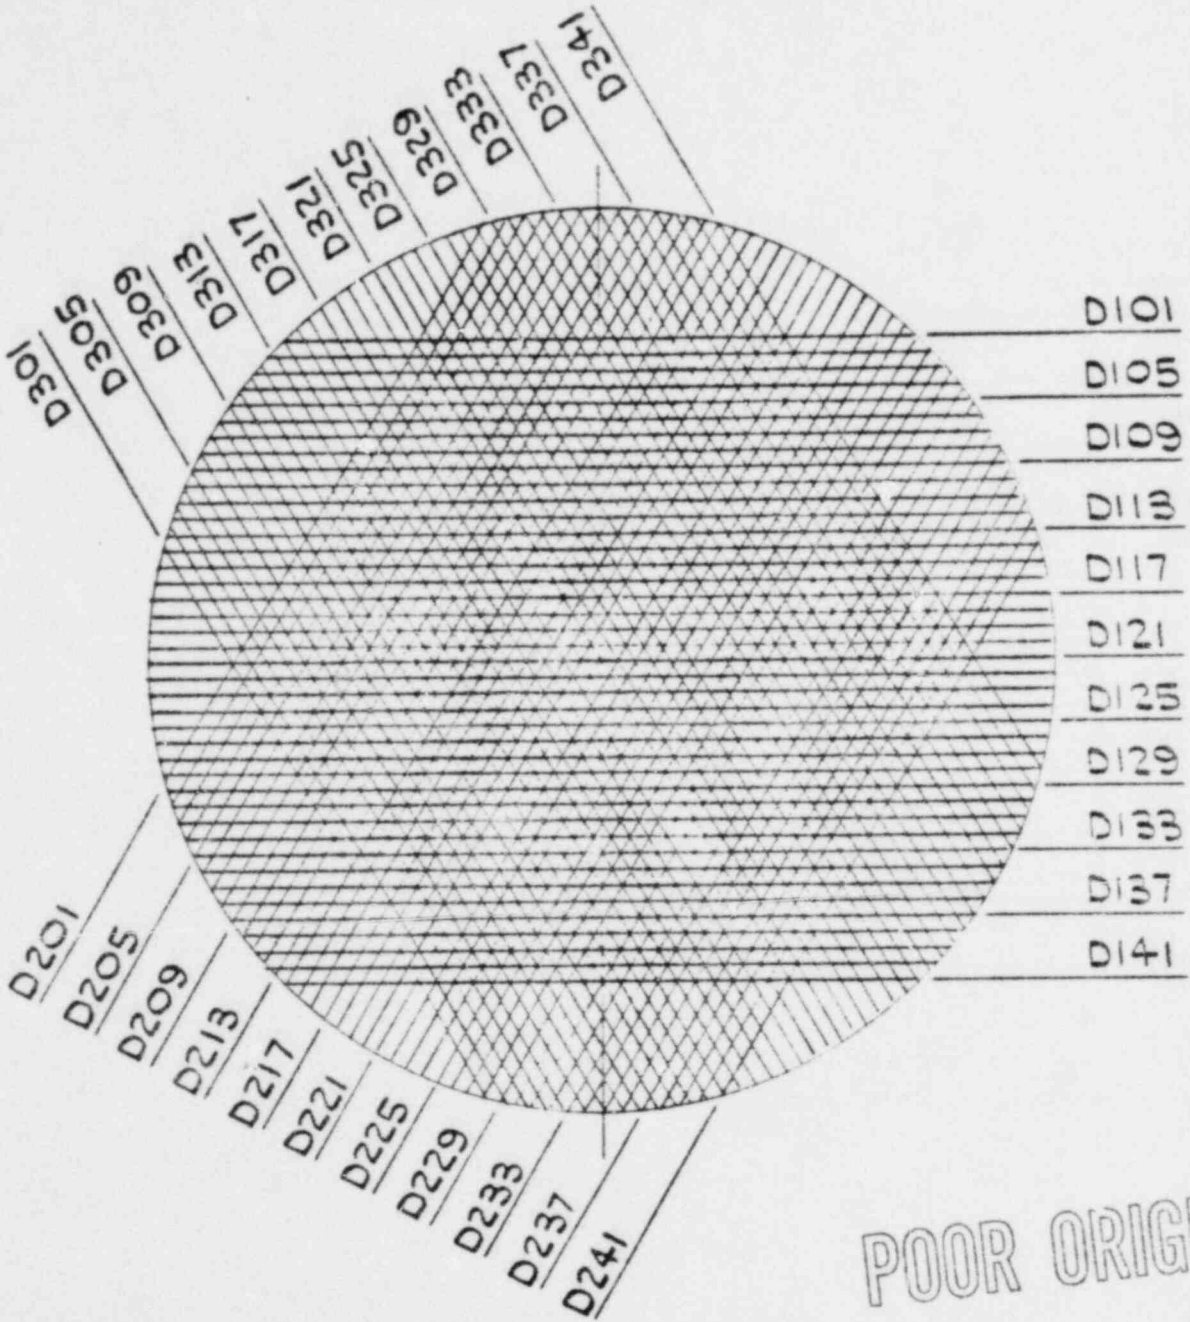
ATTACHMENT 3  
Crystal River, Unit 3  
Reactor Building Dome  
Tendon Detail

The dome is prestressed by means of tendons forming a three layer system (See attachment 3). There are 123 dome tendons arranged in 41 tendons per layer. The conduit sheathing for each tendon is a 5 inch diameter schedule 40 galvanized pipe. Each tendon has an ultimate strength of 2.355 million pounds and was made of 163 seven millimeter low-relaxation wires. The tendons are corrosion protected by bulk filling the conduit with grease.

Item 4 above may be a significant contributing factor to the problem. The temperature of the anti-corrosion grease when introduced in the tendon conduit was 130-150°F. A expansion study of 40 schedule pipe indicates a 10 rise in grease temperature produces a pressure of 10 psi on concrete surrounding the pipe conduit.

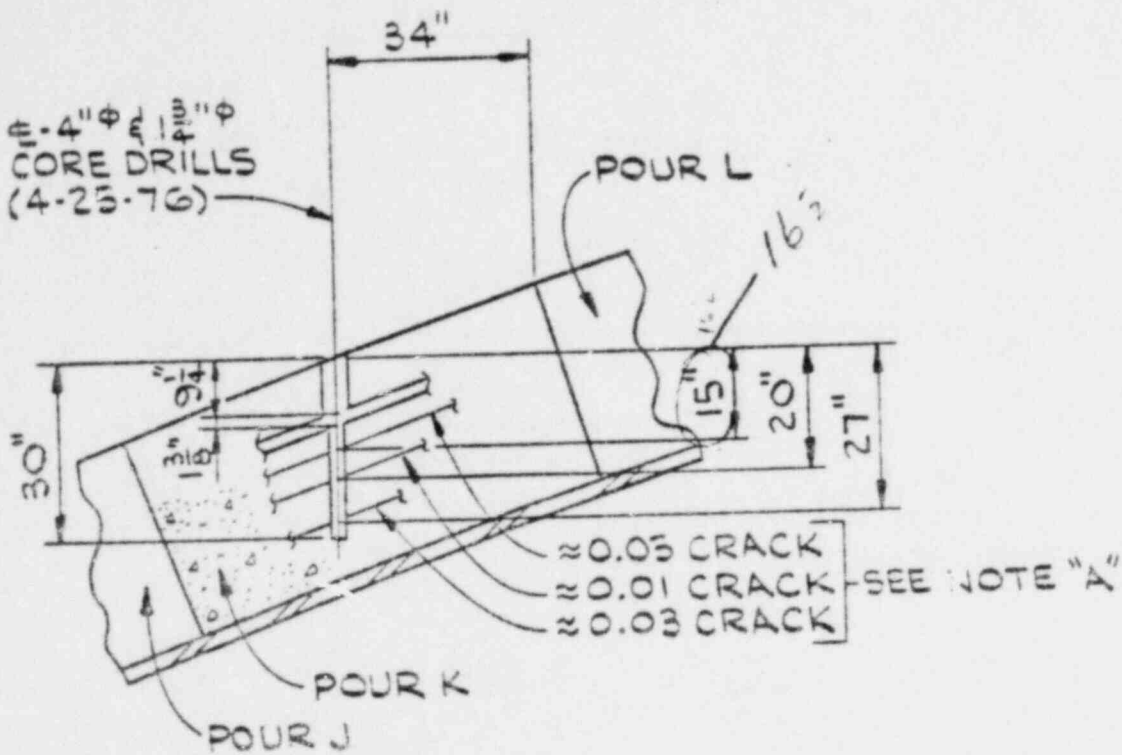
CORE #30

Core sample #30 has showed three cracks at the depths of 1 3/8 inches, 9 1/2 inches, and 11 1/16 inches. The core drilling program requires the use of water and it has been observed that water must be vacuumed out of the core sample holes indicating cracks are not excessive.
