NJK-76-118

Reference: Quad-Cities Nuclear Power Station Docket No. 50-265, DPR-30, Unit 2

in response to your inspection Report No. 050-265/76-04, the following report concerning possible generic problems related to Electro-Hydraulic Control (EHC) system oil migrating to the cable tunnel area is being submitted.

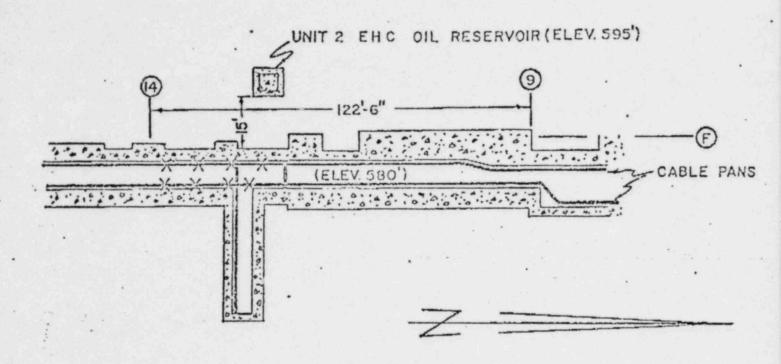
## FIGURE. I

On October 9, 1975, station personnel were cleaning up EHC fluid which had been dripping on the Unit 2 cable tunnel floor. It was noticed not only had the EHC fluid been leaking onto the floor but also it had been leaking onto the cables in the surrounding cable pans. Closer inspection of the cables revealed puffing and plasticization of cables that the EHC fluid had made contact with. At the time of discovery, Unit 2 was in the cold shutdown condition.

## UNIT 2 CABLE TUNNEL PARTIAL PLAN

X- DENOTES AREAS WHERE THE EHC OIL HAD ACCUMULATED REFERENCE DRAWING - SARGENT & LUNDY M-5

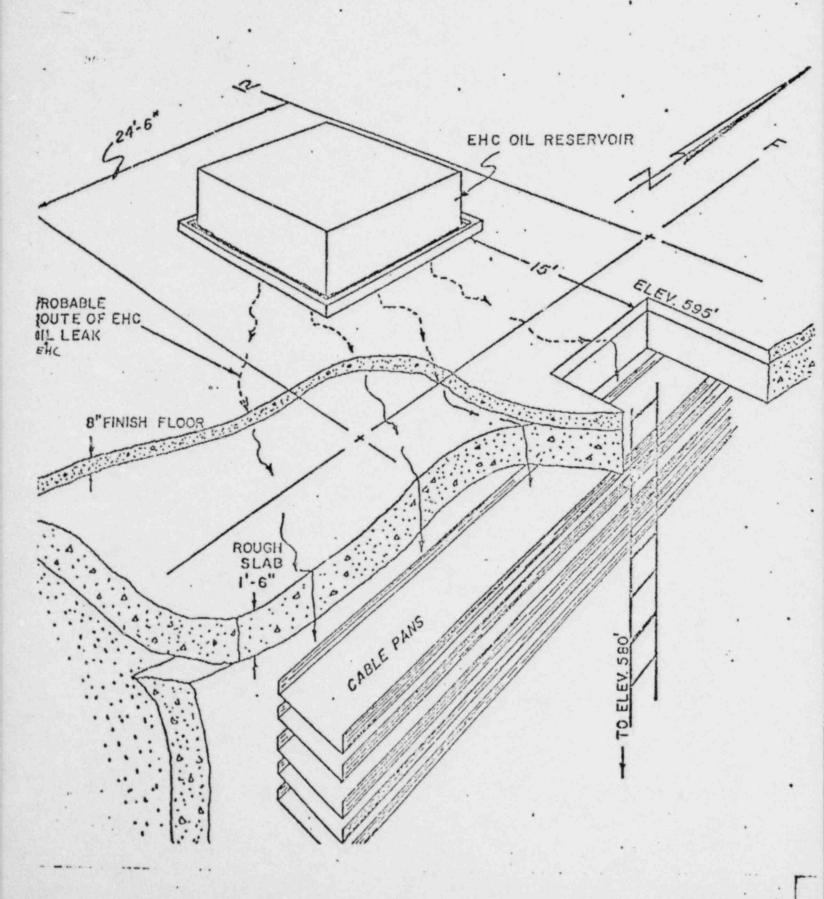
FIGURE, 2

The rough slab serves as the celling in the Unit 2 cable tunnel and minor small cracks in the celling served as a leak path out of the concrete and onto the cable trays and floor. Portions of cables within these trays thus became saturated with the EHC fluid.

The upper cable trays did not contain all of the EHC fluid, even though the pans in the cable tunnel were of solid bottom construction. This was because the EHC fluid had leaked through the cable pan connecting joints and thus all the cable pans below were subjected to the EHC fluid. The cables closest to the bottom of the cable pans were most affected by the EHC fluid because these cables were in constant saturation with EHC fluid.

At the present time, all the cables in the affected area of the Unit 2 cable tunnel are being protected from the continuing EHC fluid leakage. The leakage has subsided and once it has stopped the ceiling area will be cleaned and a protective sealer will be applied to prevent any possible leakages.

The EHC fluid reservoir foundation must also be sealed with the same protective sealer once leakages have been resolved. The sealer has been ordered from the Carboline Company, type 187 NFP, which is a recommended EHC fluid sealant.
