Enclosure: IE Circular
No. 77-03, Fire Inside
a Motor Control Center

March 4, 1977
IE Circular No. 77-03

FIRE INSIDE A MOTOR CONTROL CENTER

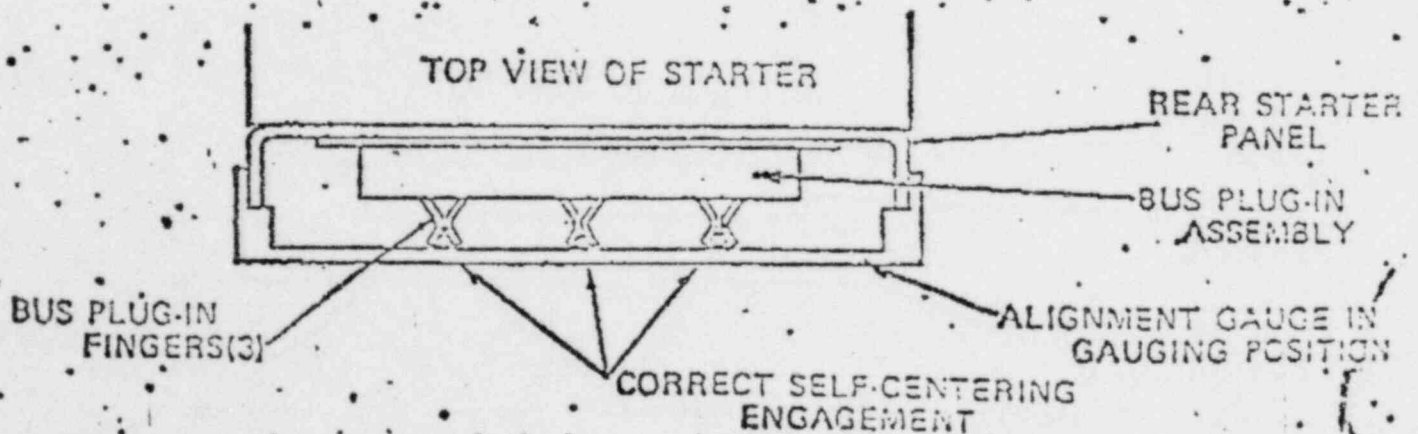
- (2) Seat the stops on the inside of the ends of the alignment gauge against the flanges of the starter mounting panel as illustrated.
- (3) The 1/4" round bars welded to the gauge approximate the vertical bus positions in the MCC. These bars should be within the flared ends of the plug-in fingers, allowing the fingers to self-center themselves lightly around the bars. If fingers are not deformed, there will be no problem visually verifying correct self-centering engagement as illustrated below.

- (4) If the self-centering action is not properly achieved, the plug-in assembly must be repaired or replaced.
- (5) After correct gauging, the starter should be handled with care and immediately installed into the Motor Control Center.
