Docket No. 50-329
 Docket No. 50-330

November 8, 1977
IE Bulletin 77-05

ELECTRICAL CONNECTOR ASSEMBLIES

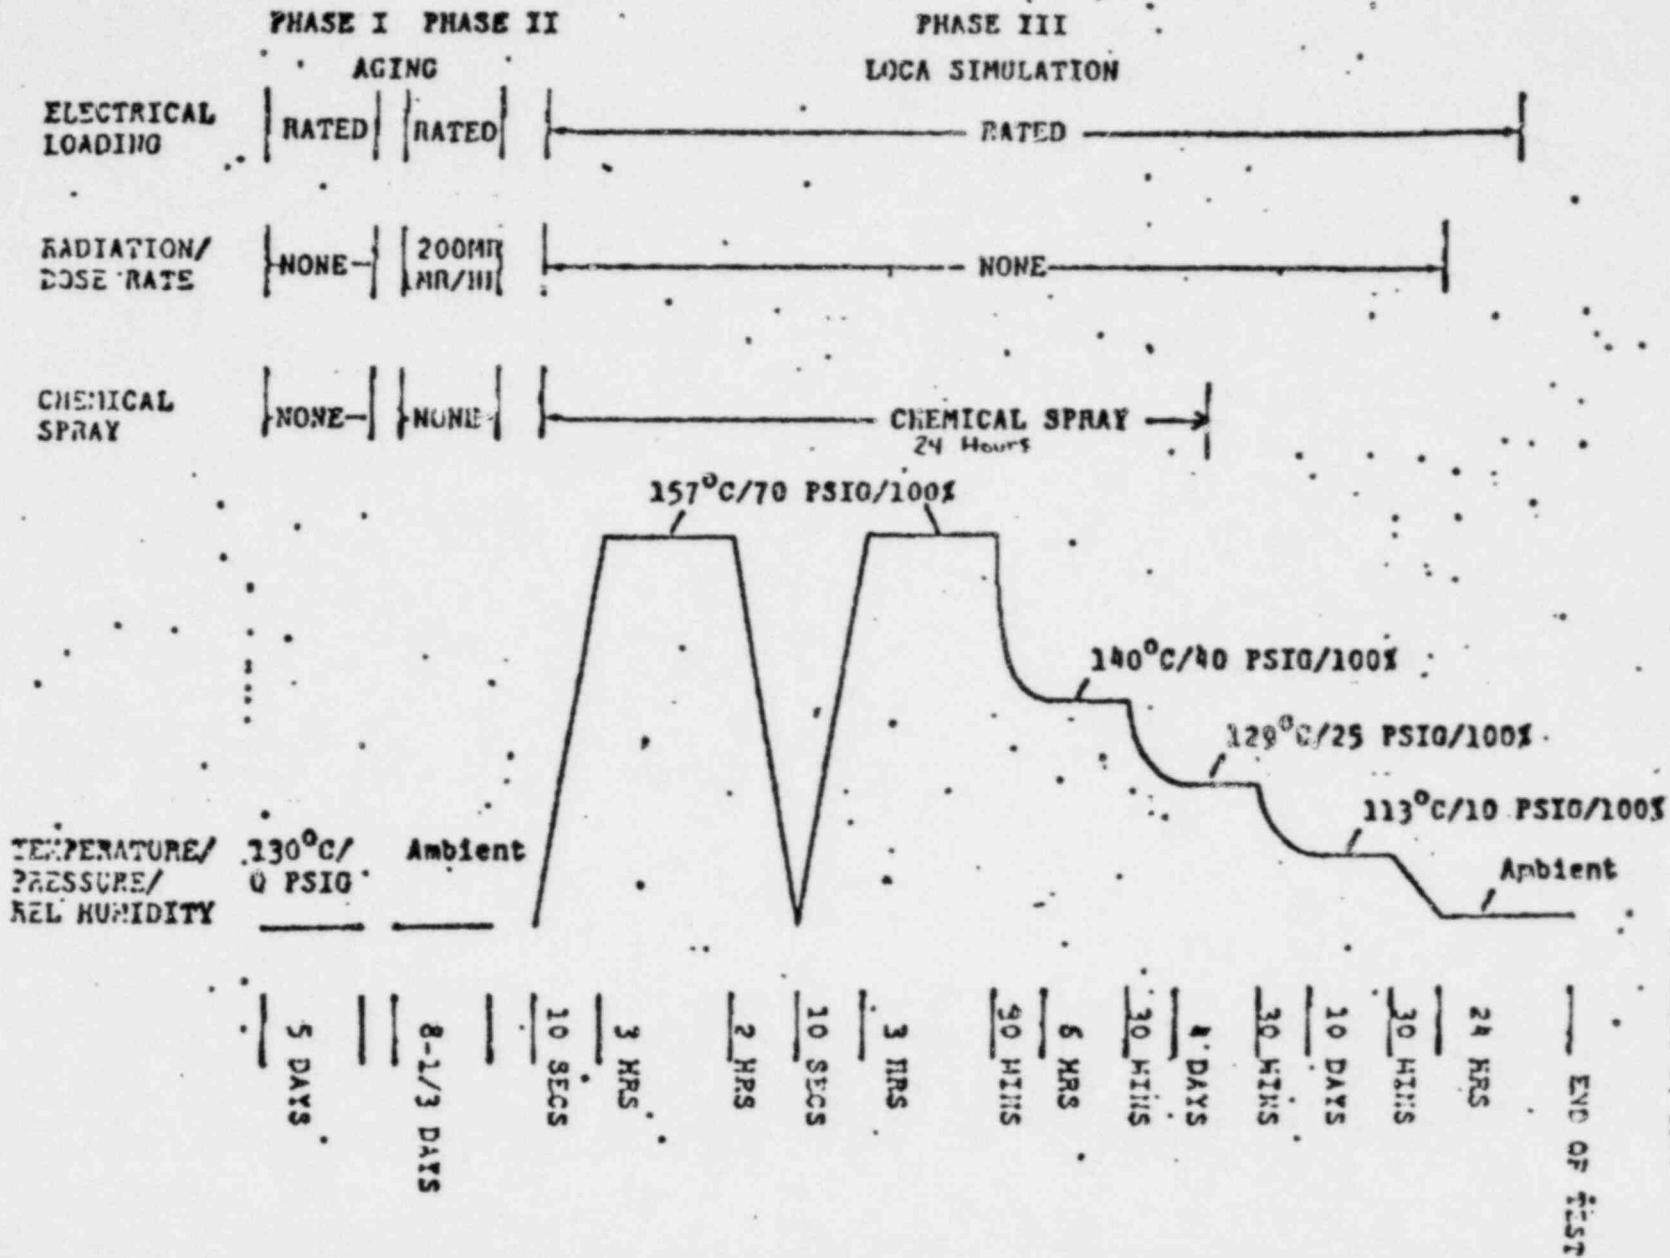
Figure 1

The three tests performed by Sandia were composed of two sequential and one simultaneous exposure to LOCA environments. In each case the equipment was exposed to radiation and thermal aging prior to operating under the simulated LOCA conditions. Figures 1 and 2 describe the test profiles for sequential and simultaneous tests respectively (Sandia tests were designed to study synergistic effects). Each of the tests satisfy the intent of IEEE 323-1974. The assemblies were electrically loaded to 20 amperes and 600 volts at the start of the tests. Insulation resistance and capacitance measurements were recorded during the tests to indicate damage.

SEQUENTIAL TEST PROFILE

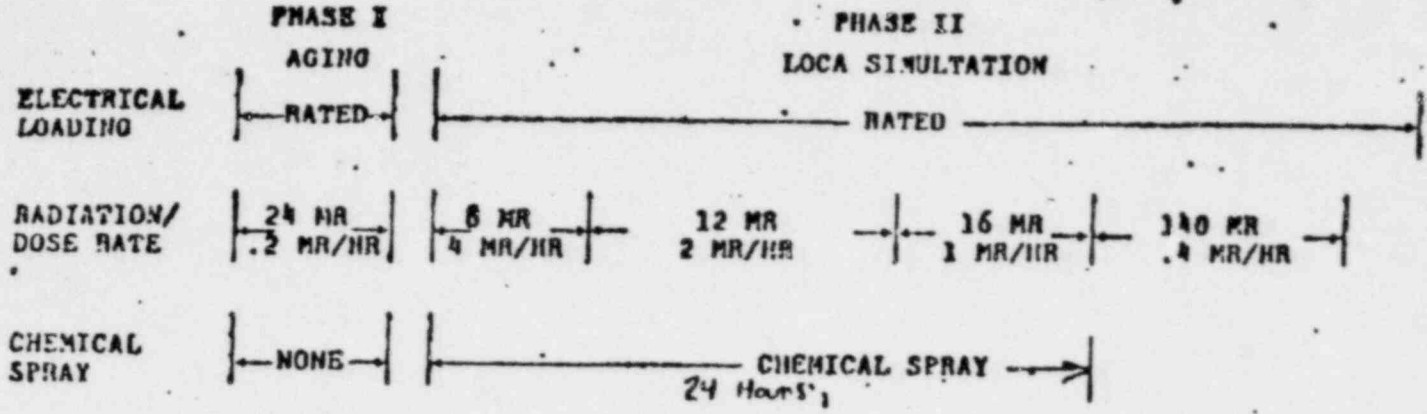
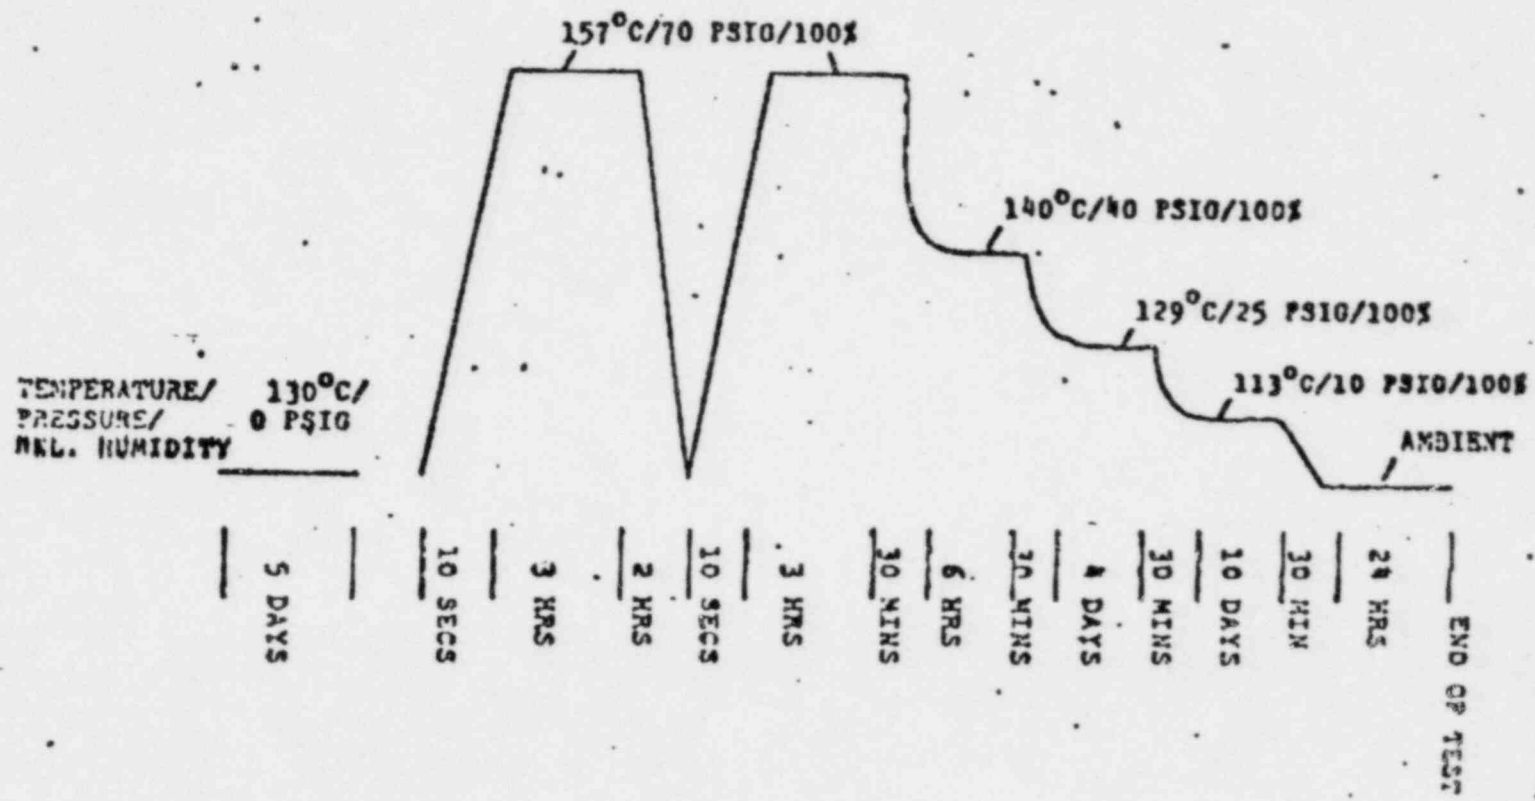
Figure 2

SIMULTANEOUS TEST PROFILE
