U.S. NUCLEAR REGULATORY COMMISSION  
OFFICE OF INSPECTION AND ENFORCEMENT

IE Bulletin No. 78-05

MALFUNCTIONING OF CIRCUIT BREAKER AUXILIARY CONTACT MECHANISM -  
GENERAL ELECTRIC MODEL CR105X

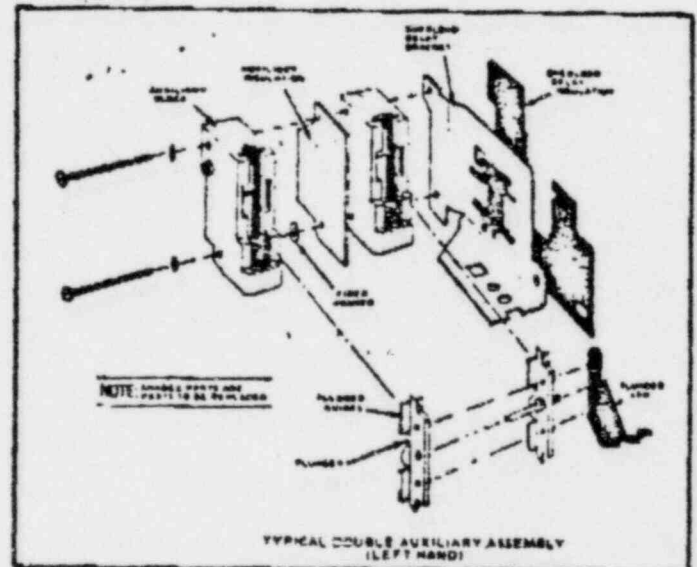
FIGURE 2

The Sacramento Municipal Utility District recently reported a problem encountered with the operation of the GE Model CR105X auxiliary contact mechanism installed in a 480 volt circuit breaker. Investigation into the cause for the inability to shutdown a booster supply fan (SF-A-7) in the control room emergency air conditioning system revealed that an auxiliary contact (GE Model CR105X) had failed in the closed position, preventing the fan's power supply circuit breaker from opening. The specific cause for failure was binding of the plunger arm due to burrs and nicks on its surface.

### CHANGING PLUNGER ARM & INSULATION (SEE FIG. 2)

1. Slide plunger assembly out of auxiliary contact block, by lifting up and out.
2. Select the new plunger arm that is bent the same way as the one installed.

3. Loosen screw on plunger to release metal arm but DO NOT REMOVE SCREW FROM PHENOLIC PLUNGER (OR PLUNGERS).
4. Mount new plunger arm on plunger. Fasten arm to plunger with screw (or plunger post if installing double aux. blocks).

5. Apply thin coat of aeroshell grease along plunger guides.
6. Reinstall plunger assembly in contact block.
7. Reassemble overload to mounting bracket. Remove overload insulation and install new. (NOTE: Overload insulation must be removed and replaced with new insulation supplied with kit.)

8. Remount complete assembly on contactor base.
9. Reconnect any wires previously removed.
10. Reassemble magnet assembly to contact base (on reversers or multispeeds be sure to interlock this assembly with mechanical interlock arm. Check for free movement of armature assemblies and mechanical interlocks).

11. Observe that auxiliary contact plunger assemblies are operating properly.
