U.S. NUCLEAR REGULATORY COMMISSION  
OFFICE OF INSPECTION AND ENFORCEMENT

IE Circular No. 78-04

INSTALLATION ERRORS THAT COULD PREVENT CLOSING OF FIRE DOORS

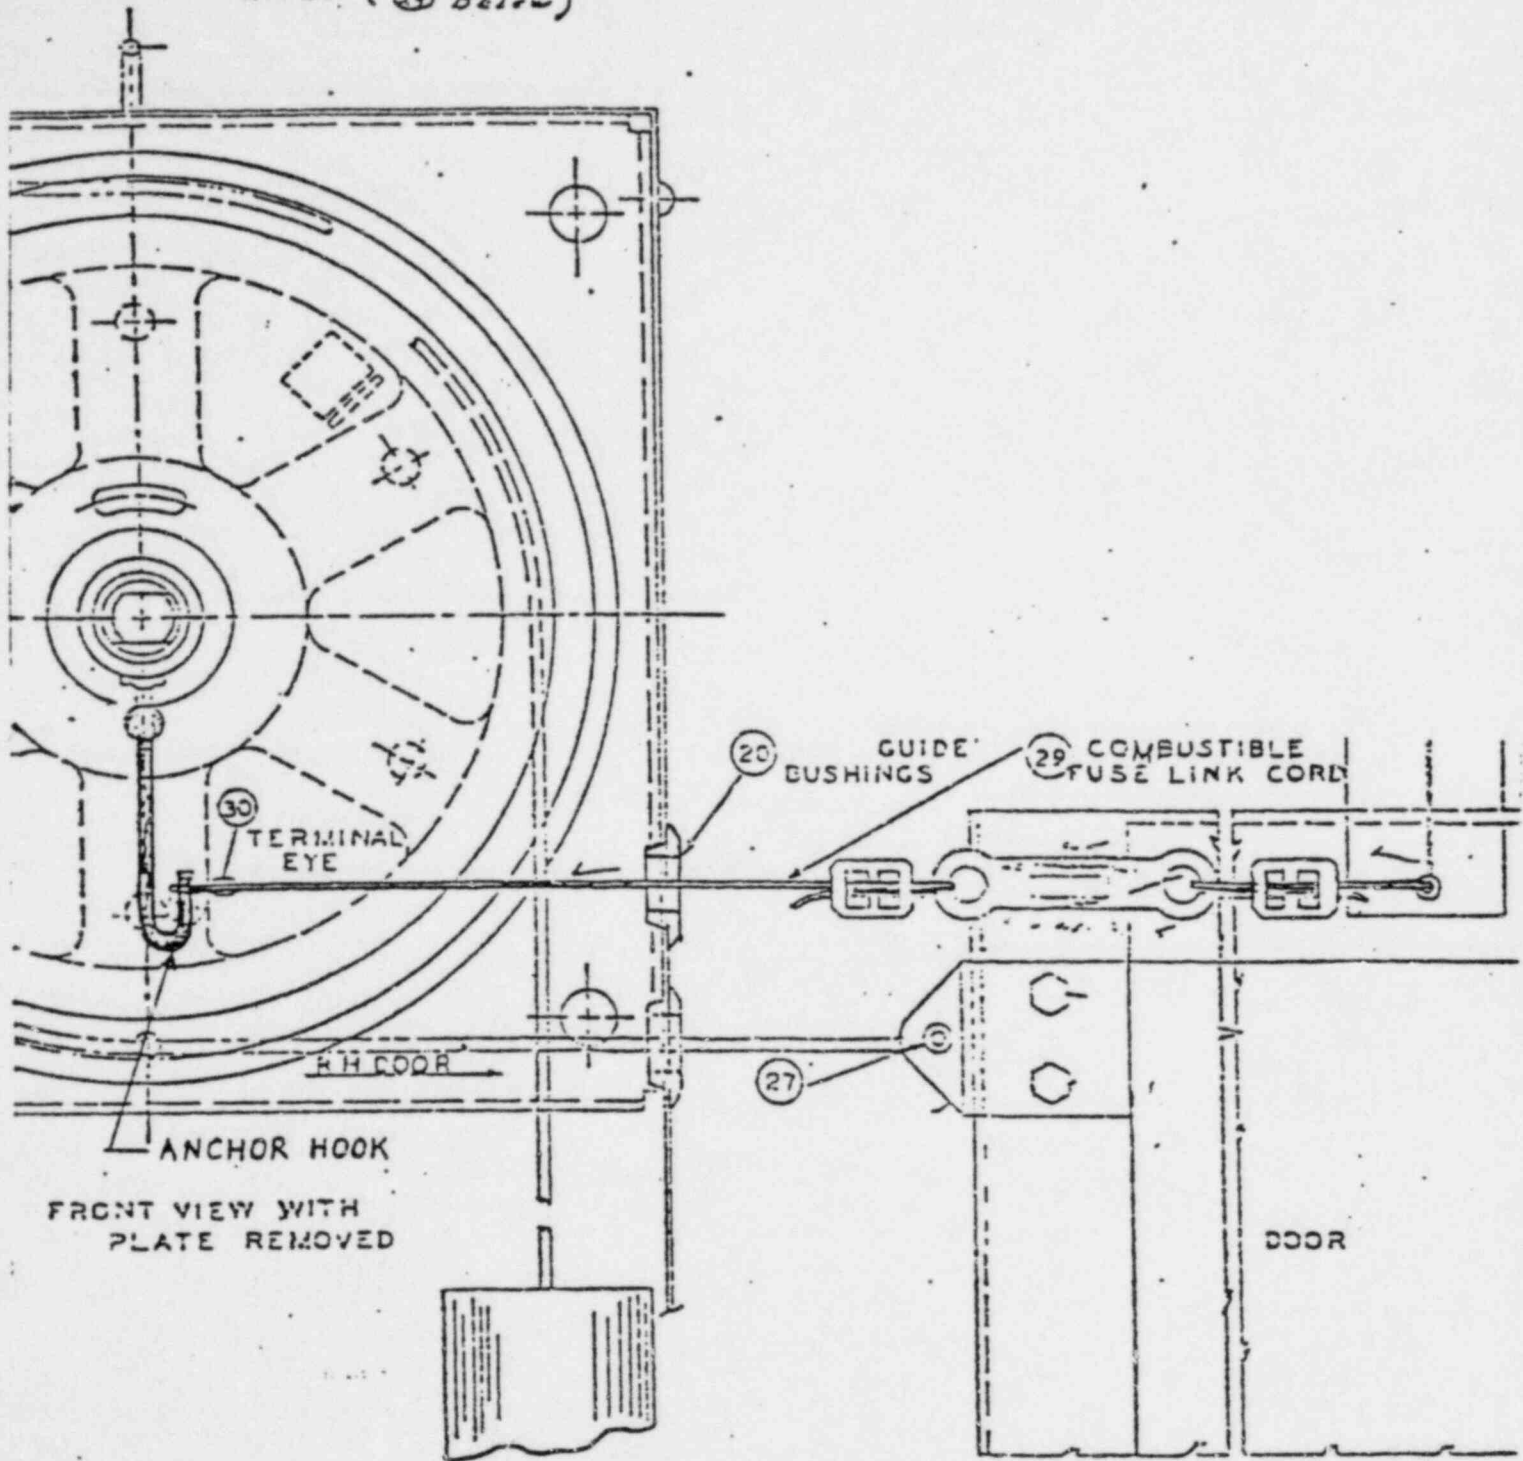
The mechanism involved are D and H Pyromatic door closers manufactured by Mesker (see attached drawing). Each unit is powered by a suspended weight which rotates a pulley arrangement to draw the fire door closed. Closure is normally prevented by a fuse link cord which acts through a lever arm. This device, called the "fuse link anchor hook," prevents rotation of the pulleys, unless the fuse links are severed by fire.

The first improper installation was the replacement of the combustible fuse cords by "S-Hook" type chain. The replacement was necessary due to random failures of the original fuse link cord. However, the cord (or chain) passes through an opening in the case containing the mechanism, and the S links tended to spring open and catch on the edges of this opening. This problem was aggravated in some instances by the lack of guide bushings which are normally installed to facilitate the passage of the chain through the opening.

Another error discovered was the mispositioning of the fuse link anchor hook. Following severance of the fuse link, the pulleys rotate clockwise and a correctly installed anchor hook is rotated through an angle that permits the terminal eye on the end of the fuse link cord to fall free. This prevents the cord (or chain) and the remains of the fuse link assembly from becoming entangled in the rotating mechanism. However, some anchor hooks were found to be installed with the curved section extending to the left (relative to the front view shown). This position can cause the terminal eye to remain hooked during rotation, instead of falling free. These errors actually caused the jamming of fire door closers during tests that followed their discovery.

CORD WAS REPLACED WITH SASH  
CHAIN BECAUSE OF RANDOM FAILURES  
OF THE COMBUSTIBLE FUSE LINK  
CORD. (35 BELOW)

The corrective actions were to replace the "S" type chain with flat sash chain, install the missing bushings and to correctly orient the fuse link anchor hooks.

It is recommended that all holders of reactor operating licenses and construction permits determine if any fire door closers of this type are installed in their facility(ies). If this is the case, it should be verified that they are installed in accordance with the manufacturers design and that improper installations, such as described herein, do not exist.
