MIDLAND NUCLEAR PLANT -  
UNIT NO. 1, DOCKET NO. 50-329  
UNIT NO. 2, DOCKET NO. 50-330  
SEISMIC CABLE TRAY SUPPORTS

QUALITY ASSURANCE PROGRAM  
MANAGEMENT CORRECTIVE ACTION REPORT  
MCAR-1

Cable tray support construction welding discrepancy

INTERIM REPORT # 1 DATE: 5/1/78

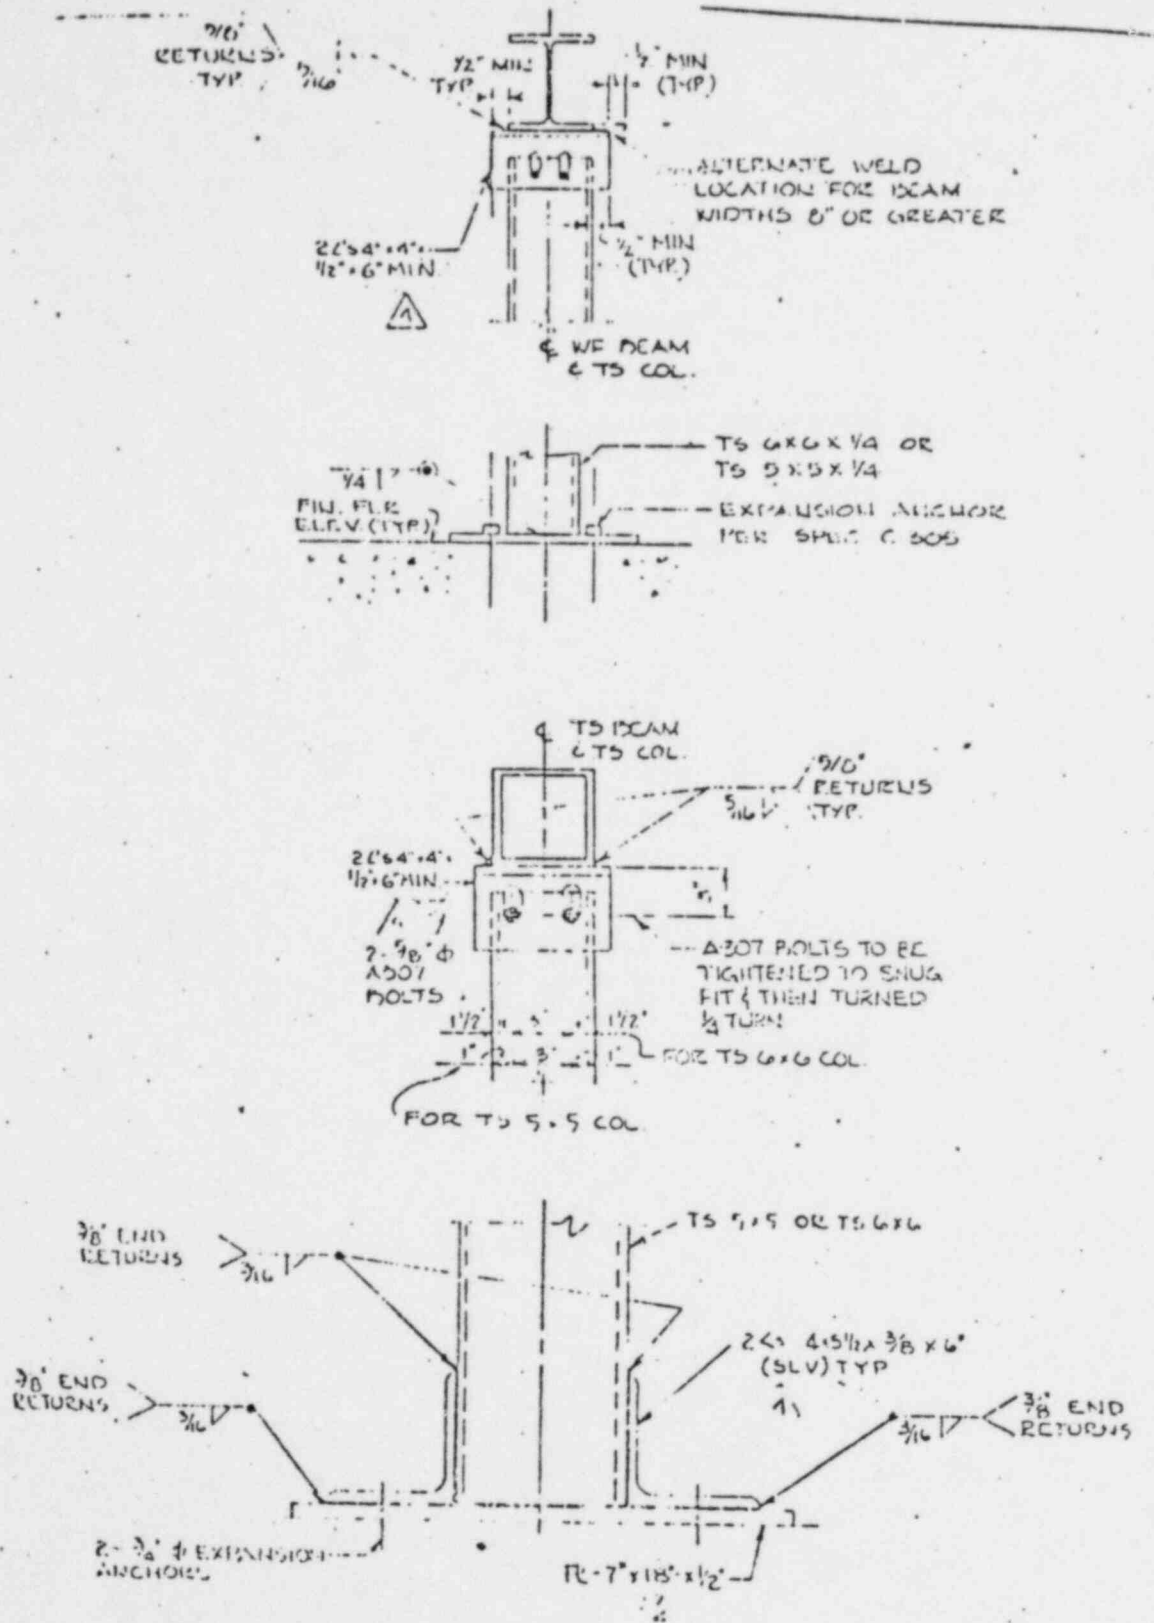
FIG. 1 TYPICAL UPPER & LOWER SUPPORT COLUMN CONNECTION.

There are four groups of typical connectons reported in the NCR 1287 and NCR 1306 as shown in Figures 1 through 4.
