MIDLAND NUCLEAR PLANT -  
UNIT NO 1, DOCKET NO 50-329  
UNIT NO 2, DOCKET NO 50-330  
CONTAINMENT BUILDING PERSONNEL AIR LOCKS

Midland Units 1 and 2  
Consumers Power Company  
Bechtel Job 7220  
MCAR-20 INTERIM REPORT 6  
Files 2417/2801

SUBJECT: MCAR #20 (Issued 2/1/78)

Cracked weld between stiffener and welding ring of  
personnel lock

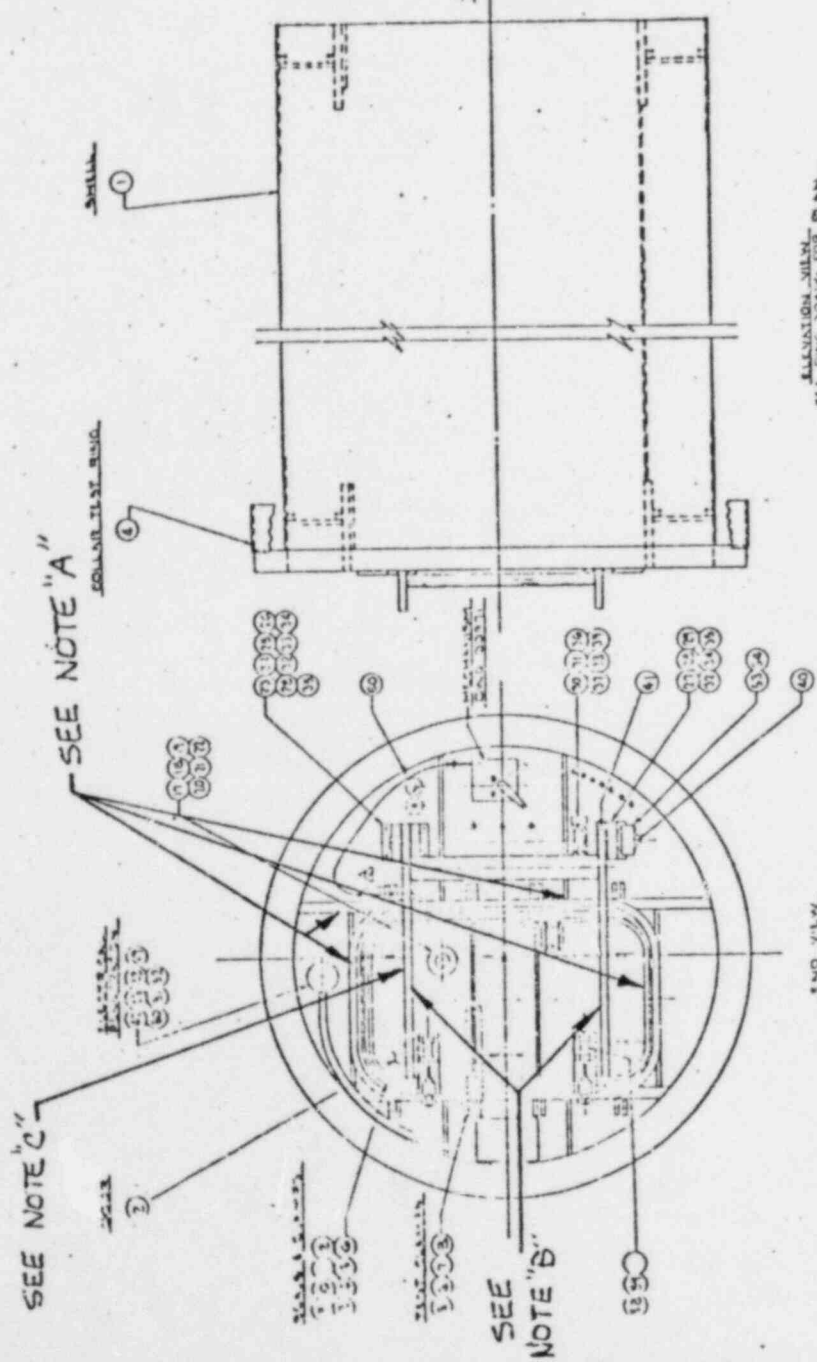
UNIT #2

Inspection of accessible 1/2" fillet welds on the bulkhead and doors of personnel locks verified that approximately 10% of the fillet welds inspected were between 1/16" - 1/8" undersize, the majority being 1/16" undersize. Also, inspection of 1/2" fillet welds revealed oversize welding in approximately 10% of the weld

The extent of the undersized welds reported in Interim Report #5 are as shown in the attached sketches.

NOTE "A" - LEG OF FILLET  
WELD  $\frac{1}{8}$ " SHORT

NOTE "B" - LEG OF FILLET  
WELD  $\frac{1}{8}$ " SHORT

NOTE "C" - THROAT OF FILLET  
WELD  $\frac{1}{16}$ " SHORT
