PART 21 IDENTIFICATION NO. 80-233-001 COMPANY NAME Westinghouse

NS-TMA-2264

No.: NSD-TB-80-9  
Date: 5/13/80

NSD TECHNICAL BULLETIN

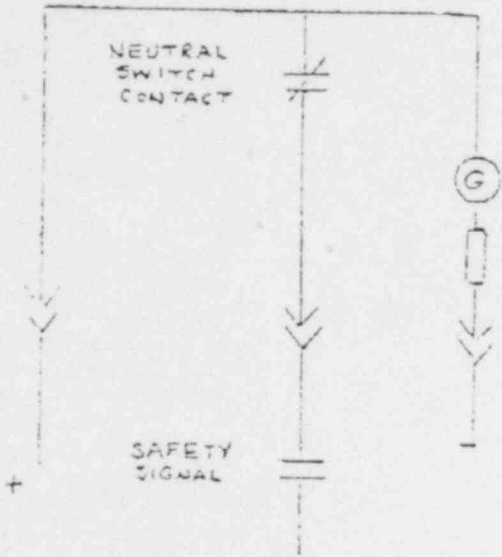
EXISTING (TYPICAL)

During monthly operational testing of the safeguards system at an operating nuclear plant, intermittent W-2 switch operation was discovered in the neutral (auto) position. Investigations revealed that the intermittent operation resulted when the switch is returned from the eleven or one o'clock positions to the neutral (auto) position. This matter was reported to the Nuclear Regulatory Commission.
