MIDLAND NUCLEAR PLANT UNIT NO 1, DOCKET NO 50-329 UNIT NO 2, DOCKET NO 50-330 POWER SUPPLIES TO EMERGENCY CORE COOLING ACTUATION SYSTEM (ECCAS) FILE: 0.4.9.40 UFI: 02210 (s) SERIAL: 9311

MCA2 32 (Issued 6/13/20)09348 Subject: Power Supplies to Emergency Core Cooling Actuation System (FCCAS) Final Peport

Consumers Power Company Project: Midland Plant Units 1 5 2 Rechtel Job 7220

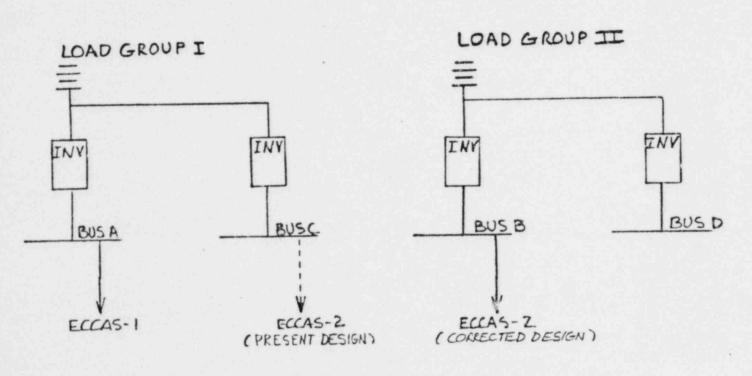
# TWO BATTERY SCHEME

Thus, based on the PAN drawing and the Rechtel schematic, a postulated event assuming a loss of power from the common load group coincident with a failure of the associated battery, would result in a loss of power to both ECCAS divital subsystems, since both buses A and C would be lost simultaneously (see attached figure).

The apparent cause of this discrepancy was due to a misinterpretation of the Midland plant 120 Vac preferred (vital) power system, specifically the electrical load grouping. The Midland 120 Vac preferred power system, which powers the ECCAS, is served by a two battery scheme, where each battery serves two protection channel buses.

The attached Figure shows the two battery scheme with the corresponding bus labeling and ECCAS digital subsystem bus assignments.

This letter is the Final Report on this matter in that the Bechtel design drawings have been corrected. B&W will have their drawings corrected by September 30, 1980. The ECCAS has not been installed. The only inplace hardware affected consists of three cables, two of which have been terminated. The revised Bechtel Design Drawings deleted these circuits. The Plant will be in conformance by September 30, 1980.
