Attachment to LER 80-029/01T-0

This report is separated into two parts; Part I provides a description of the system and Part II provides a chronology of events surrounding the violation of Technical Specification identified on July 16, 1980.

I. Pressure Boundary Leak Detection System (C-19)

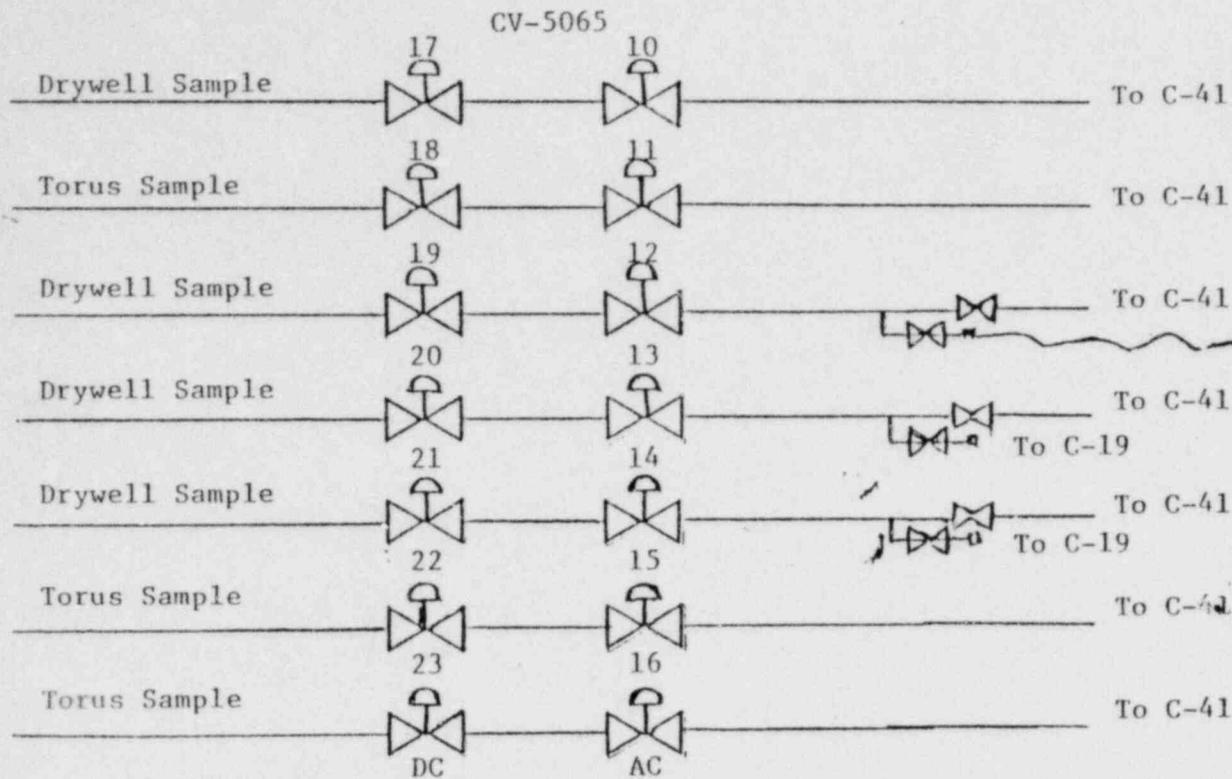
The sample flow to C-19 passes through one of seven sample lines which feed the O² Analyzer (C-41). The tap off this line is downstream of the solenoid operated control valves which are a part of the Primary Containment Isolation Logic. The seven sample lines to the O² Analyzer are shown on P&ID M-227, and the intertie to C-19 is illustrated on M-239 (see attached diagram for clarification).

1. Seven sample lines to C-41 (O² Analyzer)
2. All seven DC Solenoids controlled by one switch from Control Room Panel C-904.
3. All seven AC Solenoids controlled by one switch from Control Room Panel C-904.
4. Three Drywell Sample Lines with taps to C-19 from CV-5065-12, 13, and 14.
5. C-19 tied to line from CV-5065-12.
6. Torus sample valve 5065-23 was valve which failed timing.
