Subject: Dresden Station  
Cooling Lake Surveillance  
Reports

SUBJECT: Dresden Cooling Lake Inspection

DRESDEN LAKE INSPECTION

DTS 4450-1  
Revision 1  
January 12, 1980

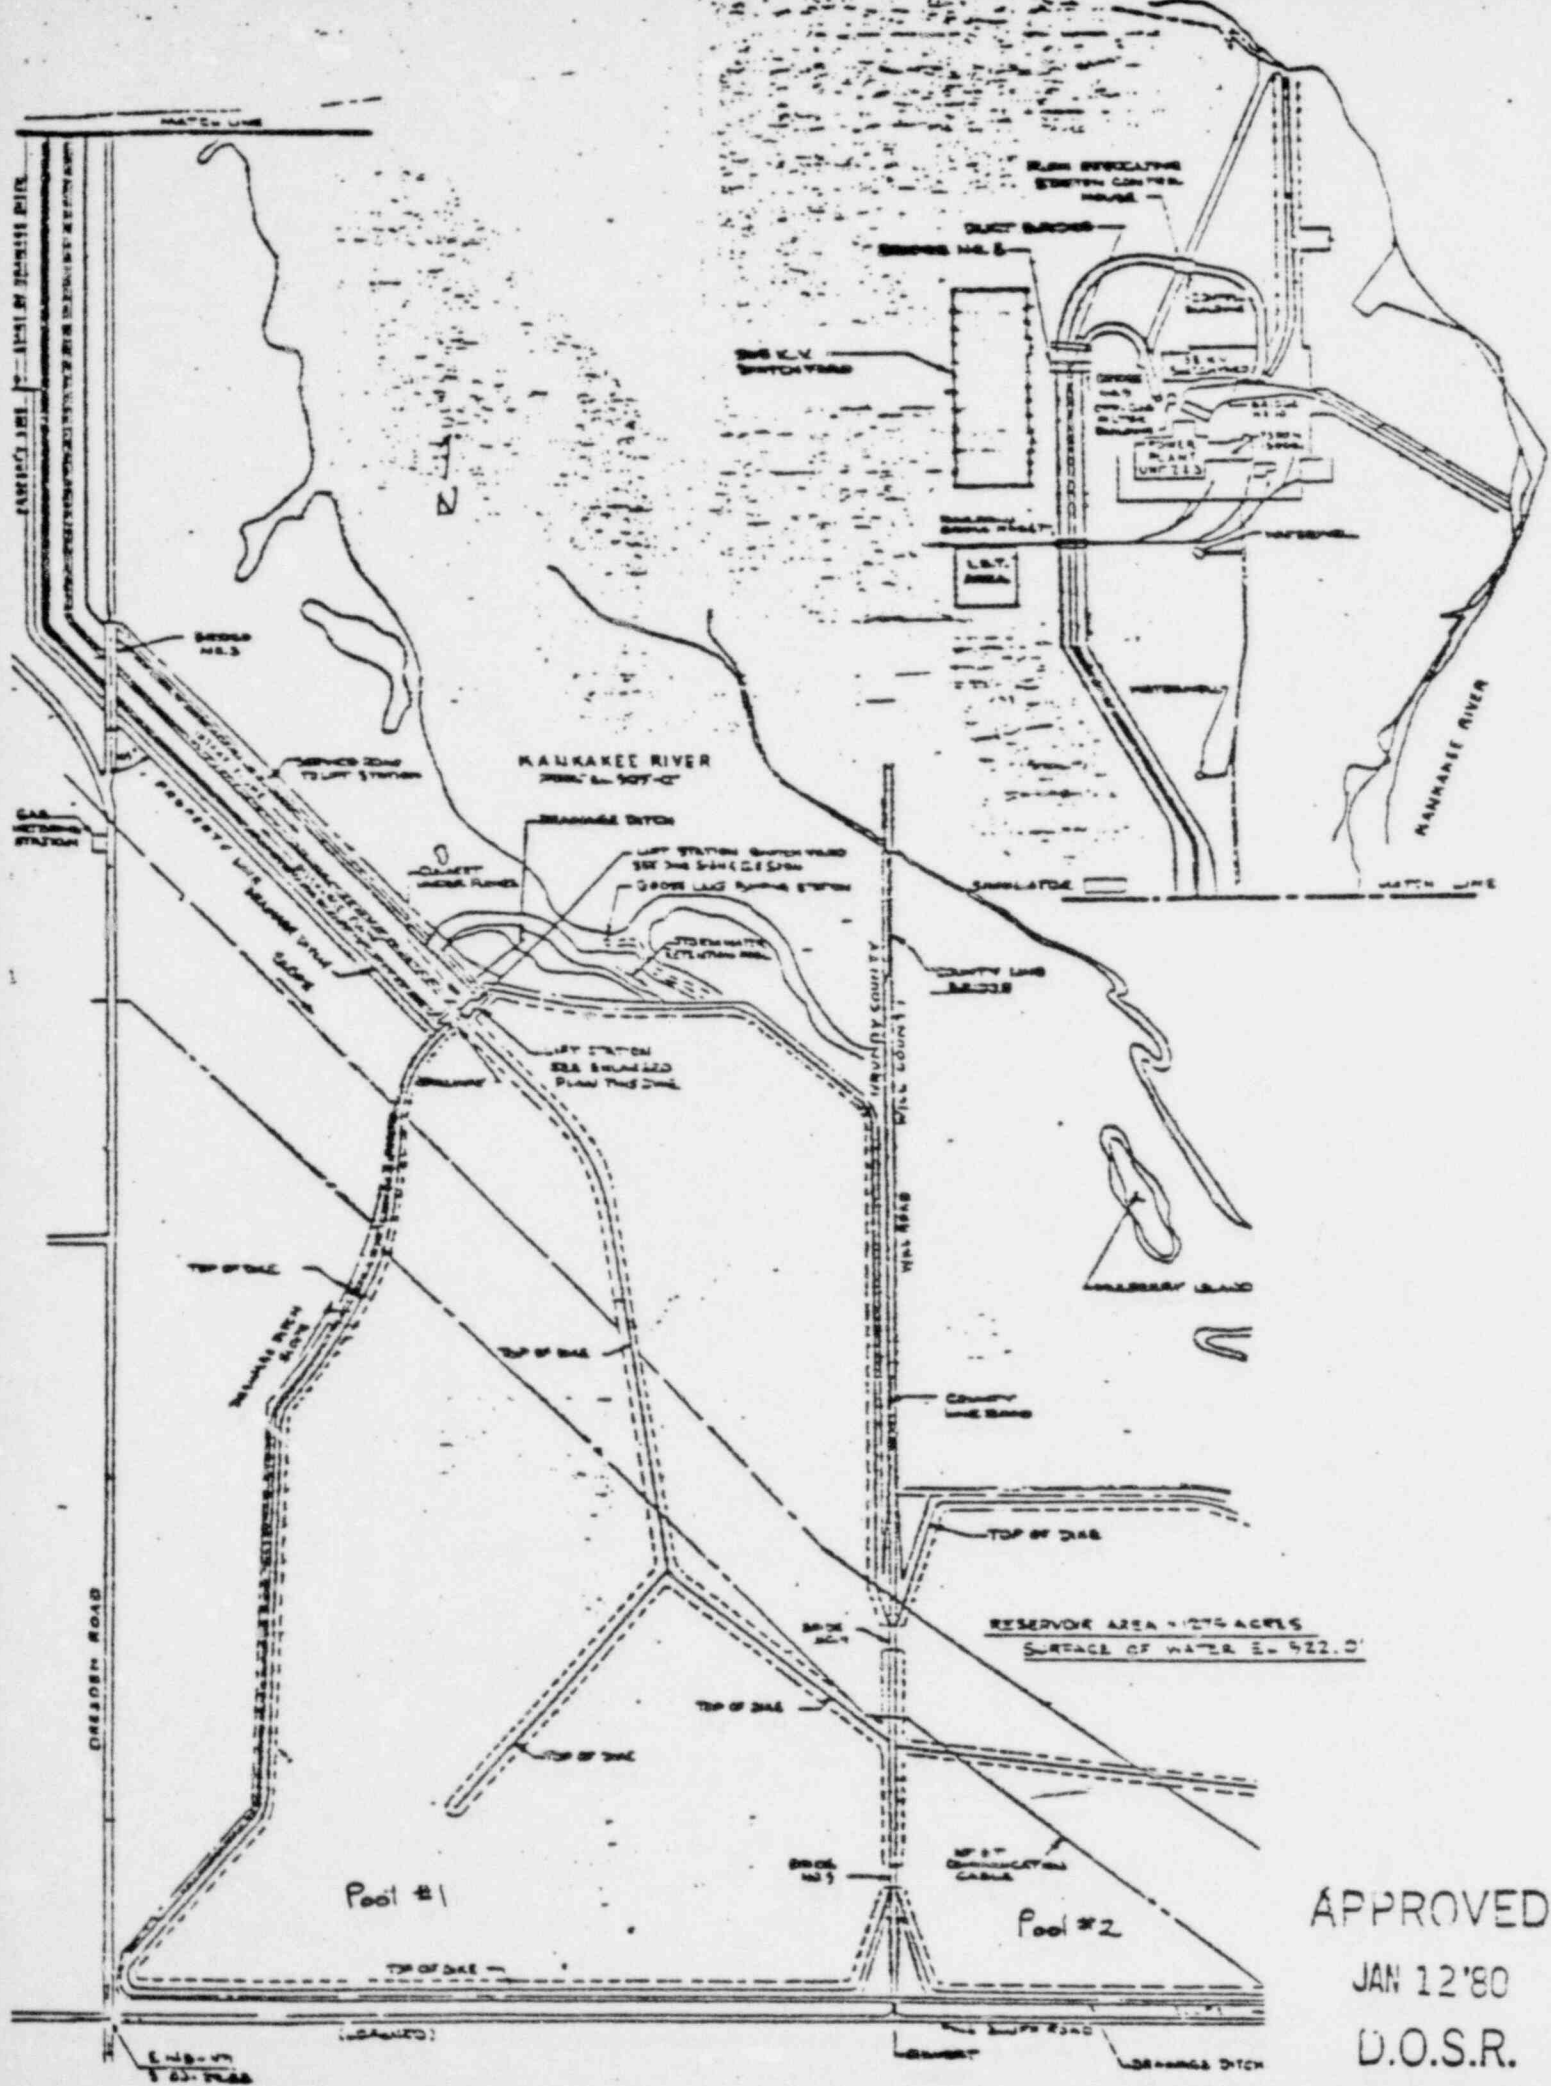
1. Water level readings are in the attachment.
2. The seepage along the Kankakee River (Point 1 on the attached map) has not changed.

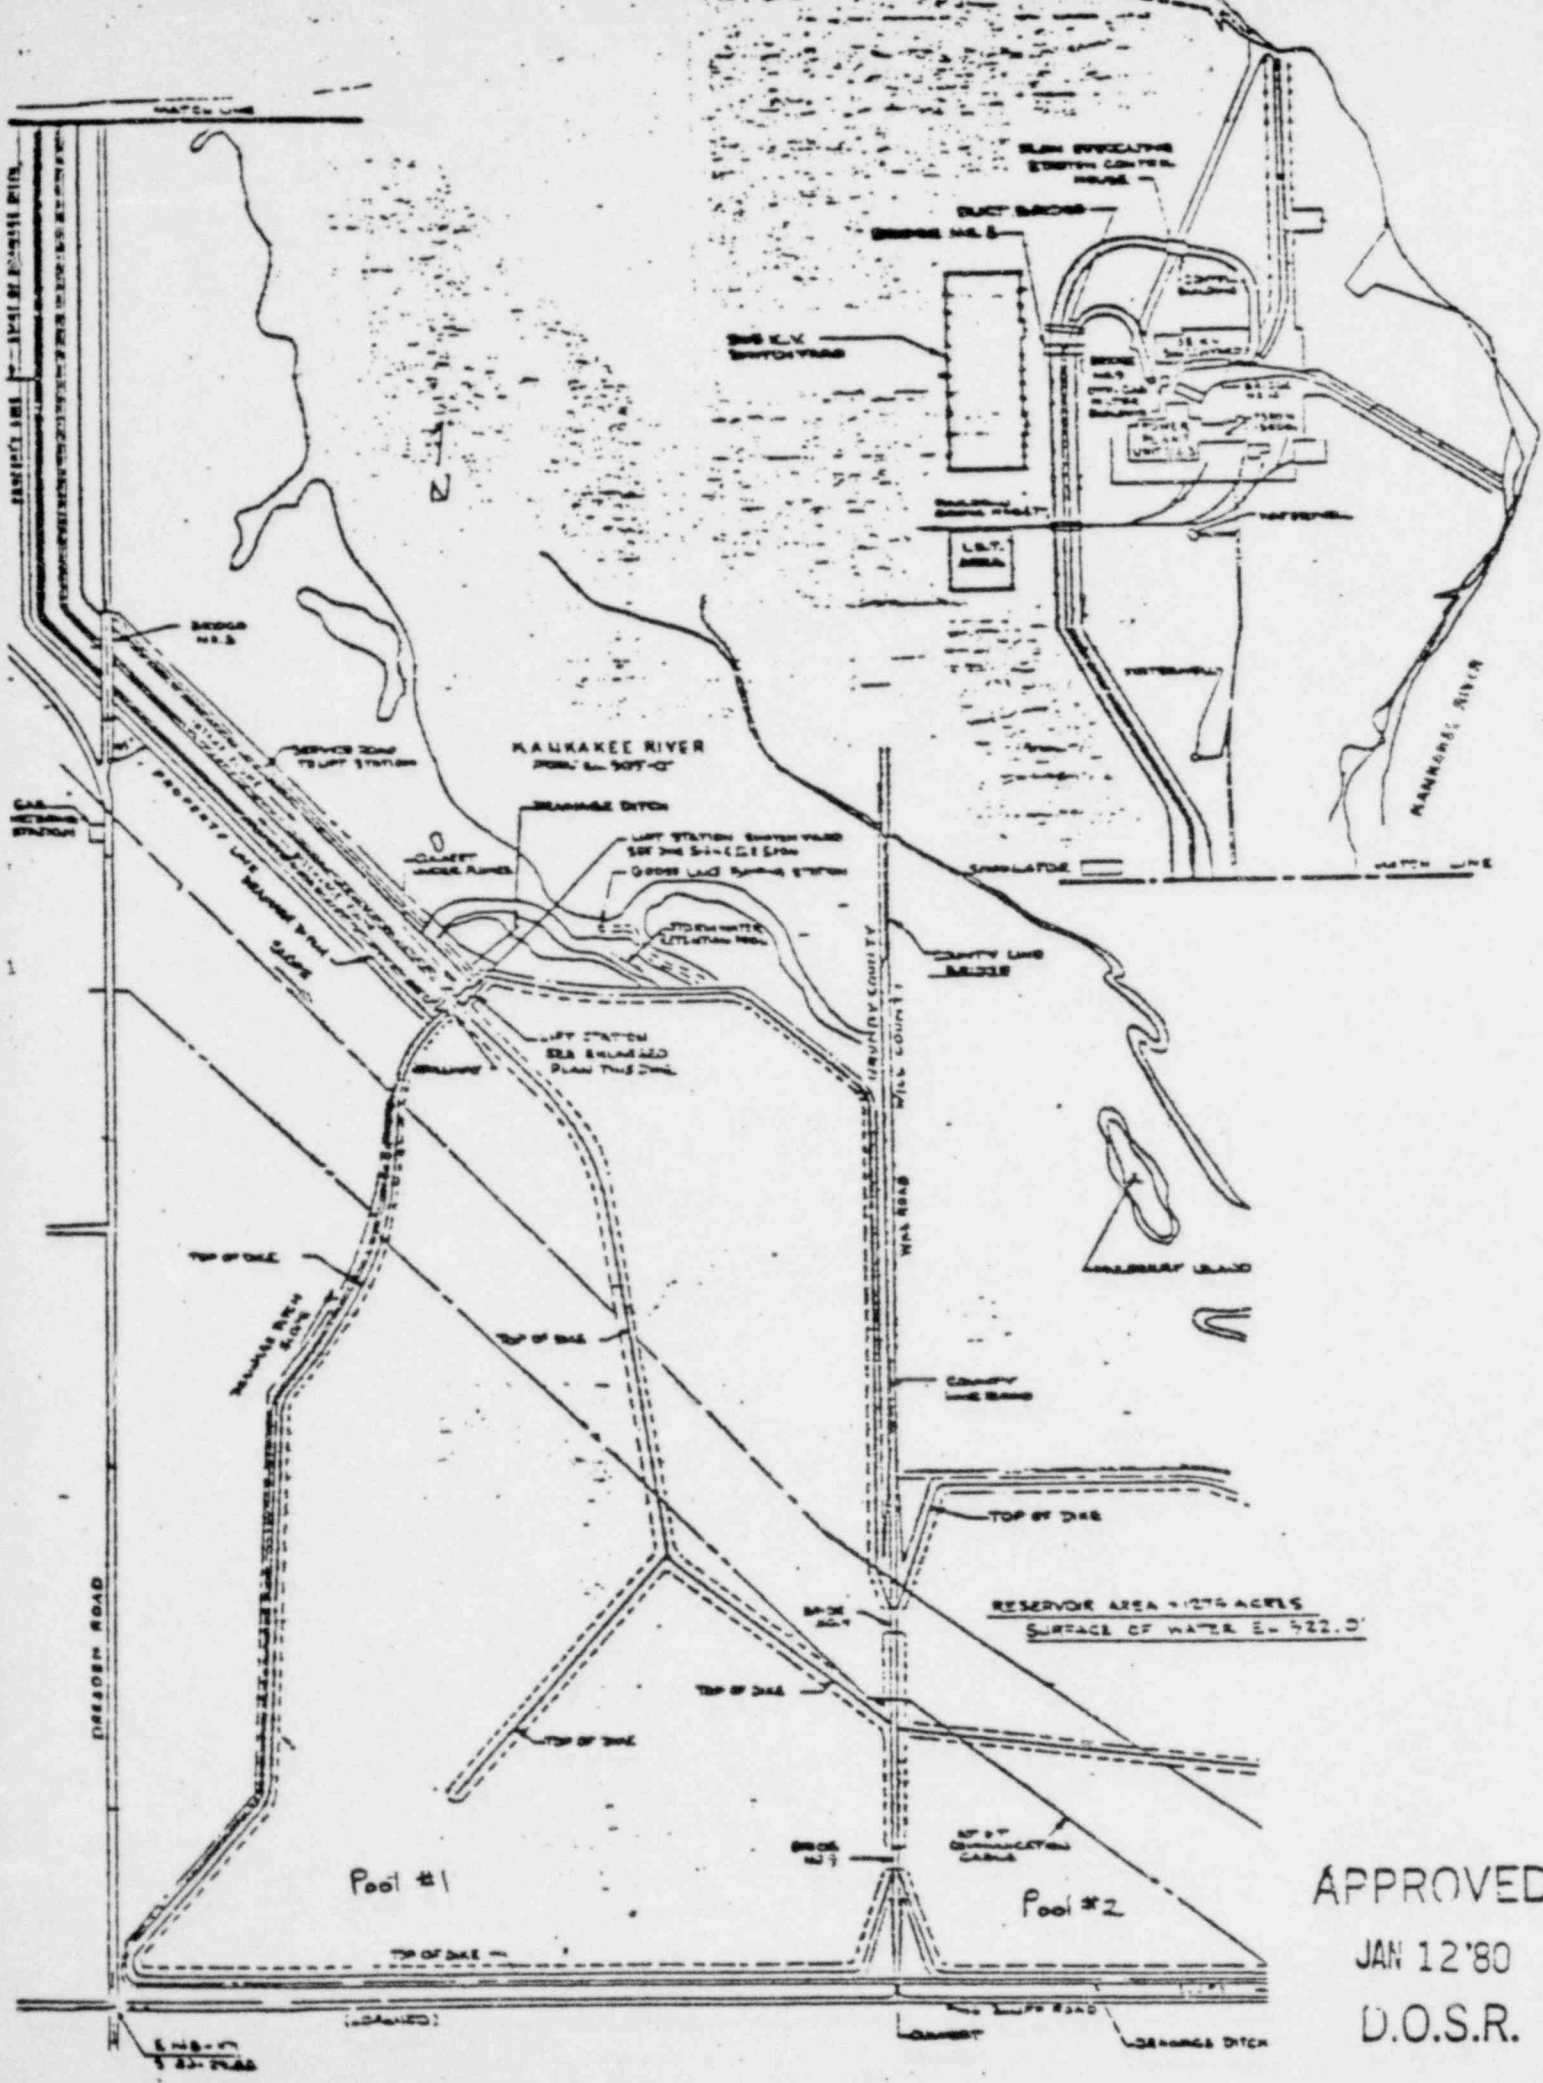
- 1) Water level readings are in the attachment.
- 2) The seepage along the Kankakee River (Point 1 on the attached map) has significantly dropped. This is due to the hot, dry weather.
