Babcock & Wilcox

Docket No. 71-6400

Reference is made to your letter dated February 29, 1980 and our subsequent response letter dated April 29, 1980. Pennsylvania Operations (PA Ops) respectfully requests amendment of Certificate of Compliance No. 6400 for the Model 6400 ("Supertiger") shipping container as presented herein.

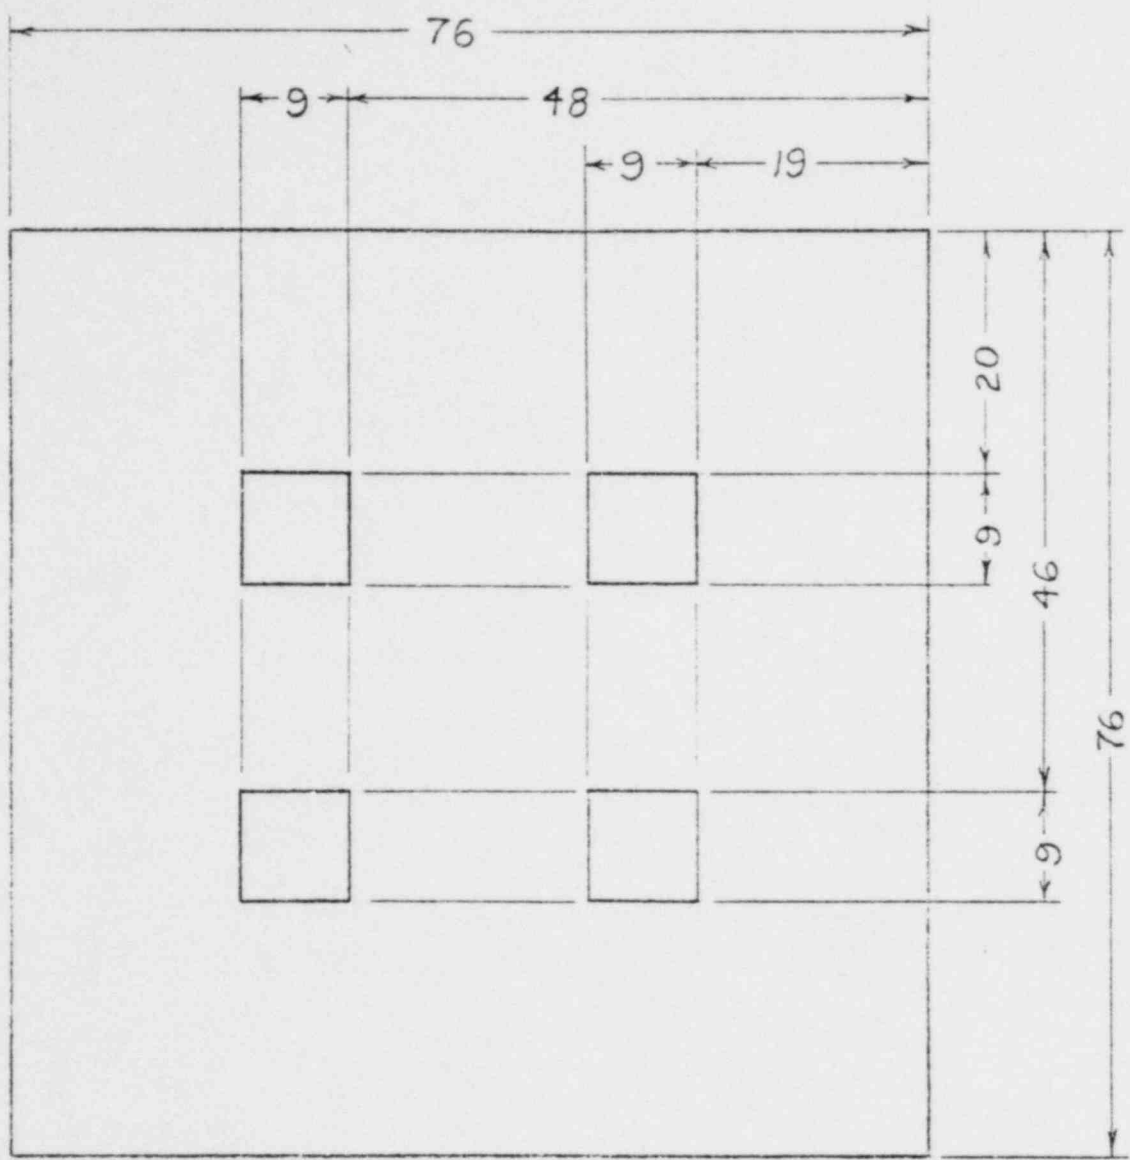
- a. Inside cavity door contains thirty-four (34) - 1/2 in. diameter bolts.
- b. Inside cavity door has three (3) hinges.
- c. Inside cavity door plate thickness is .255 in.
- d. Inside cavity door gasket thickness is .260 in.
- e. A purge hole is present in the center of the inside cavity door.
- f. Outer container door plate thickness is .370 in.
- g. Outer container door has fourteen (14) - 1 in. diameter bolts.
- h. Outer container door has two (2) hinges with a grease fitting in each hinge.
- i. Plywood on the inside of the outer door is .350 in. thick.
- j. All welds visually examined and appear sound and free of cracks.
- k. Four (4) re-enforcement steel plates are welded on the inside cavity back wall (Refer to the figure provided as Enclosure No. 1).

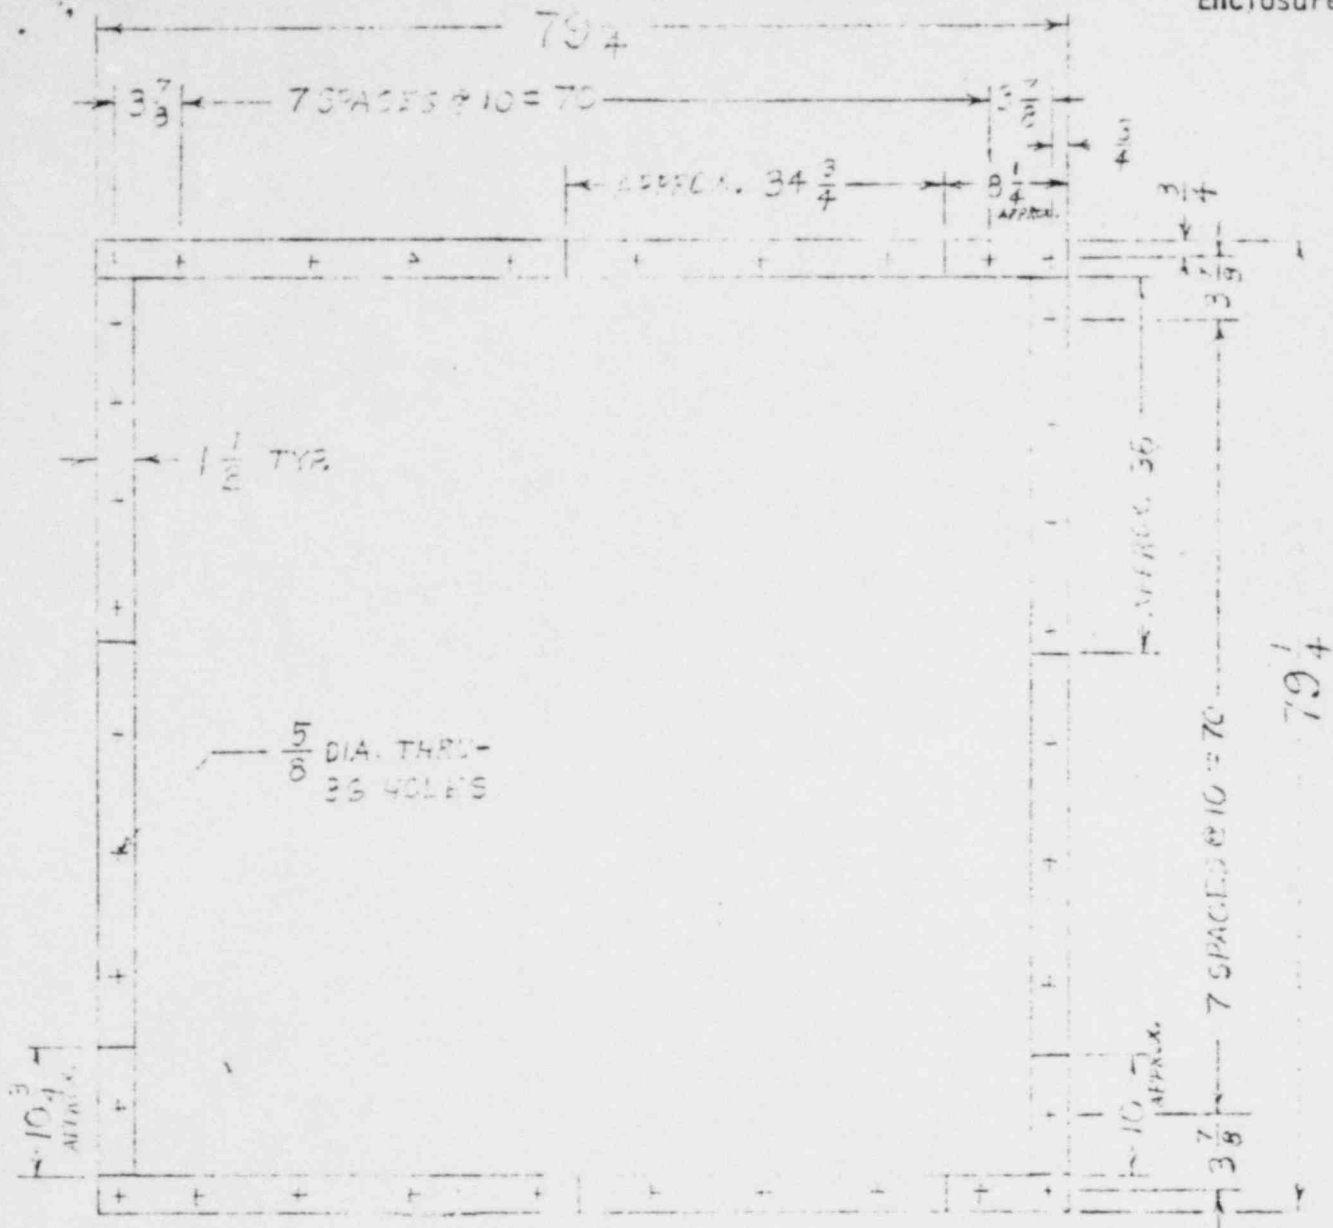
NINE DOOR GASKET

2. A detailed sketch of the seal for the inner cavity door is provided as Enclosure No. 2 to this letter.
3. On June 3, 1980, PA Ops' Quality Assurance inspected our Model 6400 shipping container for the five (5) conditions described in our above-mentioned response letter dated April 29, 1980. The inspection results are as follows:

SILICONE RUBBER GASKET
 $1\frac{1}{2}$ WIDE \times $\frac{1}{8}$ THK
