KMLNRC-017
Re: NRC Docket No. STN 50-482
Subj: 50.55(e) Report Bergen
Patterson Strut Assembly

10CFR50.55(e) FINAL REPORT

INTERFERENCE PROBLEM BETWEEN
PIPE CLAMPS AND MECHANICAL
SHOCK ARRESTORS

WOLF CREEK GENERATING STATION, UNIT NO 1

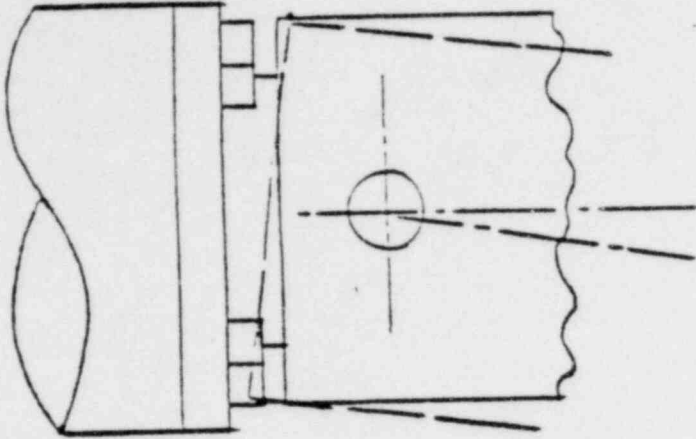
FIGURE 1

A detailed analysis of all 21 snubbers would be necessary to quantify pipe movement restrictions and resulting pipe stress. However, it appears that the interferences identified by Bergen-Patterson could inhibit the performance and function of the snubbers which could result in overstressing of the attached pipe.

6° off-axis rotation of clamp creates interference between bolt head and clamp.
