NORTHEAST UTILITIES

July 16, 1980

Docket No. 50-336
B10036

Millstone Nuclear Power Station, Unit No. 2
I&E Bulletin No. 79-14
I&E Bulletin No. 79-02

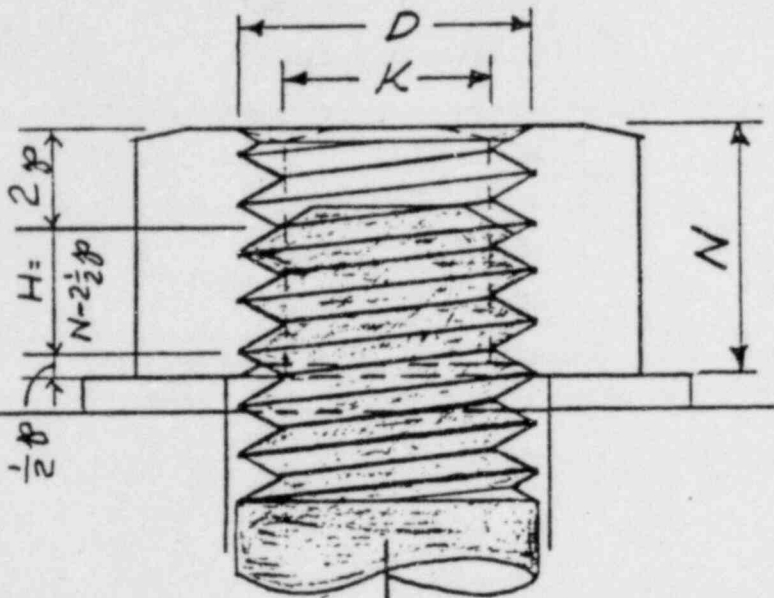
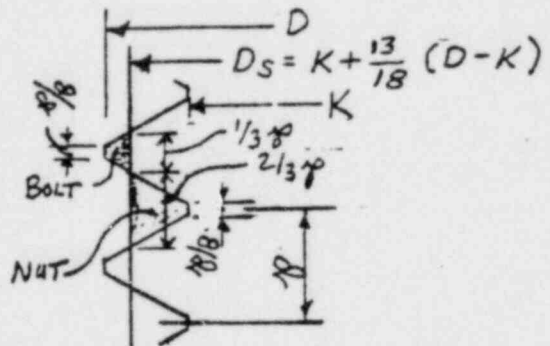
HILTI BOLT: $F_{SB} \cong 20$ KSI

A307 NUT: $F_{SN} \cong 10$ KSI

ANNULAR PLANE OF EQUAL SHEAR CAPACITY OF BOLT THREADS AND NUT THREADS.

$$P_T = A_{SB} F_{SB} = A_{SN} F_{SN}$$

•• BOLT TWO THREADS SHORT CAN RESIST ALLOW. TENSILE LOADS AT EMBEDMENTS NOTED.
