Consumers
Power
Company

March 21, 1975

NONCONFORMANCE - REPORT LOG & STATUS BOOK

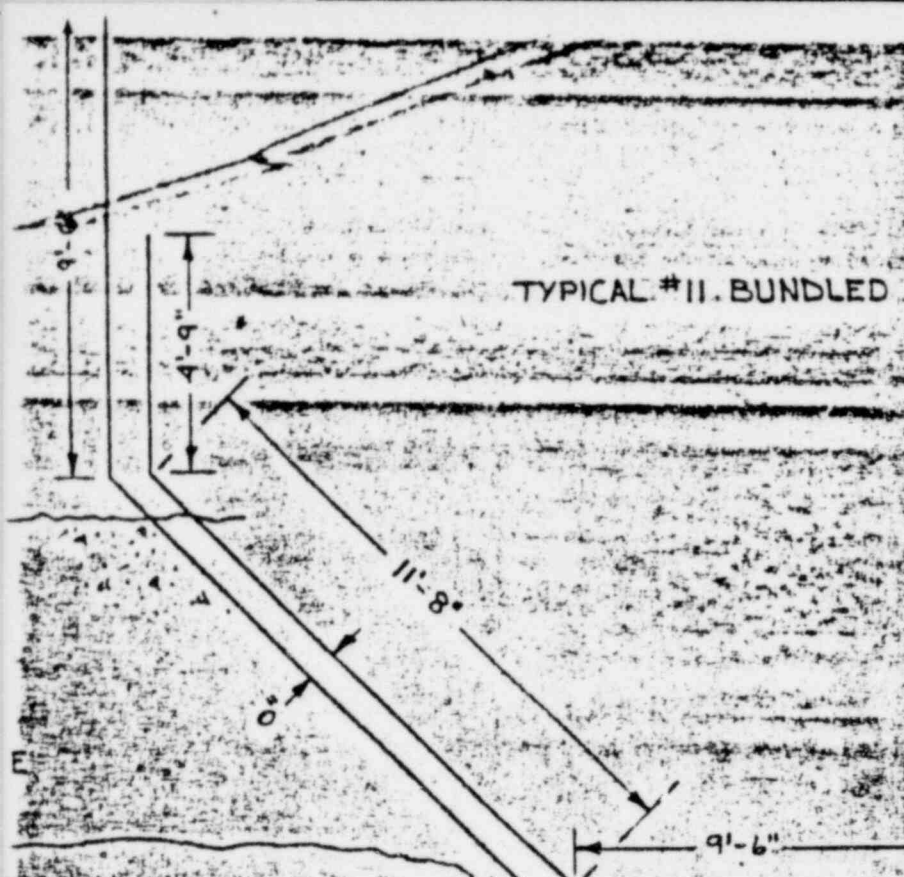
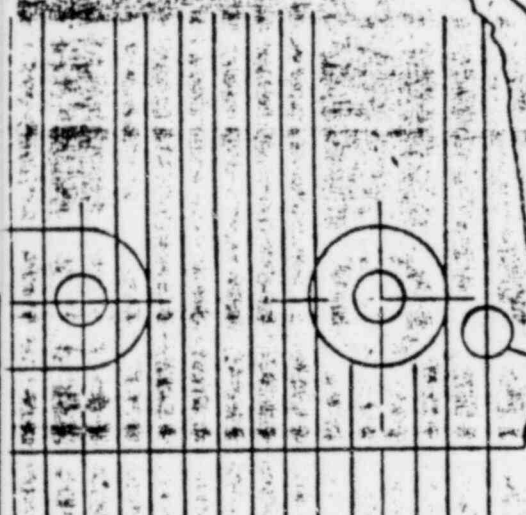
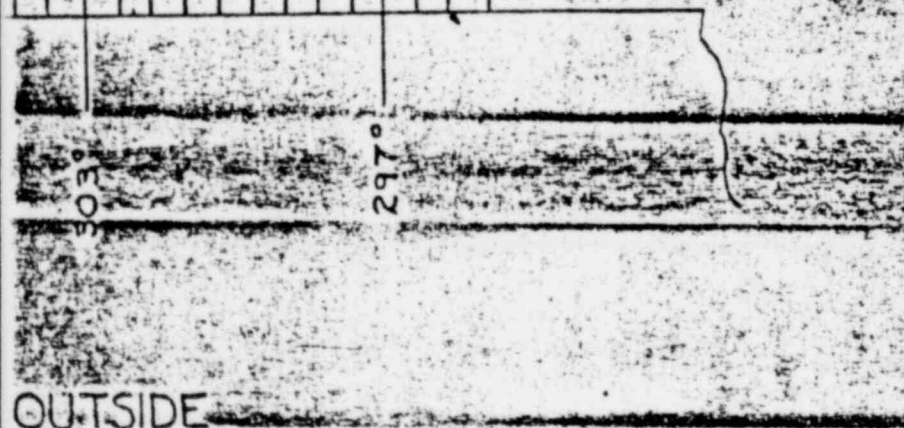
TYPICAL #11 BUNDLED HAUNCH BARS

19. NONCONFORMING CONDITION:
 8-2 #11 bundled hauch bars were cut off to make room for the penetrations welded to the liner plate at El. 596'-0 in Reactor Building #2. The attached Drawing FSK-C-296 shows the #11 bars that were cut off. These bars do not conform to Section A of Drawing C-324, Rev. 10. The Q number for rebar is 1.103. The item was noted during liner plate installation record review.

We have reviewed the as built condition described in Reference 1 concerning cutting the tail of 8-2#11 inclined bundled bars which interfere with penetrations at elevation 596'-0" in Reactor Building #2.

22. ENGINEERING DISPOSITION
has
 Engineering *has* evaluated the as-built rebar condition for Unit #2 Containment Wall and found it is structurally adequate as we had stated in BEBC-442 dated 8/8/74. We, therefore, concur with the field recommendation to use as is. *1/23/75 J.C. Salzman 2/3/75*

We request that you issue an NCR for the above mentioned subject since it was a deviation from the design drawing. Our review has indicated that the as built condition is structurally adequate, and we will approve the NCR to "use-as-is" when it is received in our office.
