UNITED STATES
NUCLEAR REGULATORY COMMISSION
OFFICE OF INSPECTION AND ENFORCEMENT
WASHINGTON, D.C. 20555

IE Bulletin No. 80-20
Page 1 of 2

FAILURES OF WESTINGHOUSE TYPE W-2 SPRING RETURN TO NEUTRAL CONTROL SWITCHES

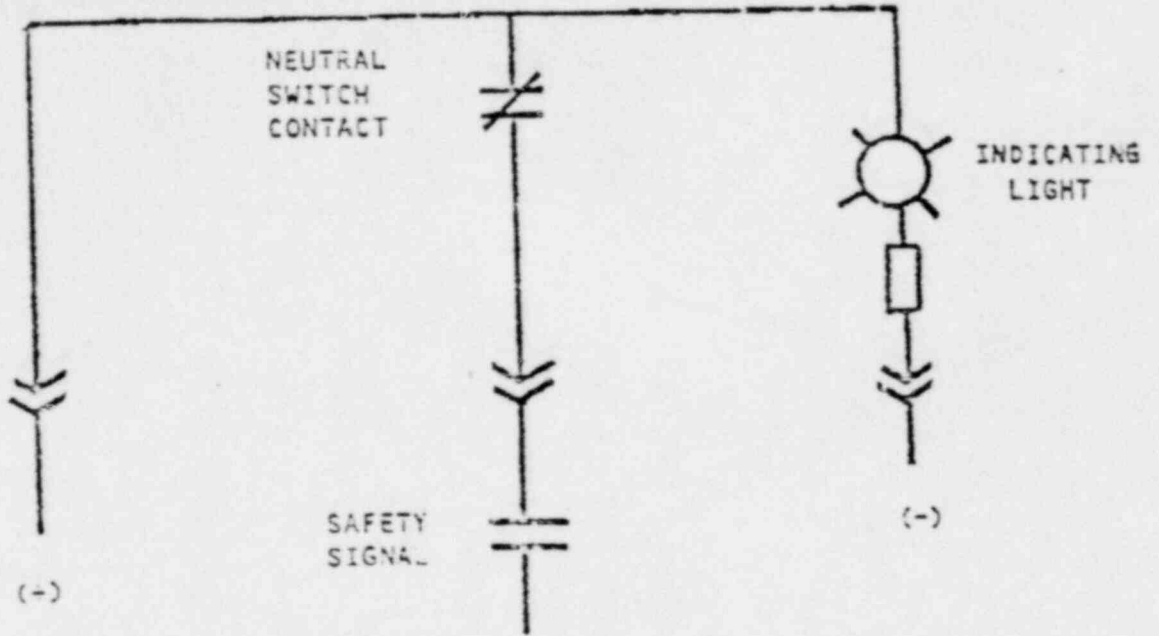
EXISTING INDICATING LIGHT CIRCUIT (TYPICAL)

Depending on how the indicating light circuit is wired, loss of continuity thru the neutral position contact of a W-2 switch could remain undetected until the equipment associated with the switch were called upon to operate. Since such a failure would be equivalent to by-passing the system associated with the switch, consideration should be given to rewiring the switches used in safety-related applications as shown in Figure 1. Such rewiring would provide an acceptable means for detecting contact failure, provided the indicating light is in the control room and readily visible by the operator. If the indicating light is not so located, consideration should be given to annunciating the neutral position contact failures at the control room to alert the operator of the inoperable status of a safety-related system. In addition, consideration should be given to adding redundant contacts to the W-2 switches or to replacing the W-2 switches with others having a more positive contact wiping action.

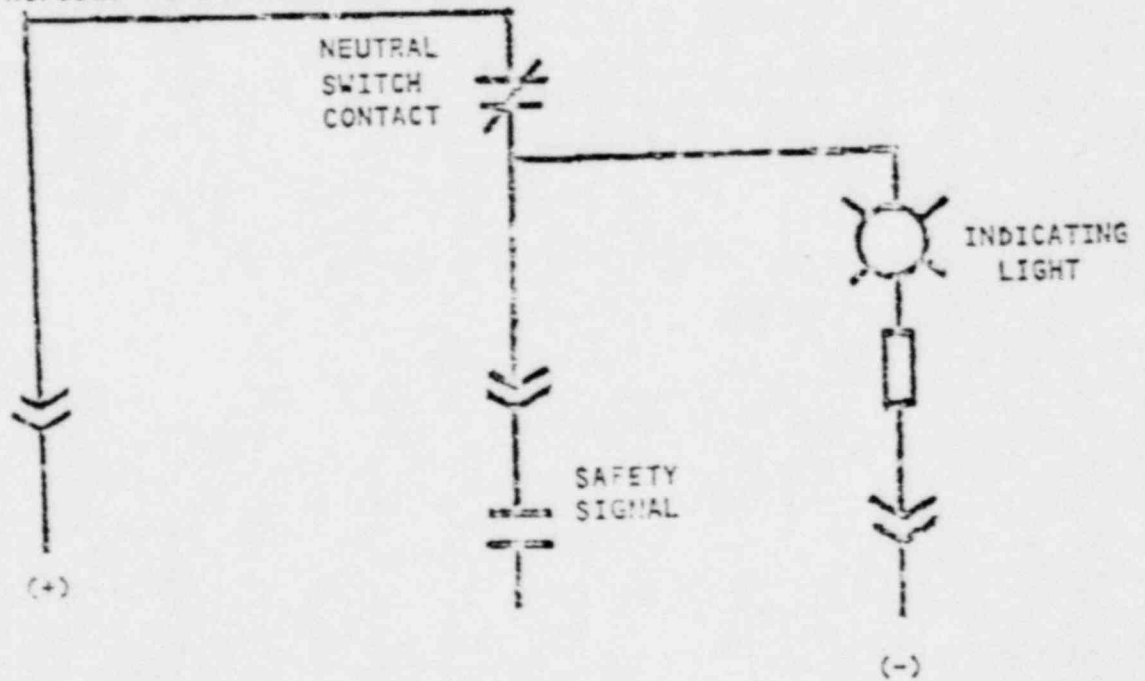
PROPOSED REWIRING OF INDICATING LIGHT CIRCUIT (TYPICAL)

REWIRING OF INDICATING LIGHT CIRCUIT OF W-2 SWITCHES
AS RECOMMENDED BY WESTINGHOUSE TECHNICAL BULLETIN NSD-TB-80-9

A review of this matter by Westinghouse led to the issuance of NSD Technical Bulletin No. NSD-TB-80-9 to the utility owners of all Westinghouse operating plants. The recommendations contained in the Westinghouse technical bulletin include: (i) testing the neutral position contacts of the subject W-2 switches for continuity, and (ii) rewiring of the indicating light circuit to permit the early detection of a neutral contact failure as shown in Figure 1.

3. Licensees of operating plants and holders of construction permits shall describe the longer term corrective measures planned and the date by which such measures will be implemented by actual installation or by design change, as appropriate. As a minimum, the longer term corrective measures should include rewiring the indicating light as shown in Figure 1 provided the light is readily visible to the control room operator. If not, failures of the neutral position contacts should be annunciated in the control room.
