UNITED STATES  
NUCLEAR REGULATORY COMMISSION  
REGION V  
1990 N. CALIFORNIA BOULEVARD  
SUITE 202, WALNUT CREEK PLAZA  
WALNUT CREEK, CALIFORNIA 94596

IE Bulletin No. 80-20

FAILURES OF WESTINGHOUSE TYPE W-2 SPRING RETURN TO NEUTRAL CONTROL SWITCHES

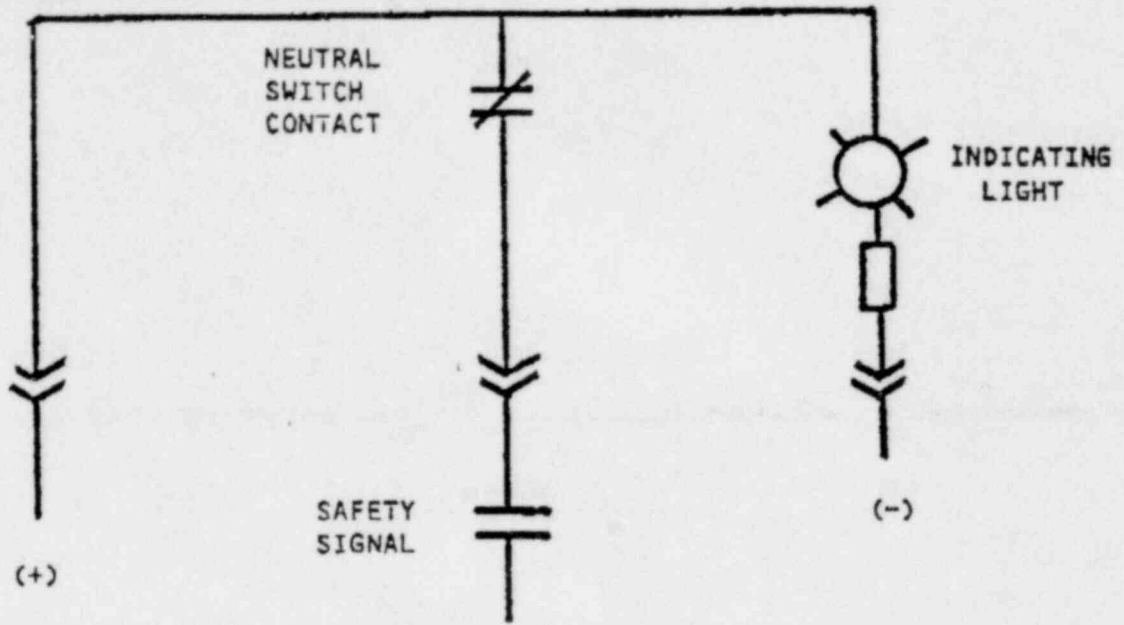
EXISTING INDICATING LIGHT CIRCUIT (TYPICAL)

Depending on how the indicating light circuit is wired, loss of continuity thru the neutral position contact of a W-2 switch could remain undetected until the equipment associated with the switch were called upon to operate. Since such a failure would be equivalent to by-passing the system associated with the switch, consideration should be given to rewiring the switches used in safety-related applications as shown in Figure 1. Such rewiring would provide an acceptable means for detecting contact failure, provided the indicating light is in the control room and readily visible by the operator. If the indicating light is not so located, consideration should be given to annunciating the neutral position contact failures at the control room to alert the operator of the inoperable status of a safety-related system. In addition, consideration should be given to adding redundant contacts to the W-2 switches or to replacing the W-2 switches with others having a more positive contact wiping action.

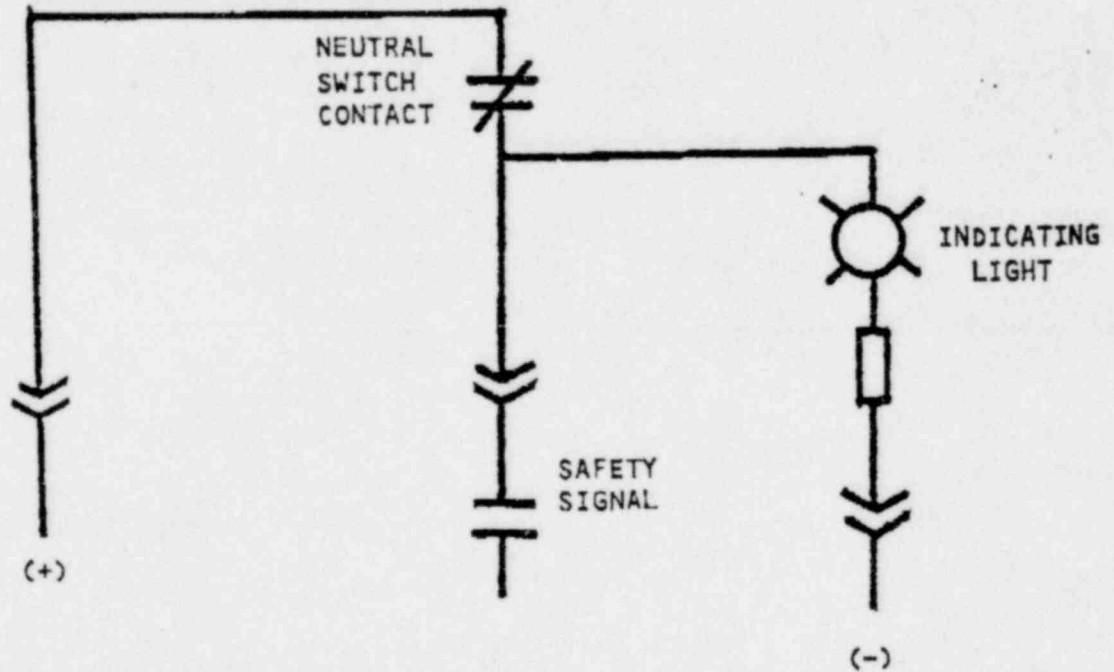
PROPOSED REWIRING OF INDICATING LIGHT CIRCUIT (TYPICAL)

REWIRING OF INDICATING LIGHT CIRCUIT OF W-2 SWITCHES  
AS RECOMMENDED BY WESTINGHOUSE TECHNICAL BULLETIN NSD-TB-80-9

A review of this matter by Westinghouse led to the issuance of NSD Technical Bulletin No. NSD-TB-80-9 to the utility owners of all Westinghouse operating plants. The recommendations contained in the Westinghouse technical bulletin include: (i) testing the neutral position contacts of the subject W-2 switches for continuity, and (ii) rewiring of the indicating light circuit to permit the early detection of a neutral contact failure as shown in Figure 1.

3. Licensees of operating plants and holders of construction permits shall describe the longer term corrective measures planned and the date by which such measures will be implemented by actual installation or by design change, as appropriate. As a minimum, the longer term corrective measures should include rewiring the indicating light as shown in Figure 1 provided the light is readily visible to the control room operator. If not, failures of the neutral position contacts should be annunciated in the control room.
