July 31, 1980

IE Bulletin No. 80-20

FAILURES OF WESTINGHOUSE TYPE W-2 SPRING RETURN TO NEUTRAL CONTROL SWITCHES

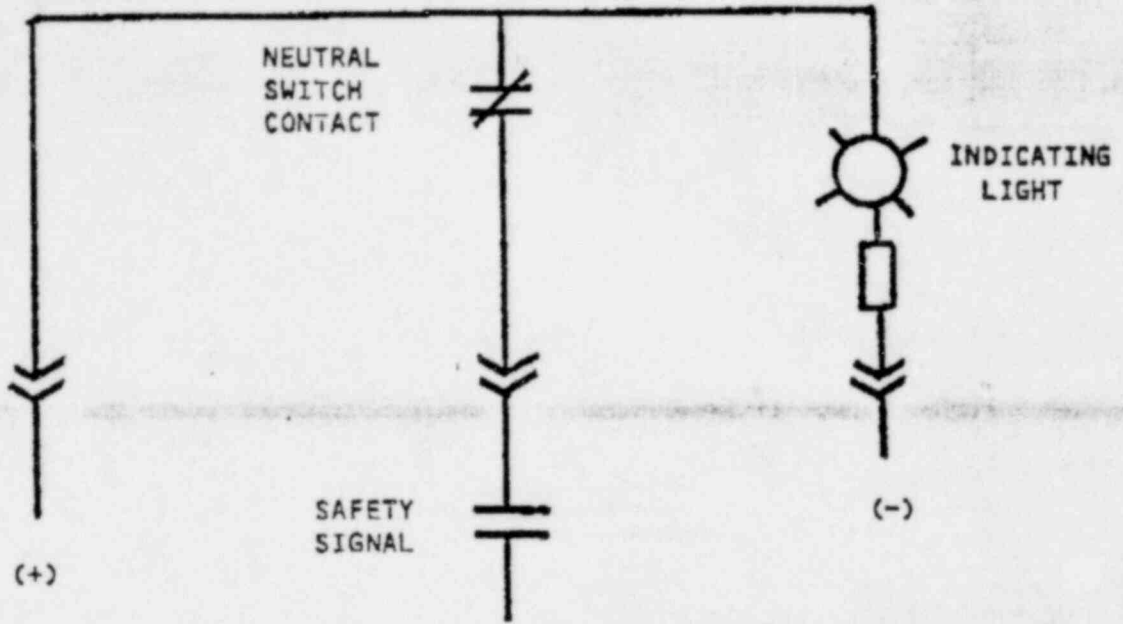
EXISTING INDICATING LIGHT CIRCUIT (TYPICAL)

Depending on how the indicating light circuit is wired, loss of continuity thru the neutral position contact of a W-2 switch could remain undetected until the equipment associated with the switch were called upon to operate. Since such a failure would be equivalent to by-passing the system associated with the switch, consideration should be given to rewiring the switches used in safety-related applications as shown in Figure 1. Such rewiring would provide an acceptable means for detecting contact failure, provided the indicating light is in the control room and readily visible by the operator. If the indicating light is not so located, consideration should be given to annunciating the neutral position contact failures at the control room to alert the operator of the inoperable status of a safety-related system. In addition, consideration should be given to adding redundant contacts to the W-2 switches or to replacing the W-2 switches with others having a more positive contact wiping action.

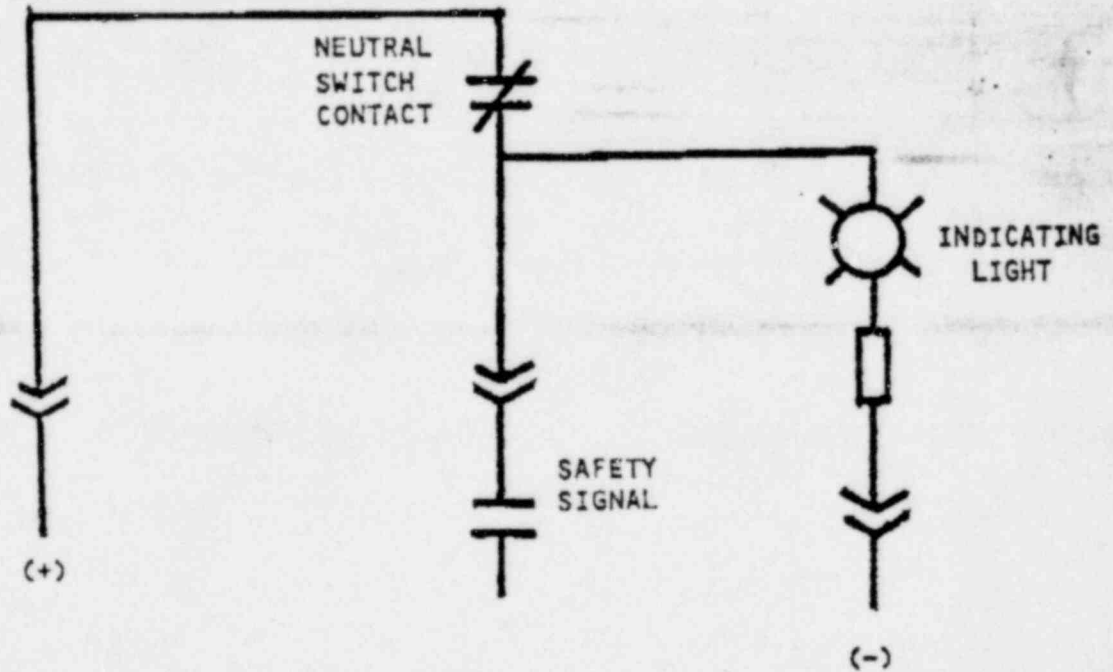
PROPOSED REWIRING OF INDICATING LIGHT CIRCUIT (TYPICAL)

REWIRING OF INDICATING LIGHT CIRCUIT OF W-2 SWITCHES
AS RECOMMENDED BY WESTINGHOUSE TECHNICAL BULLETIN NSD-TB-80-9

A review of this matter by Westinghouse led to the issuance of NSD Technical Bulletin No. NSD-TB-80-9 to the utility owners of all Westinghouse operating plants. The recommendations contained in the Westinghouse technical bulletin include: (i) testing the neutral position contacts of the subject W-2 switches for continuity, and (ii) rewiring of the indicating light circuit to permit the early detection of a neutral contact failure as shown in Figure 1.

3. Licensees of operating plants and holders of construction permits shall describe the longer term corrective measures planned and the date by which such measures will be implemented by actual installation or by design change, as appropriate. As a minimum, the longer term corrective measures should include rewiring the indicating light as shown in Figure 1 provided the light is readily visible to the control room operator. If not, failures of the neutral position contacts should be annunciated in the control room.
