UNITED STATES  
NUCLEAR REGULATORY COMMISSION  
REGION I  
631 PARK AVENUE  
KING OF PRUSSIA, PENNSYLVANIA 19406

IE Bulletin No. 80-20  
Page 1 of 2

FAILURES OF WESTINGHOUSE TYPE W-2 SPRING RETURN TO NEUTRAL CONTROL SWITCHES

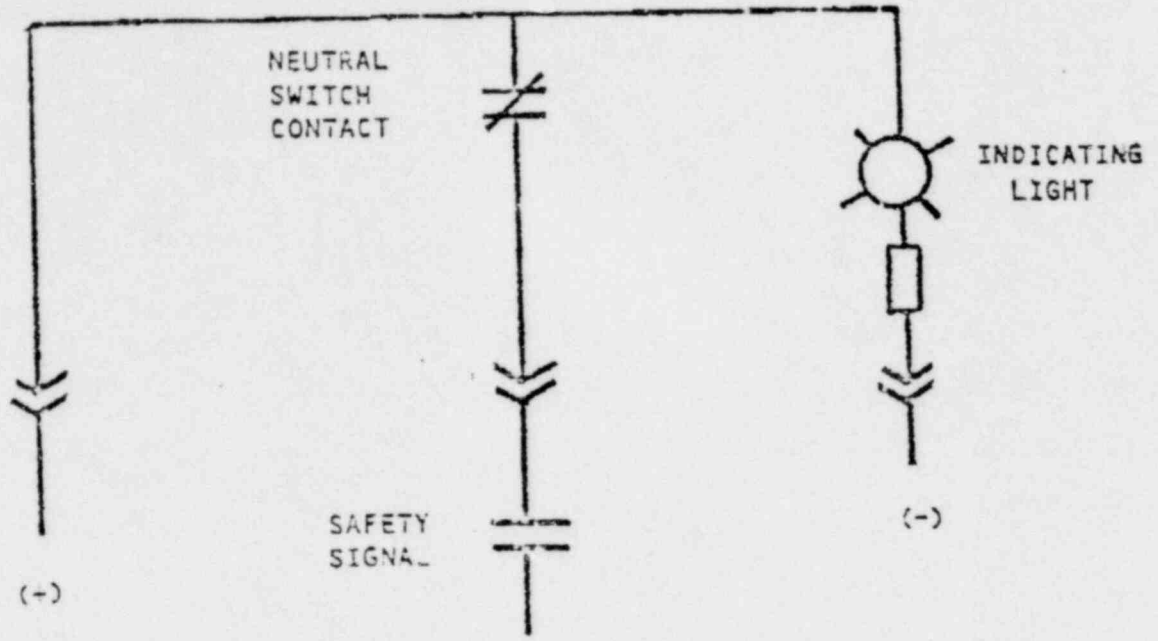
EXISTING INDICATING LIGHT CIRCUIT (TYPICAL)

Depending on how the indicating light circuit is wired, loss of continuity thru the neutral position contact of a W-2 switch could remain undetected until the equipment associated with the switch were called upon to operate. Since such a failure would be equivalent to bypassing the system associated with the switch, consideration should be given to rewiring the switches used in safety-related applications as shown in Figure 1. Such rewiring would provide an acceptable means for detecting contact failure, provided the indicating light is in the control room and readily visible by the operator. If the indicating light is not so located, consideration should be given to annunciating the neutral position contact failures at the control room to alert the operator of the inoperable status of a safety-related system. In addition, consideration should be given to adding redundant contacts to the W-2 switches or to replacing the W-2 switches with others having a more positive contact wiping action.

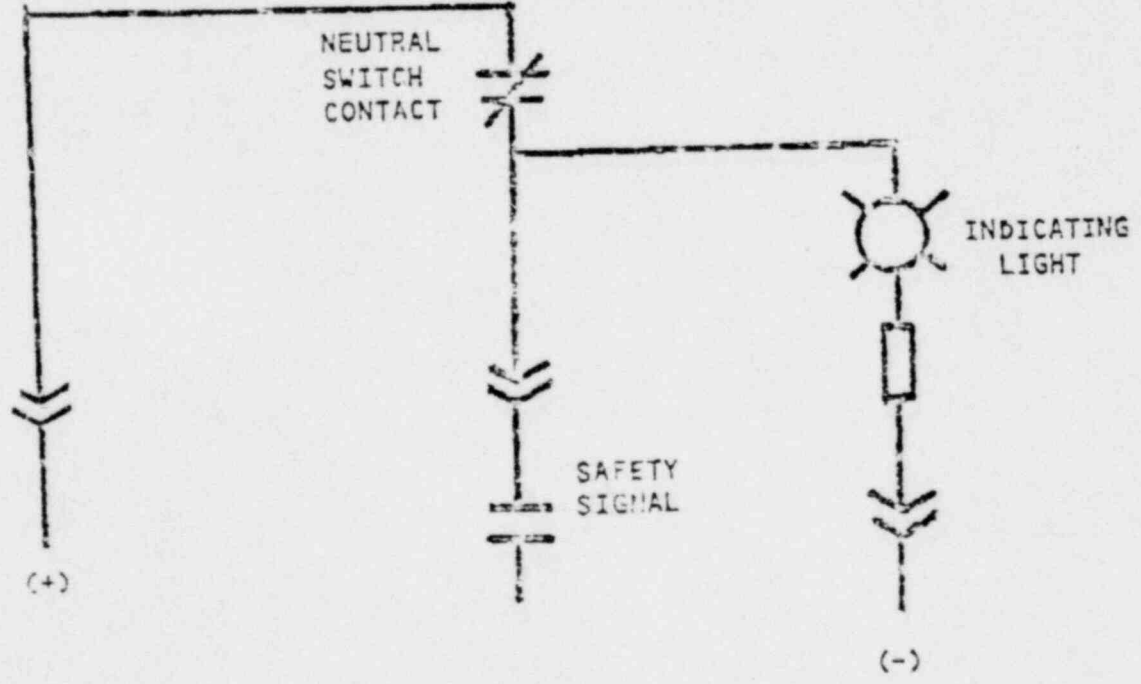
PROPOSED REWIRING OF INDICATING LIGHT CIRCUIT (TYPICAL)

REWIRING OF INDICATING LIGHT CIRCUIT OF W-2 SWITCHES  
AS RECOMMENDED BY WESTINGHOUSE TECHNICAL BULLETIN NSD-T2-80-9

A review of this matter by Westinghouse led to the issuance of NSD Technical Bulletin No. NSD-TB-80-9 to the utility owners of all Westinghouse operating plants. The recommendations contained in the Westinghouse technical bulletin include: (i) testing the neutral position contacts of the subject W-2 switches for continuity, and (ii) rewiring of the indicating light circuit to permit the early detection of a neutral contact failure as shown in Figure 1.

3. Licensees of operating plants and holders of construction permits shall describe the longer term corrective measures planned and the date by which such measures will be implemented by actual installation or by design change, as appropriate. As a minimum, the longer term corrective measures should include rewiring the indicating light as shown in Figure 1 provided the light is readily visible to the control room operator. If not, failures of the neutral position contacts should be annunciated in the control room.
