IE Bulletin No. 80-20

FAILURES OF WESTINGHOUSE TYPE W-2 SPRING RETURN TO NEUTRAL CONTROL SWITCHES

IE Bulletin No. 80-20  
July 31, 1980

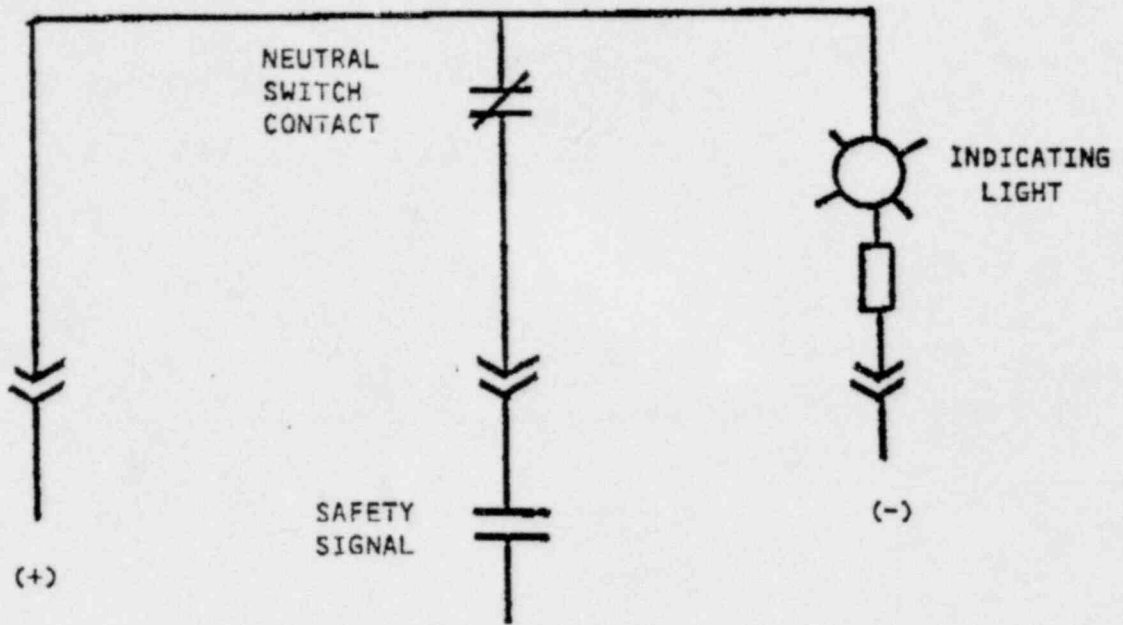
FIGURE 1

Depending on how the indicating light circuit is wired, loss of continuity thru the neutral position contact of a W-2 switch could remain undetected until the equipment associated with the switch were called upon to operate. Since such a failure would be equivalent to by-passing the system associated with the switch, consideration should be given to rewiring the switches used in safety-related applications as shown in Figure 1. Such rewiring would provide an acceptable means for detecting contact failure, provided the indicating light is in the control room and readily visible by the operator. If the indicating light is not so located, consideration should be given to annunciating the neutral position contact failures at the control room to alert the operator of the inoperable status of a safety-related system. In addition, consideration should be given to adding redundant contacts to the W-2 switches or to replacing the W-2 switches with others having a more positive contact wiping action.

EXISTING INDICATING LIGHT CIRCUIT (TYPICAL)

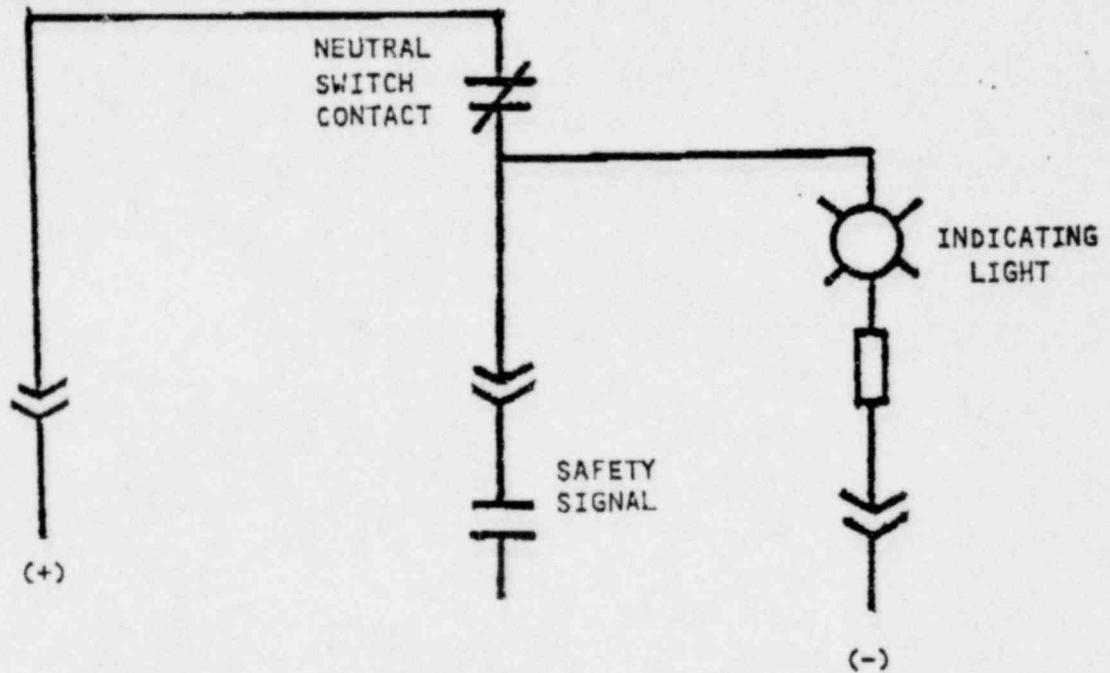
PROPOSED REWIRING OF INDICATING LIGHT CIRCUIT (TYPICAL)

REWIRING OF INDICATING LIGHT CIRCUIT OF W-2 SWITCHES  
AS RECOMMENDED BY WESTINGHOUSE TECHNICAL BULLETIN NSD-TB-80-9

A review of this matter by Westinghouse led to the issuance of NSD Technical Bulletin No. NSD-TB-80-9 to the utility owners of all Westinghouse operating plants. The recommendations contained in the Westinghouse technical bulletin include: (i) testing the neutral position contacts of the subject W-2 switches for continuity, and (ii) rewiring of the indicating light circuit to permit the early detection of a neutral contact failure as shown in Figure 1.

3. Licensees of operating plants and holders of construction permits shall describe the longer term corrective measures planned and the date by which such measures will be implemented by actual installation or by design change, as appropriate. As a minimum, the longer term corrective measures should include rewiring the indicating light as shown in Figure 1 provided the light is readily visible to the control room operator. If not, failures of the neutral position contacts should be annunciated in the control room.
