UNITED STATES
NUCLEAR REGULATORY COMMISSION
OFFICE OF INSPECTION AND ENFORCEMENT
WASHINGTON, D.C. 20555

IE Bulletin No. 80-20
Page 1 of 2

FAILURES OF WESTINGHOUSE TYPE W-2 SPRING RETURN TO NEUTRAL CONTROL SWITCHES

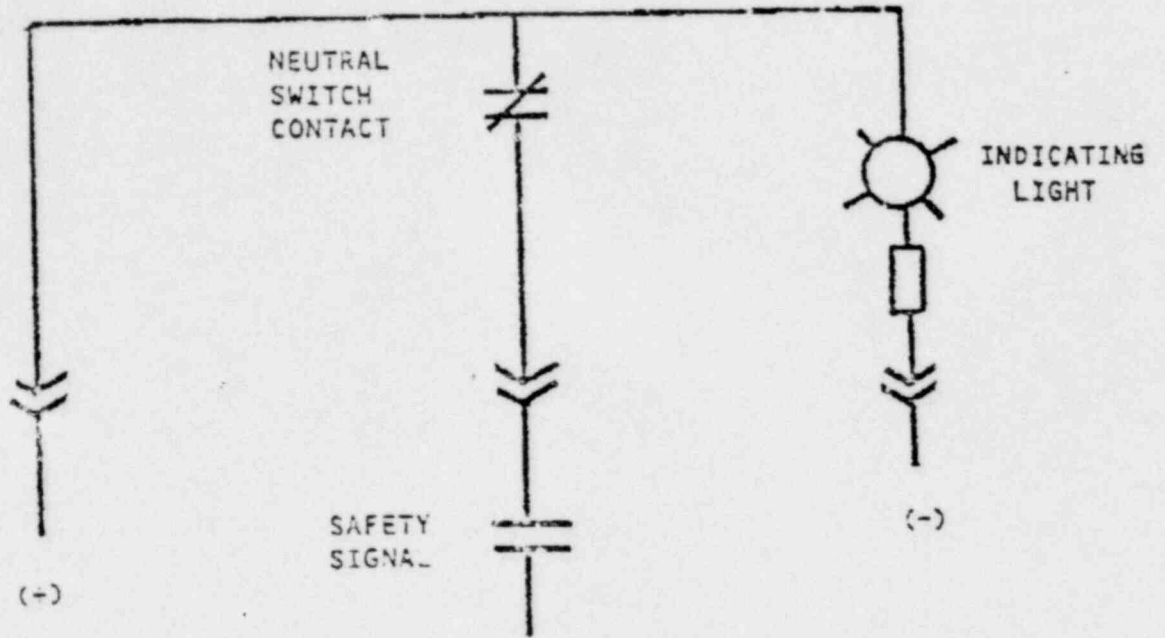
EXISTING INDICATING LIGHT CIRCUIT (TYPICAL)

Depending on how the indicating light circuit is wired, loss of continuity thru the neutral position contact of a W-2 switch could remain undetected until the equipment associated with the switch were called upon to operate. Since such a failure would be equivalent to by-passing the system associated with the switch, consideration should be given to rewiring the switches used in safety-related applications as shown in Figure 1. Such rewiring would provide an acceptable means for detecting contact failure, provided the indicating light is in the control room and readily visible by the operator. If the indicating light is not so located, consideration should be given to annunciating the neutral position contact failures at the control room to alert the operator of the inoperable status of a safety-related system. In addition, consideration should be given to adding redundant contacts to the W-2 switches or to replacing the W-2 switches with others having a more positive contact wiping action.

A review of this matter by Westinghouse led to the issuance of NSD Technical Bulletin No. NSD-TB-80-9 to the utility owners of all Westinghouse operating plants. The recommendations contained in the Westinghouse technical bulletin include: (i) testing the neutral position contacts of the subject W-2 switches for continuity, and (ii) rewiring of the indicating light circuit to permit the early detection of a neutral contact failure as shown in Figure 1.

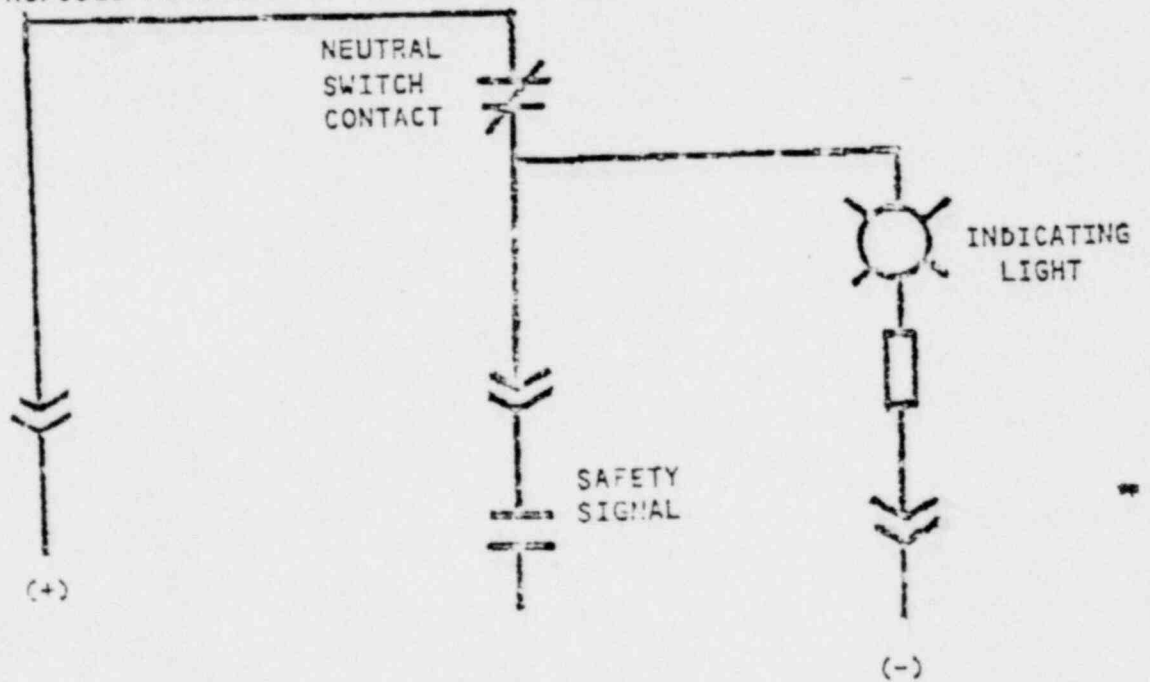
PROPOSED REWIRING OF INDICATING LIGHT CIRCUIT (TYPICAL)

REWIRING OF INDICATING LIGHT CIRCUIT OF W-2 SWITCHES
AS RECOMMENDED BY WESTINGHOUSE TECHNICAL BULLETIN NSD-TB-80-9

3. Licensees of operating plants and holders of construction permits shall describe the longer term corrective measures planned and the date by which such measures will be implemented by actual installation or by design change, as appropriate. As a minimum, the longer term corrective measures should include rewiring the indicating light as shown in Figure 1 provided the light is readily visible to the control room operator. If not, failures of the neutral position contacts should be annunciated in the control room.
