UNITED STATES  
NUCLEAR REGULATORY COMMISSION  
OFFICE OF INSPECTION AND ENFORCEMENT  
WASHINGTON, D.C. 20555

IE Bulletin No. 80-20  
Page 1 of 2

FAILURES OF WESTINGHOUSE TYPE W-2 SPRING RETURN TO NEUTRAL CONTROL SWITCHES

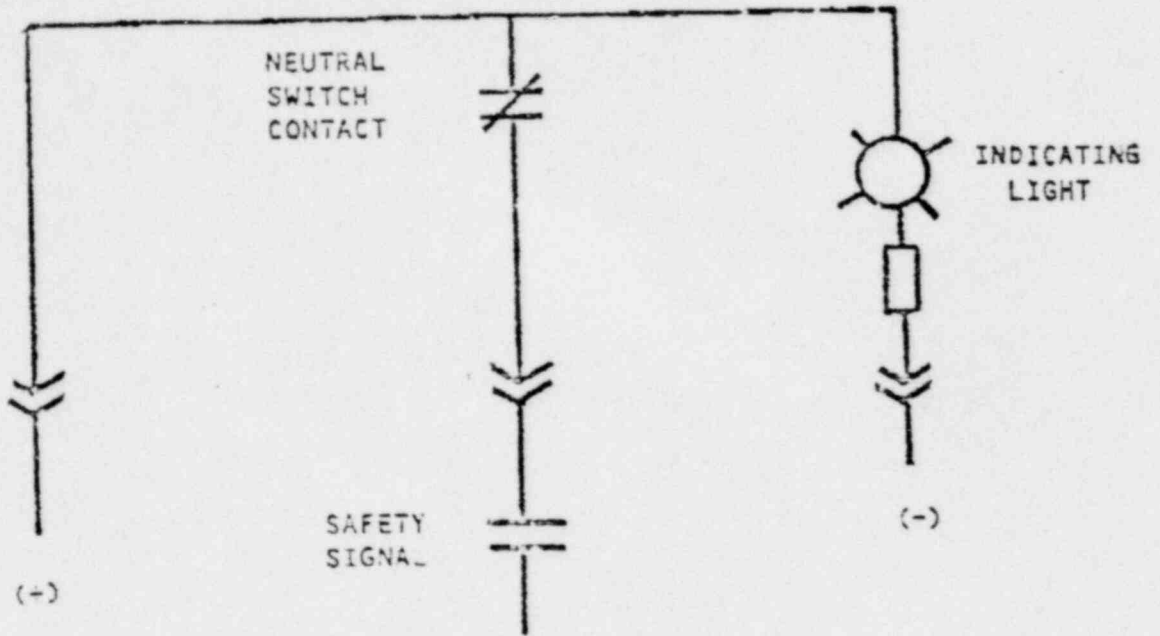
EXISTING INDICATING LIGHT CIRCUIT (TYPICAL)

Depending on how the indicating light circuit is wired, loss of continuity thru the neutral position contact of a W-2 switch could remain undetected until the equipment associated with the switch were called upon to operate. Since such a failure would be equivalent to by-passing the system associated with the switch, consideration should be given to rewiring the switches used in safety-related applications as shown in Figure 1. Such rewiring would provide an acceptable means for detecting contact failure, provided the indicating light is in the control room and readily visible by the operator. If the indicating light is not so located, consideration should be given to annunciating the neutral position contact failures at the control room to alert the operator of the inoperable status of a safety-related system. In addition, consideration should be given to adding redundant contacts to the W-2 switches or to replacing the W-2 switches with others having a more positive contact wiping action.

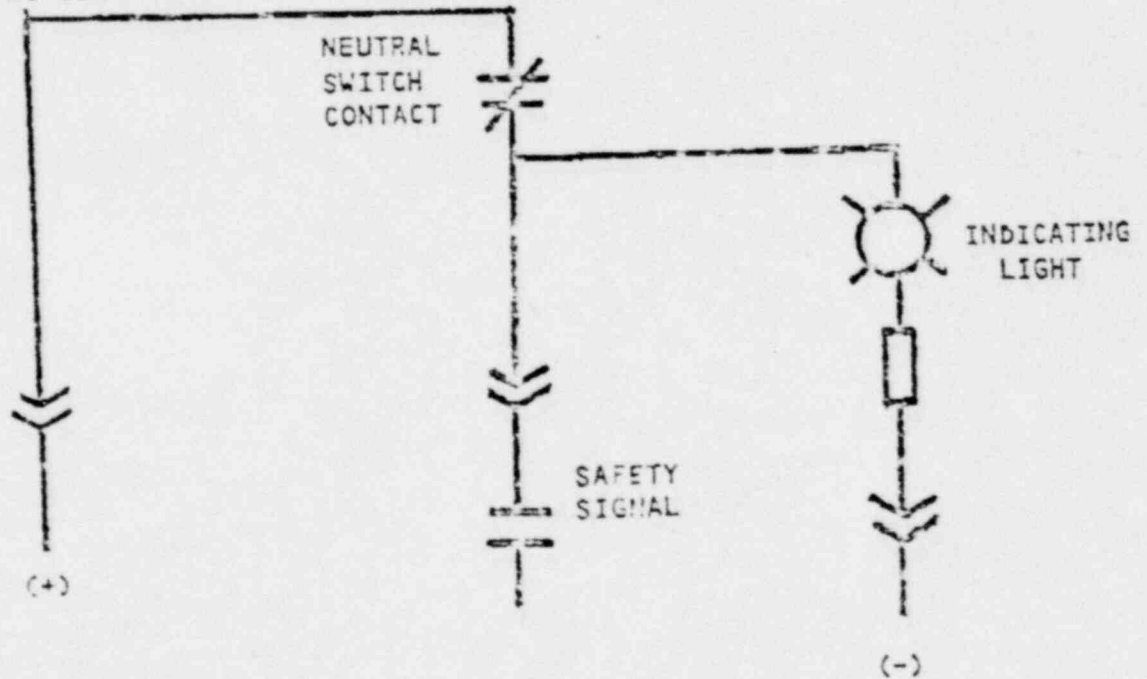
PROPOSED REWIRING OF INDICATING LIGHT CIRCUIT (TYPICAL)

REWIRING OF INDICATING LIGHT CIRCUIT OF W-2 SWITCHES  
AS RECOMMENDED BY WESTINGHOUSE TECHNICAL BULLETIN NSD-TB-80-9

A review of this matter by Westinghouse led to the issuance of NSD Technical Bulletin No. NSD-TB-80-9 to the utility owners of all Westinghouse operating plants. The recommendations contained in the Westinghouse technical bulletin include: (i) testing the neutral position contacts of the subject W-2 switches for continuity, and (ii) rewiring of the indicating light circuit to permit the early detection of a neutral contact failure as shown in Figure 1.

3. Licensees of operating plants and holders of construction permits shall describe the longer term corrective measures planned and the date by which such measures will be implemented by actual installation or by design change, as appropriate. As a minimum, the longer term corrective measures should include rewiring the indicating light as shown in Figure 1 provided the light is readily visible to the control room operator. If not, failures of the neutral position contacts should be annunciated in the control room.
