Docket Nos. 50-458/IE Bulletin No. 80-20
50-459/IE Bulletin No. 80-20

IE Bulletin No. 80-20
Date: July 31, 1980
Page 1 of 2

FAILURES OF WESTINGHOUSE TYPE W-2 SPRING RETURN TO NEUTRAL CONTROL SWITCHES

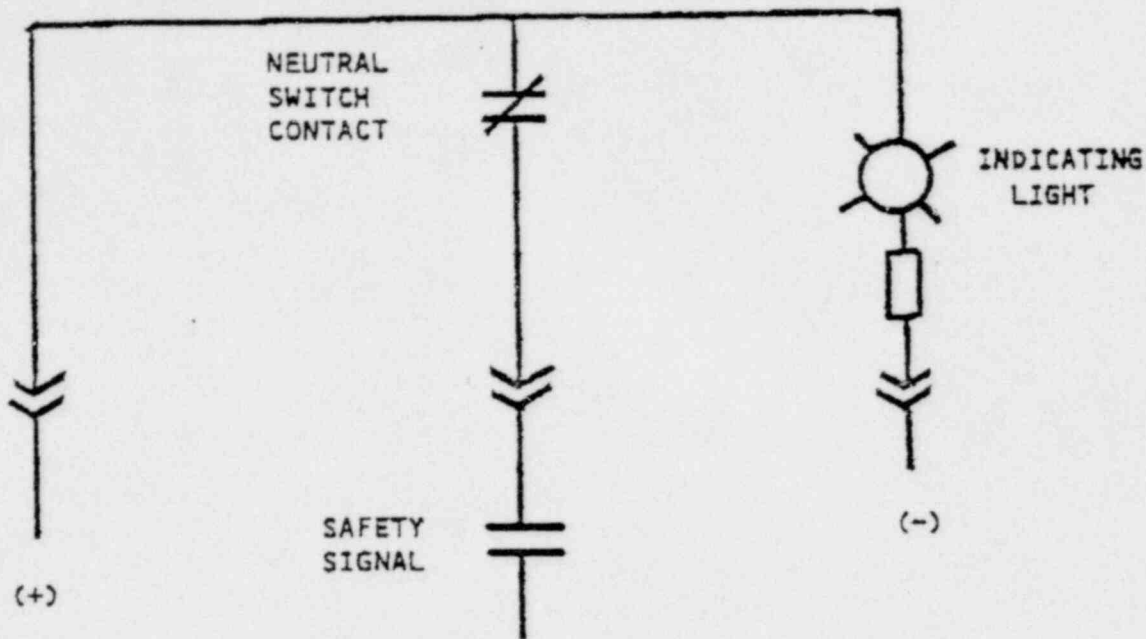
EXISTING INDICATING LIGHT CIRCUIT (TYPICAL)

Depending on how the indicating light circuit is wired, loss of continuity thru the neutral position contact of a W-2 switch could remain undetected until the equipment associated with the switch were called upon to operate. Since such a failure would be equivalent to by-passing the system associated with the switch, consideration should be given to rewiring the switches used in safety-related applications as shown in Figure 1. Such rewiring would provide an acceptable means for detecting contact failure, provided the indicating light is in the control room and readily visible by the operator. If the indicating light is not so located, consideration should be given to annunciating the neutral position contact failures at the control room to alert the operator of the inoperable status of a safety-related system. In addition, consideration should be given to adding redundant contacts to the W-2 switches or to replacing the W-2 switches with others having a more positive contact wiping action.

3. Licensees of operating plants and holders of construction permits shall describe the longer term corrective measures planned and the date by which such measures will be implemented by actual installation or by design change, as appropriate. As a minimum, the longer term corrective measures should include rewiring the indicating light as shown in Figure 1 provided the light is readily visible to the control room operator. If not, failures of the neutral position contacts should be annunciated in the control room.

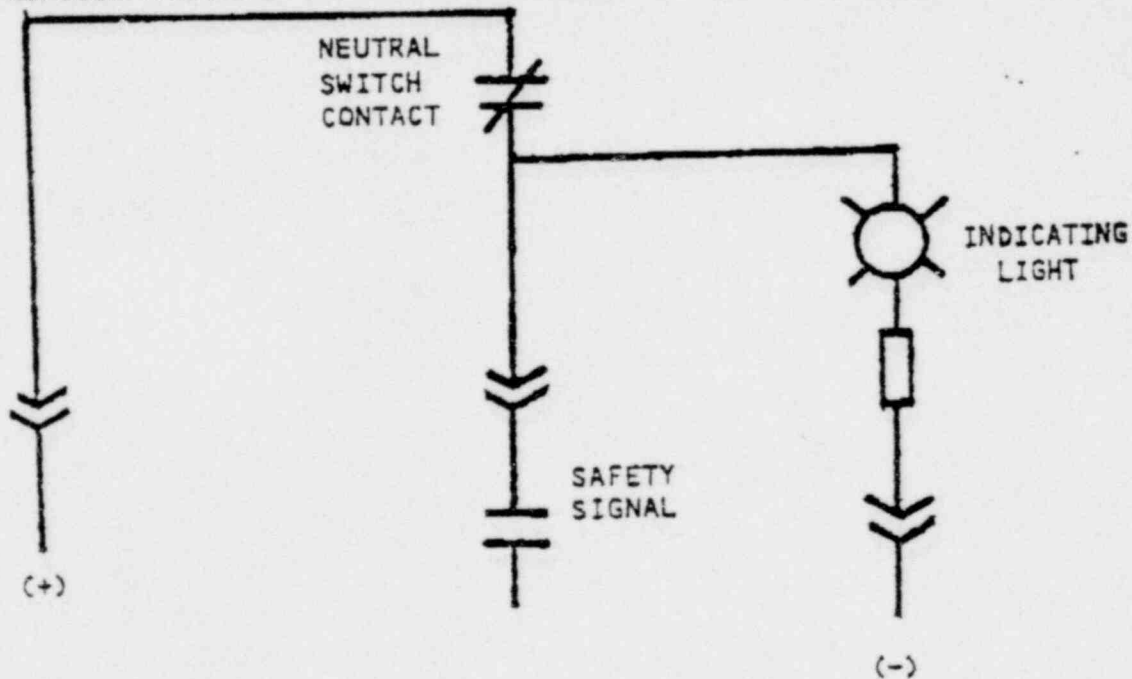
PROPOSED REWIRING OF INDICATING LIGHT CIRCUIT (TYPICAL)

A review of this matter by Westinghouse led to the issuance of NSD Technical Bulletin No. NSD-TB-80-9 to the utility owners of all Westinghouse operating plants. The recommendations contained in the Westinghouse technical bulletin include: (i) testing the neutral position contacts of the subject W-2 switches for continuity, and (ii) rewiring of the indicating light circuit to permit the early detection of a neutral contact failure as shown in Figure 1.

REWIRING OF INDICATING LIGHT CIRCUIT OF W-2 SWITCHES
AS RECOMMENDED BY WESTINGHOUSE TECHNICAL BULLETIN NSD-TB-80-9
