UNITED STATES
NUCLEAR REGULATORY COMMISSION
REGION I
631 PARK AVENUE
KING OF PRUSSIA, PENNSYLVANIA 19406

IE Bulletin No. 80-20
Page 1 of 2

FAILURES OF WESTINGHOUSE TYPE W-2 SPRING RETURN TO NEUTRAL CONTROL SWITCHES

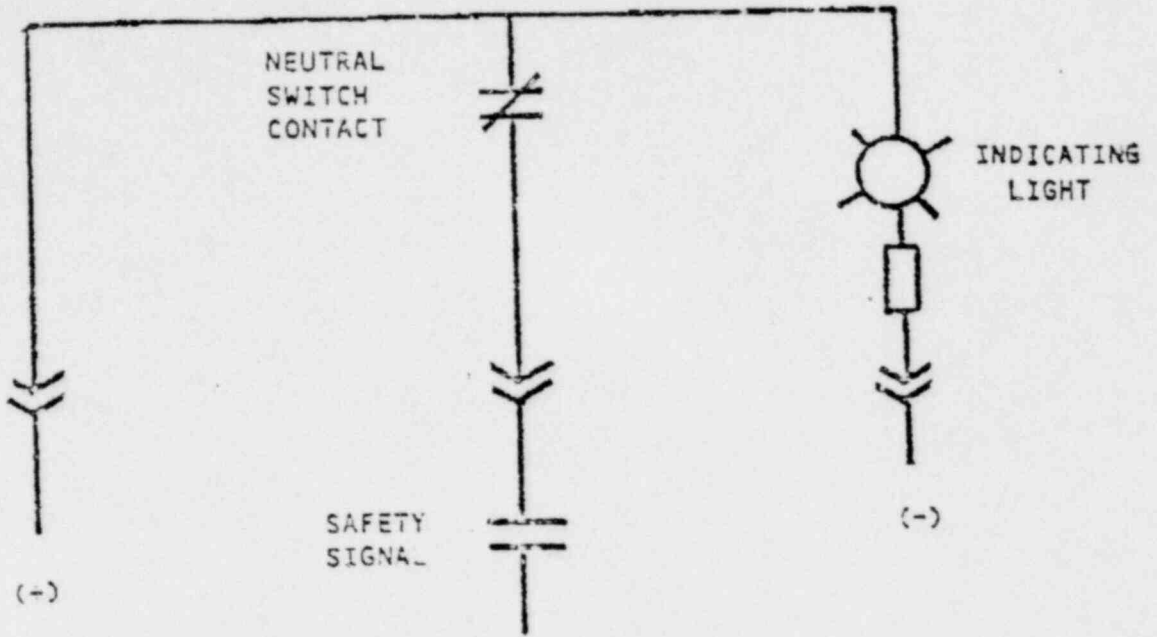
EXISTING INDICATING LIGHT CIRCUIT (TYPICAL)

Depending on how the indicating light circuit is wired, loss of continuity thru the neutral position contact of a W-2 switch could remain undetected until the equipment associated with the switch were called upon to operate. Since such a failure would be equivalent to by-passing the system associated with the switch, consideration should be given to rewiring the switches used in safety-related applications as shown in Figure 1. Such rewiring would provide an acceptable means for detecting contact failure, provided the indicating light is in the control room and readily visible by the operator. If the indicating light is not so located, consideration should be given to annunciating the neutral position contact failures at the control room to alert the operator of the inoperable status of a safety-related system. In addition, consideration should be given to adding redundant contacts to the W-2 switches or to replacing the W-2 switches with others having a more positive contact wiping action.

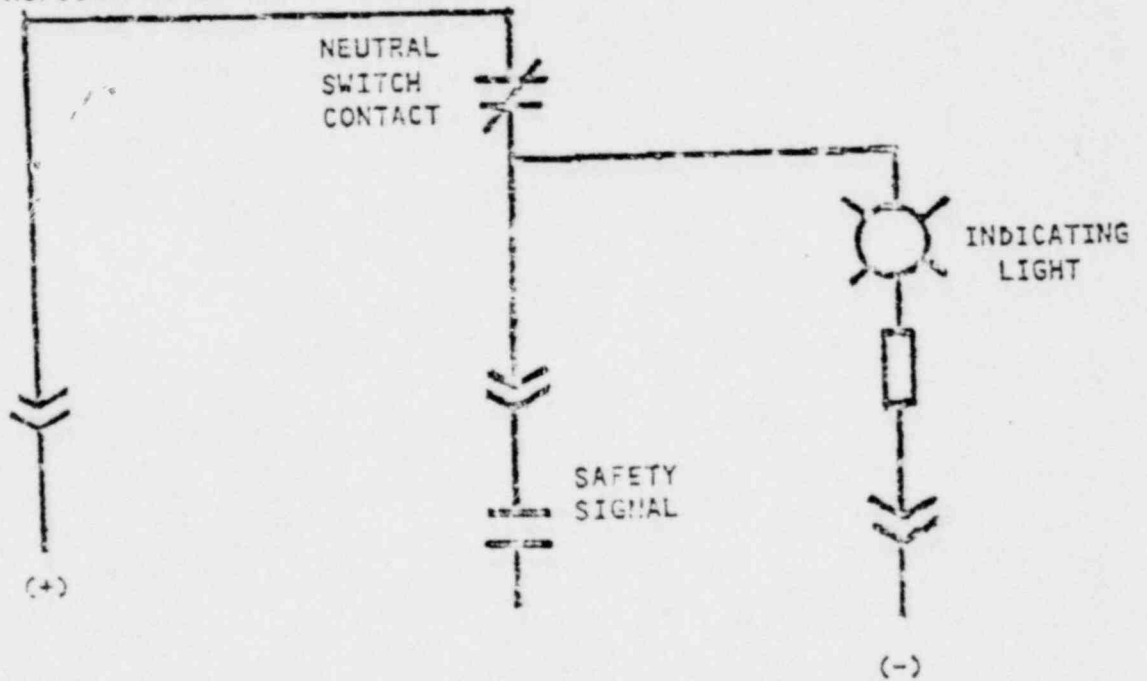
PROPOSED REWIRING OF INDICATING LIGHT CIRCUIT (TYPICAL)

REWIRING OF INDICATING LIGHT CIRCUIT OF W-2 SWITCHES
AS RECOMMENDED BY WESTINGHOUSE TECHNICAL BULLETIN NSD-TB-80-9

A review of this matter by Westinghouse led to the issuance of NSD Technical Bulletin No. NSD-TB-80-9 to the utility owners of all Westinghouse operating plants. The recommendations contained in the Westinghouse technical bulletin include: (i) testing the neutral position contacts of the subject W-2 switches for continuity, and (ii) rewiring of the indicating light circuit to permit the early detection of a neutral contact failure as shown in Figure 1.

3. Licensees of operating plants and holders of construction permits shall describe the longer term corrective measures planned and the date by which such measures will be implemented by actual installation or by design change, as appropriate. As a minimum, the longer term corrective measures should include rewiring the indicating light as shown in Figure 1 provided the light is readily visible to the control room operator. If not, failures of the neutral position contacts should be annunciated in the control room.
