Report Nos. 50-259/80-32, 50-260/80-25 and 50-296/80-26

Facility Name: Browns Ferry

This special, announced inspection involved approximately 300 inspector-hours on site in the areas of inspection and evaluation of the licensee's investigation of the Unit 3 failure to fully insert control rods following a scram on June 28, 1980.

FAILURE TO FULLY INSERT CONTROL RODS FOLLOWING A SCRAM ON 6/28/80

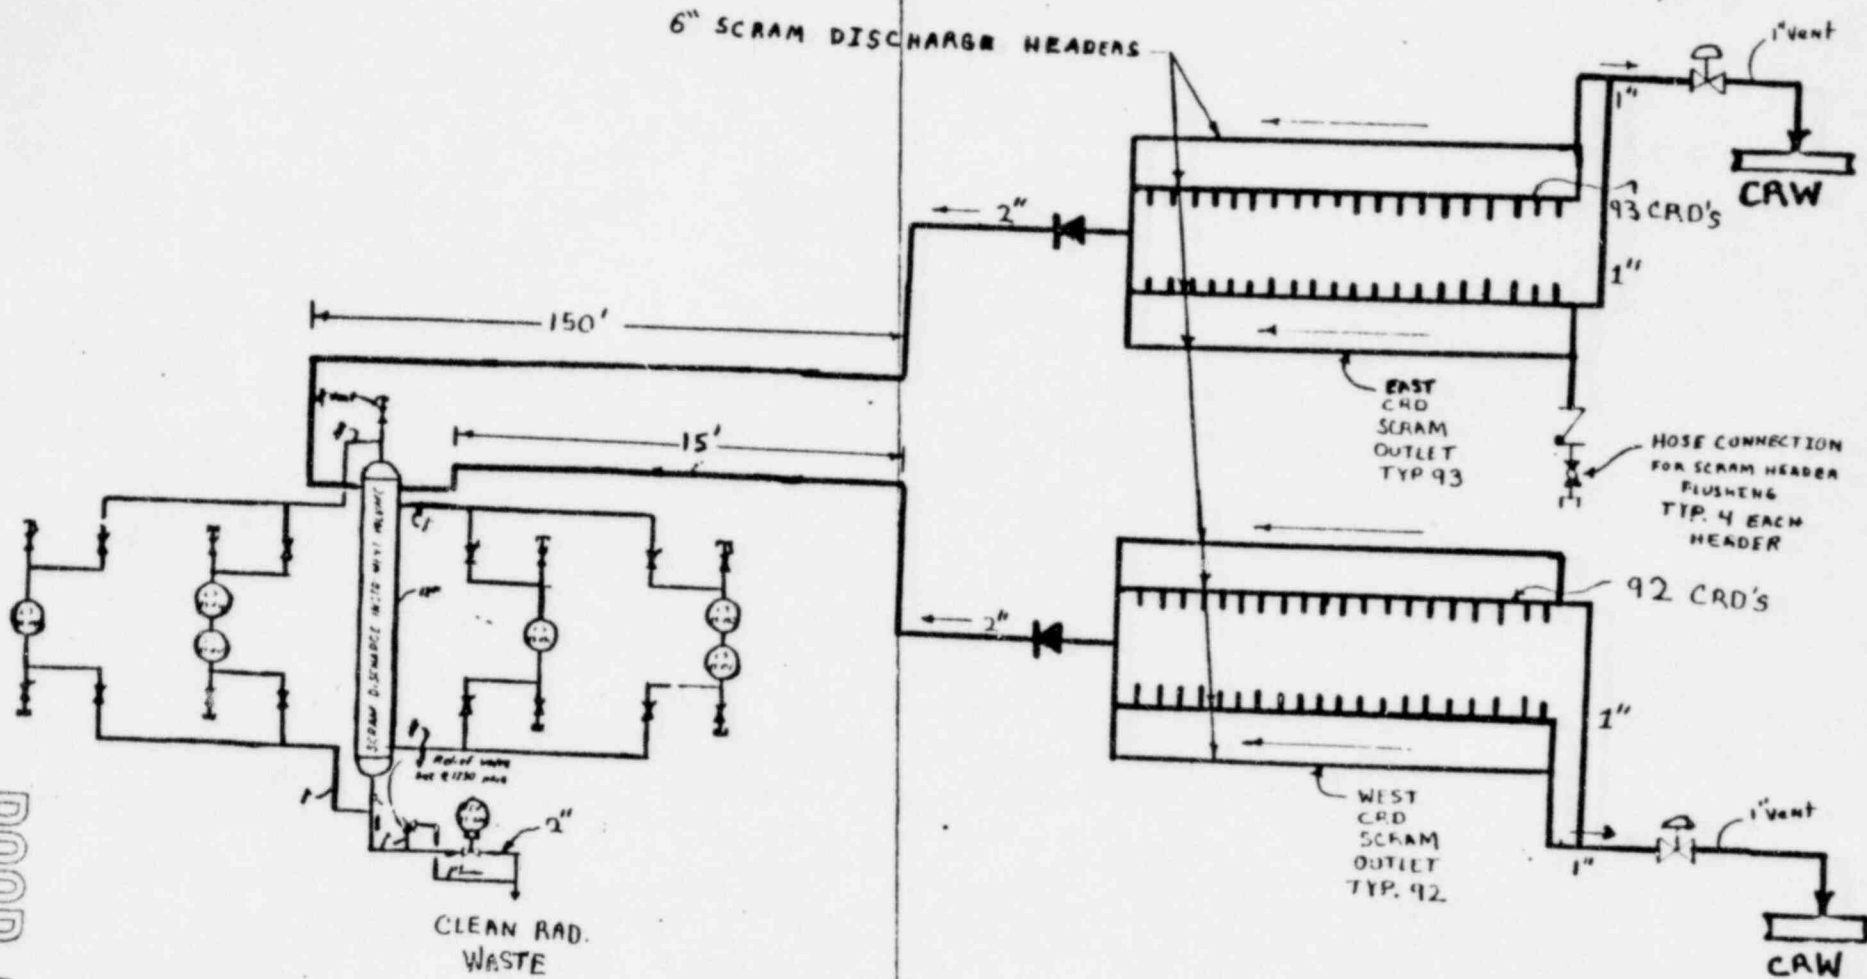
The apparent cause of the control rods on the east side of the reactor to insert is the east scram discharge volume header (SDVH) was partially filled with water prior to the scram. This is also supported by the SDV Hi level (scram) switch which activated in 18 seconds after the initial scram. Review of 12 previous scrams indicated normal times of 42-56 seconds. Figure 1 is a schematic of the system. The design intent is that the SDV system remains empty, with vent and drain valves open, during normal operation. Upon a scram, the vent and drain valves close, and the scram discharge water from above the CRD piston empties rapidly into both SDVH chambers. With the east SDVH partially filled, the pressure quickly equalized to that of the CRD scram inlet water, and the CRD's stopped motion and settled into the nearest notch.

Upon reset of the scram signal, the scram outlet valves from the CRD's close, the vent and drain valves of the SDV open, and water begins to drain from the SDV providing free volume. When the reactor was scrammed again, scram discharge water again flowed into the SDV and all partially withdrawn rods drove in. When pressure equalized above and below the CRD pistons, the rods not fully inserted again stopped and settled into the nearest notch. By repeating this process of reset and scram, three times, the rods were finally able to fully insert. The periods of reset, during which the SDV was allowed to drain, were 94, 53, and 160 seconds. The amount of control rod insertion after each scram signal roughly corresponds to the relative length of drain times. The fact that the final scram which fully inserted the remaining rods was initiated from the automatic circuitry is apparently not significant. At that point, the SDV had been allowed to drain for 160 seconds and a manual scram at that point would have accomplished the same results.

SCRAM DISCHARGE VOLUME
