DOCKETS 50-266 AND 50-301
POTENTIAL WELDING DEFECTS IN TANKS MANUFACTURED
BY GRAVER TANK AND MANUFACTURING COMPANY
POINT BEACH NUCLEAR PLANT, UNITS 1 AND 2

POINT BEACH NUCLEAR PLANT UNIT 1
REFUELING WATER STORAGE TANK
16-INCH PROCESS PIPE CONNECTION

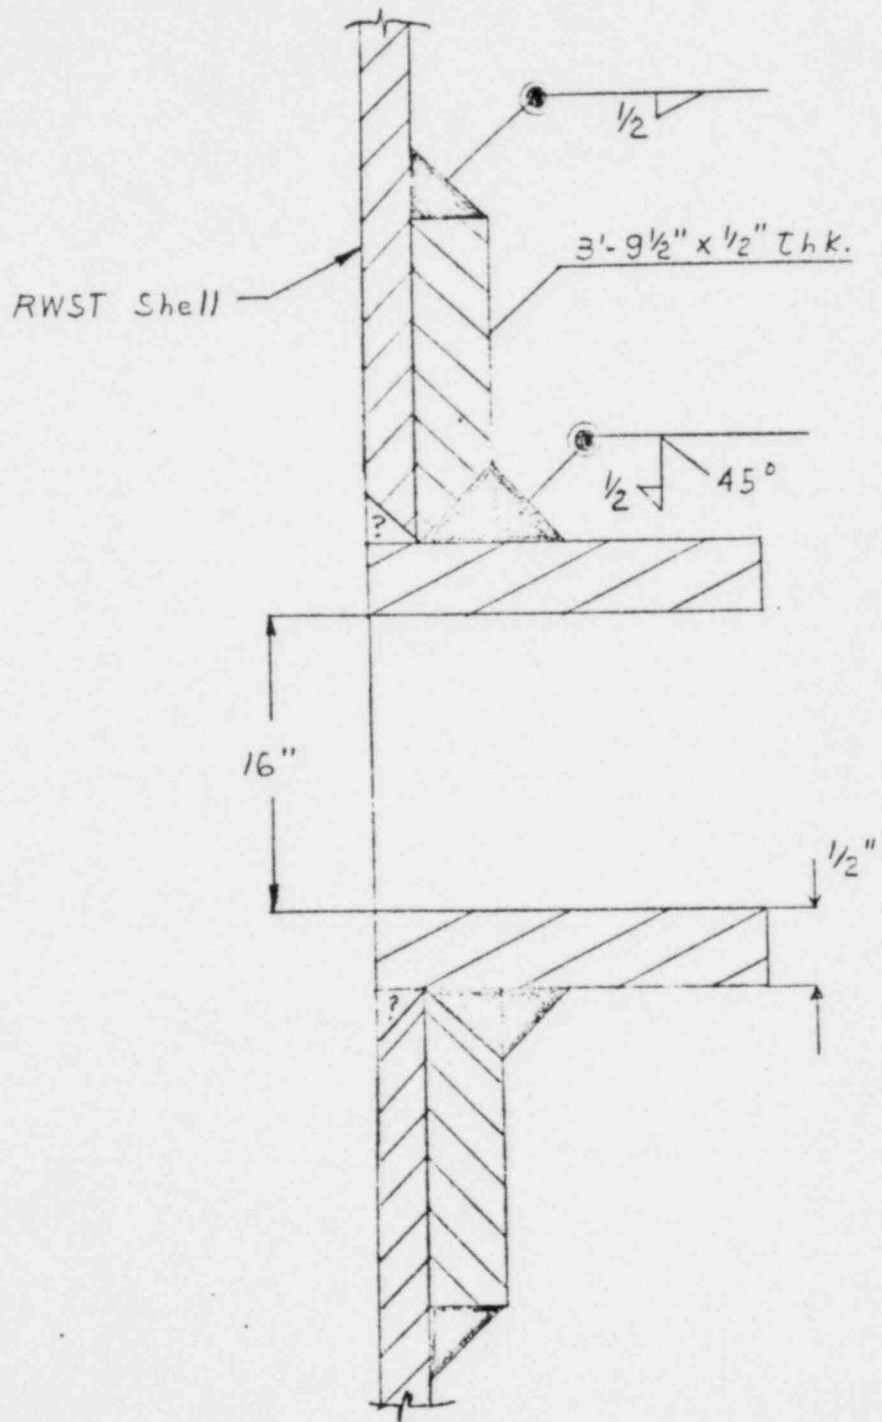
At the present time we have inspected the Unit 1 16-inch process pipe connection. The configuration of this weldment is shown in Attachment A. (The configuration of the internal pipe to tank weldment could not be determined by this inspection.) Ultrasonic inspection verified that the reinforcing pad to pipe weld is a full penetration weld. The reinforcing pad to shell weld was verified by visual inspection. Ultrasonic inspection of the remaining pipe connections and penetrations and sample inspections of seam welds will be performed during the next refueling for each unit. Should welds be found which are not in accordance with design specifications, they will be repaired if necessary to assure the capability to withstand design loading conditions.

"As-Found" Condition
