Vogle Project

Reference: 50-424, 50-425 Final Report on Potential 10CFR50.55(e)
Dewatering and Erosion of Backfill

PLANT VOGTLE UNITS 1 AND 2

FINAL REPORT ON DEWATERING AND REPAIR OF EROSION
IN CATEGORY I BACKFILL IN POWER BLOCK AREA

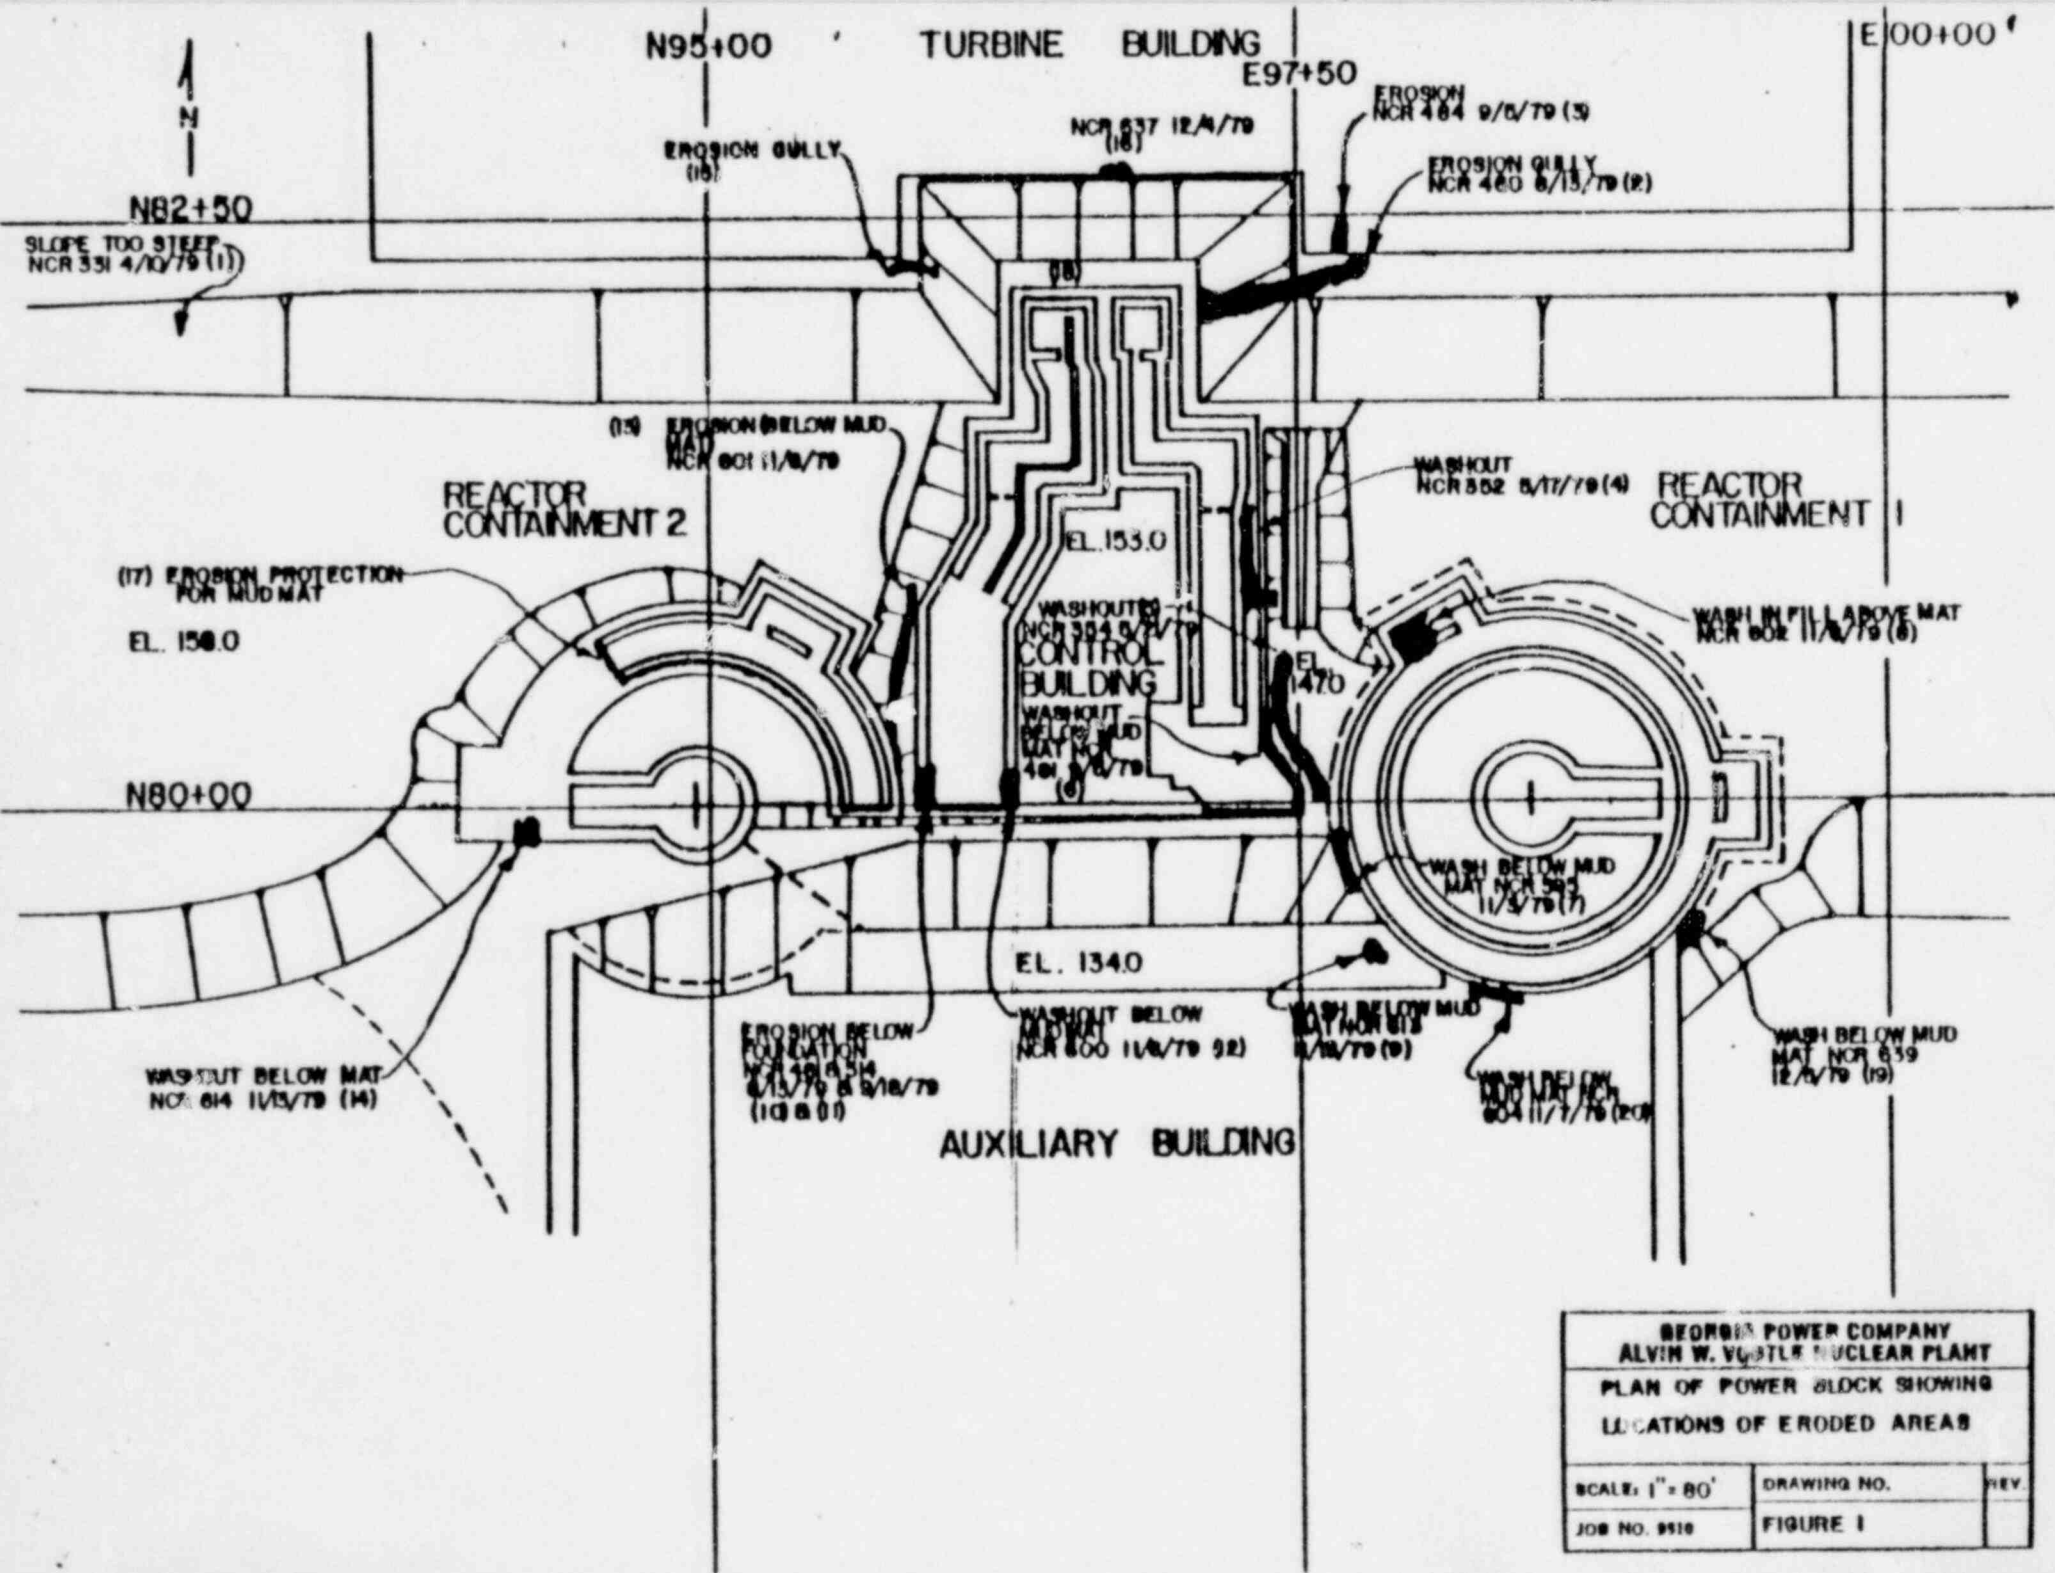
SCALE: 1" = 80'	DRAWING NO.	REV.
JOB NO. 9518	FIGURE 1

Erosion in this vicinity was identified as Areas 1, 2, 3, 15, 16 and 18 respectively (Figure 1). Areas 1, 2, 3, 15 and 16 referred to erosion areas along the Turbine Building south slope; Area 18 referred to the area between the toe of the Turbine Building south slope and the edge of the Control Building shafts' mudslab. All these areas were repaired in accordance with the procedures specified in Reference 1.

Erosion areas for repair in this area were identified as Areas 4, 5 and 6 respectively (Figure 1).

Erosion outside the Unit 1 Containment area was identified as Areas 7, 8, 9, 19 and 20 respectively (Figure 1). Area 7 had been repaired earlier in November, 1979 (Reference 1). Areas 8, 9 and 19 were repaired in accordance with specified procedures. The depth of the disturbed zone was determined by proving ring penetrometer probing. The disturbed fill was excavated to competent fill material and backfilled. At least one sand cone density test was made in each of the above areas prior to fill placement. Area 20,

Erosion in the Unit 2 Containment area was designated as Areas 14 and 17 (Figure 1). Area 14 referred to erosion below the Tendon Gallery mudslab on the west side. However, the construction of the Tendon Gallery had not begun on this section of the mudslab. Erosion in Area 14 was quite limited in extent. Repairs in this area involved removal of the mudslab over the eroded area, excavation to undisturbed material and then backfilling the excavation. Area 17 pertained to erosion below the mudslab of the partially built

Erosion in this area was identified as Areas 10, 11, 12, and 13 (Figure 1). Areas 10 and 11 were repaired in late 1979, as described in Reference 1. Areas 12 and 13 were repaired in February, 1980, in accordance with approved procedures.

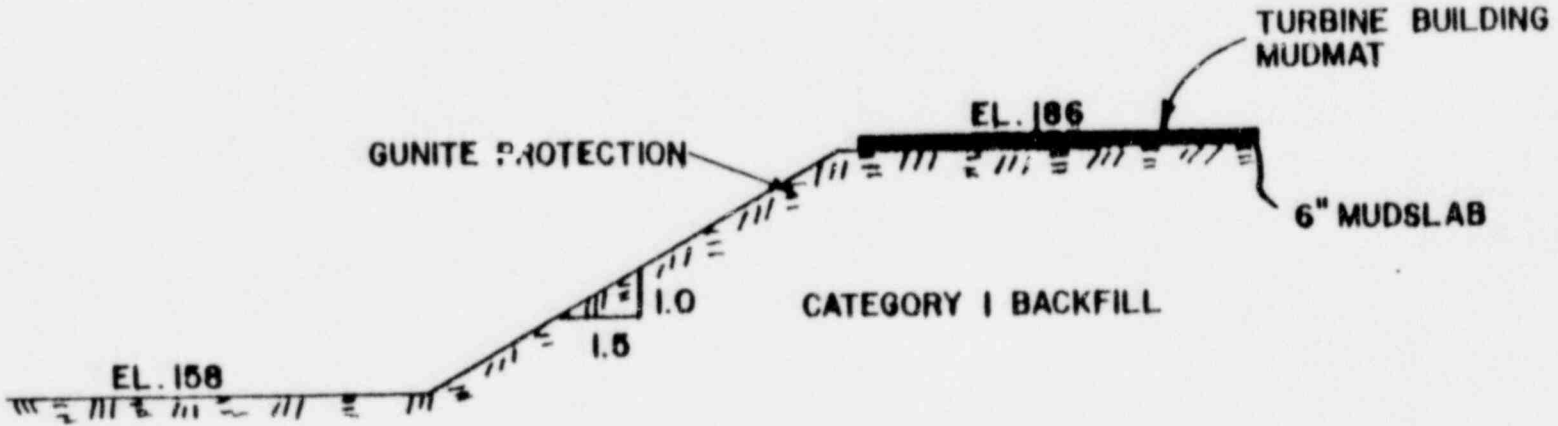
GEORGIA POWER COMPANY ALVIN W. YOBLE NUCLEAR PLANT		
TYPICAL REWORKED SECTION OF TURBINE BUILDING SOUTH SLOPE		
SCALE:	DRAWING NO.	REV.
JOB NO. 9810	FIGURE 4

The Turbine Building foundation base slab was not subjected to any erosion. The erosion that occurred was confined to the south slope, off the south side of the Turbine Building mudslabs. Erosion gulleys extending to a maximum of 4-feet below the mudslab caused cracking to occur in the mudslab. During repair all cracked sections of the mudslab were removed and the erosion gulleys were cut back to sound material at a slope of 1.5 horizontal to 1.0 vertical.

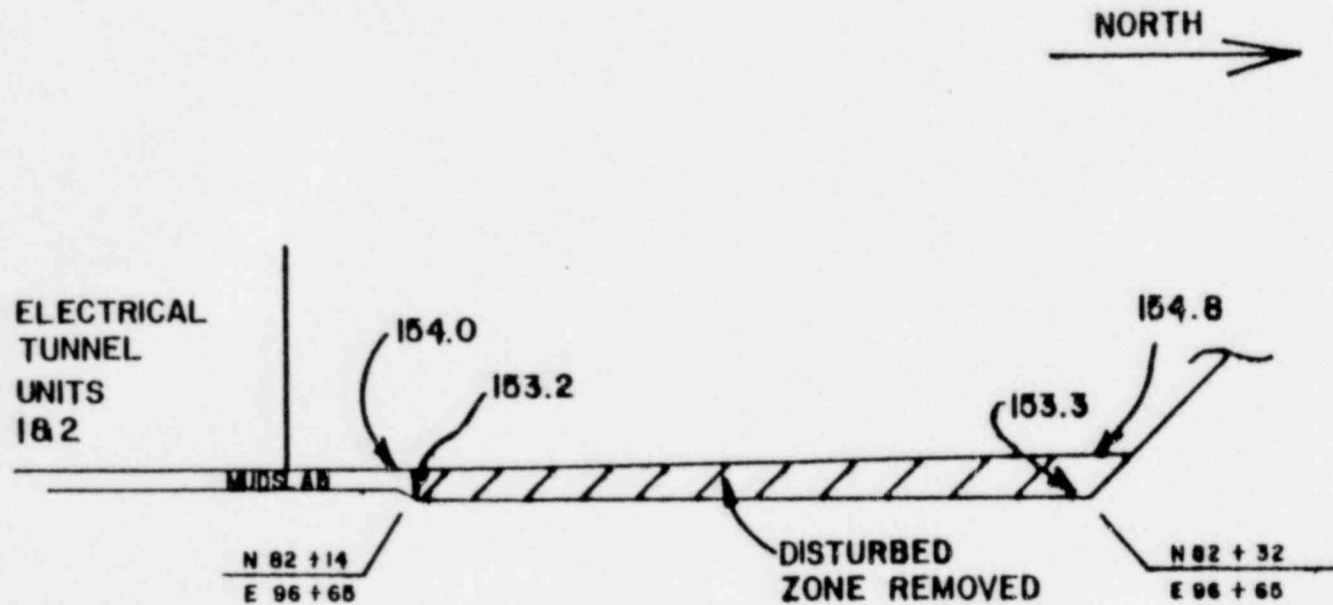
GEORGIA POWER COMPANY ALVIN W. YORTLE NUCLEAR PLANT		
TYPICAL SECTION SHOWING EXTENT OF DISTURBED ZONE REMOVED IN CONTROL BLDG. SHAFT AREA		
SCALE:	DRAWING NO.	REV.
JOB NO. 9919	FIGURE 5

Erosion of backfill in the Control Building shafts area occurred at least 2-feet away from the permanent foundations. Visual inspection showed that the foundations were not affected by erosion. All disturbed areas in the proximity of the Control Building shafts were repaired in accordance with the specified procedures. Settlement in these areas is discussed under Items "D" and "E" below.

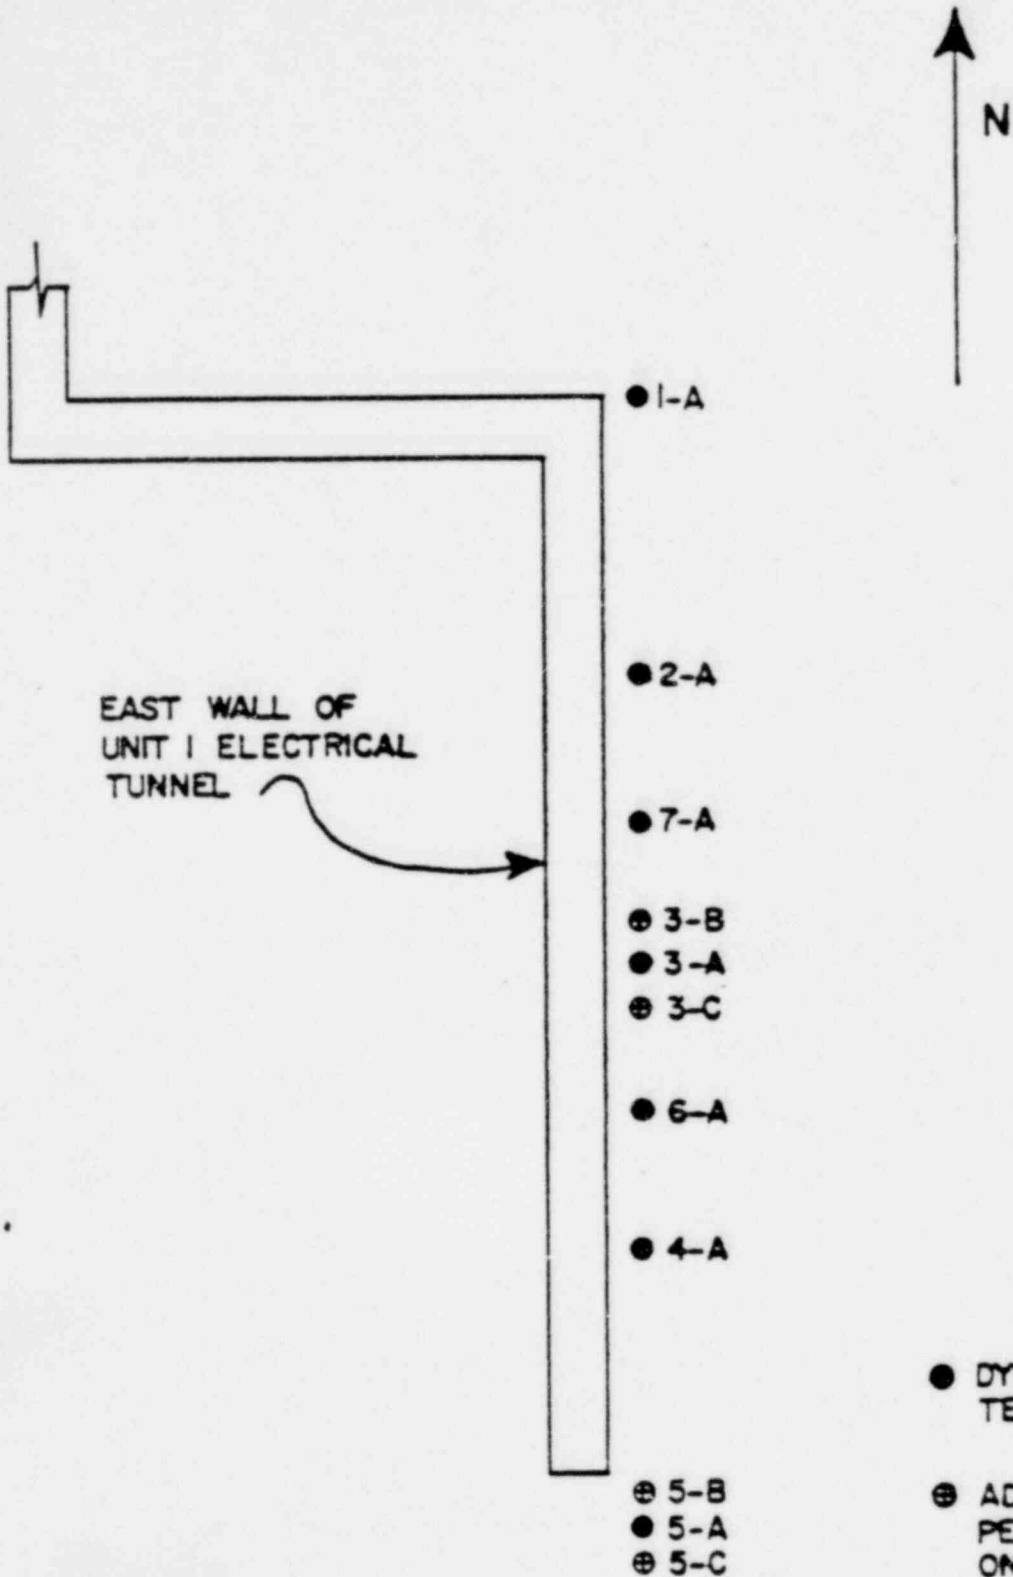
GEORGIA POWER COMPANY ALYNN W. FOSTLE NUCLEAR PLANT		
ELECTRICAL TUNNEL EAST WALL DCP TEST LOCATIONS		
SCALE:	DRAWING NO.	REV.
JOB NO. 9530	FIGURE 6

relating to these dynamic cone penetrometer tests are presented in Table 3. The data indicate that with the exception of Test Locations 3A and 5A, high resistances were obtained in the backfill adjacent to the tunnel wall. In addition, these resistances were observed to generally increase with depth.

Along the Unit 1 Electrical Tunnel east wall, the data obtained from cone penetrometer and sand cone density tests indicated that the backfill adjacent to the tunnel foundation was in sound condition. The disturbed material in the two erosion areas along the slope adjacent to the foundation was carefully removed by hand excavation and the areas backfilled in accordance with the procedure described in Section II.C.2. A visual inspection made prior to backfill revealed that the zone of erosion in both areas did not extend to below the tunnel foundation.

The procedure used to backfill against the east wall was in compliance with the repair procedure specified in Reference 1, with the exception of the variation which is explained below.

The approved repair procedure specified hand-excavation to remove existing gunite and loose materials near the toe of the slope to a maximum height of 1.5-feet from the backfill surface. After repairing the exposed portion of the slope, the area was to be backfilled to

a maximum depth of 1-foot. The procedure specified that all further stages of slope repair work and backfilling be done at height and depth increments of 1.5-feet and 1.0-foot respectively. Subsequent to the erosion last year, the undisturbed Electrical Tunnel slope surface was protected by polyethylene sheeting, on which a layer of loose fill was placed. The entire slope was then gunited. Apparently, no bond existed between the existing loose fill and gunite with Category I backfill because of the polyethylene sheeting. Consequently, the protection system became unstable when the lower section was removed, necessitating removal of the full height rather than in 1.5-foot increments.

The intent of the specified repair procedure was to prevent long-term exposure of the undisturbed fill slope prior to backfilling. This was satisfied, since backfilling was accomplished expeditiously in the east-west direction in slope lengths not exceeding 10-feet. This involved removing the gunite and loose fill to a height dictated by practical considerations but restricting the working slope to a segment 10-feet long, thus limiting the area exposed to possible erosion during the repair work.

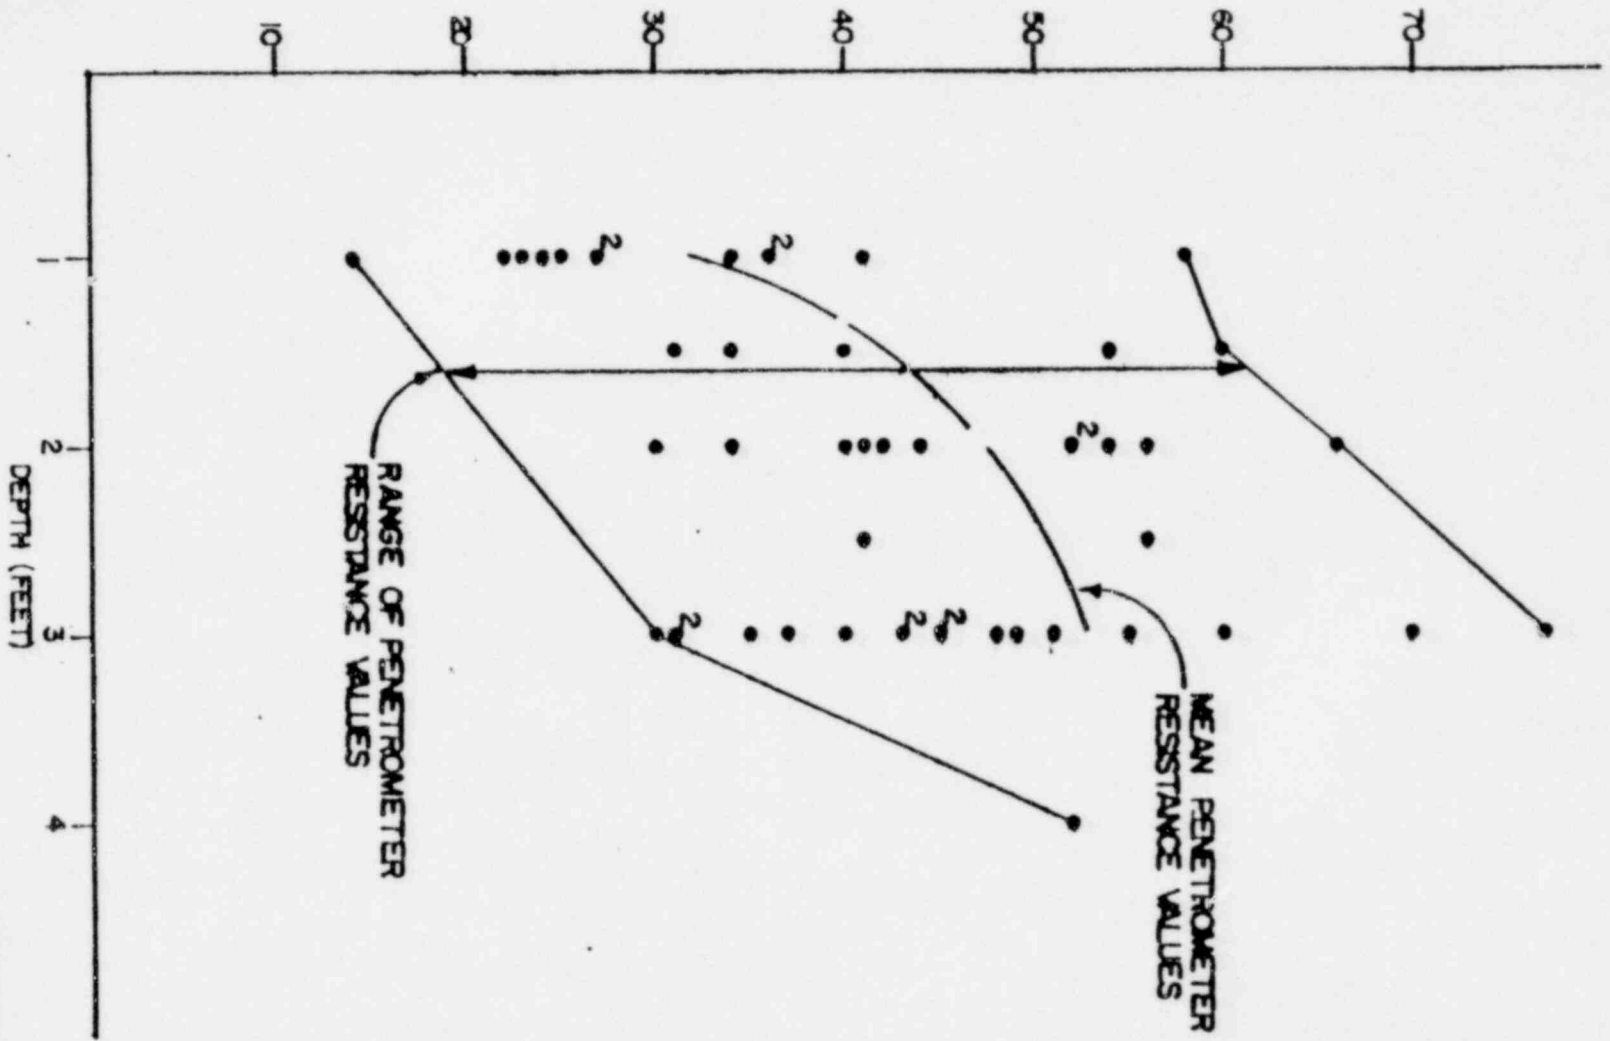
GEORGIA POWER COMPANY ALVIN W. YOSTLE NUCLEAR PLANT			
DYNAMIC CONE PENETRATOR RESISTANCE VERSUS DEPTH FOR UNIT 1 TUNNELL GALLERY			
SCALE:	DRAWING NO.	REV.	
JOB NO. 9510	FIGURE NO.

The NRC, in a letter to Georgia Power Company (GPC), directed that for the Unit 1 Tendon Gallery an investigative approach similar to that proposed by GPC for Unit 2 be followed to determine the extent of any erosion around the Tendon Gallery foundation (Reference 2). For Unit 2 Containment, a number of dynamic cone penetrometer and sand cone density tests were proposed around the inside perimeter of the Tendon Gallery mudslab. Accordingly, a program of in situ density testing around the inside perimeter of the Unit 1 Tendon Gallery mudslab was developed by Bechtel for the purpose of verifying the competency of the backfill. Dynamic cone penetrometer tests taken at seventeen locations shown in Figure 9 were performed below the mudslab after core-cutting through it. These tests were made to a maximum depth of 3-feet. A summary of the test results is in Table 4. Figure 10 represents a plot of the penetrometer blowcounts with depth.

In summary, the Unit 1 Tendon Gallery wall foundation was not jeopardized by the heavy rainfall of early November, 1979. It has been concluded from field test data and visual observations that no erosion occurred below the Tendon Gallery base slab.

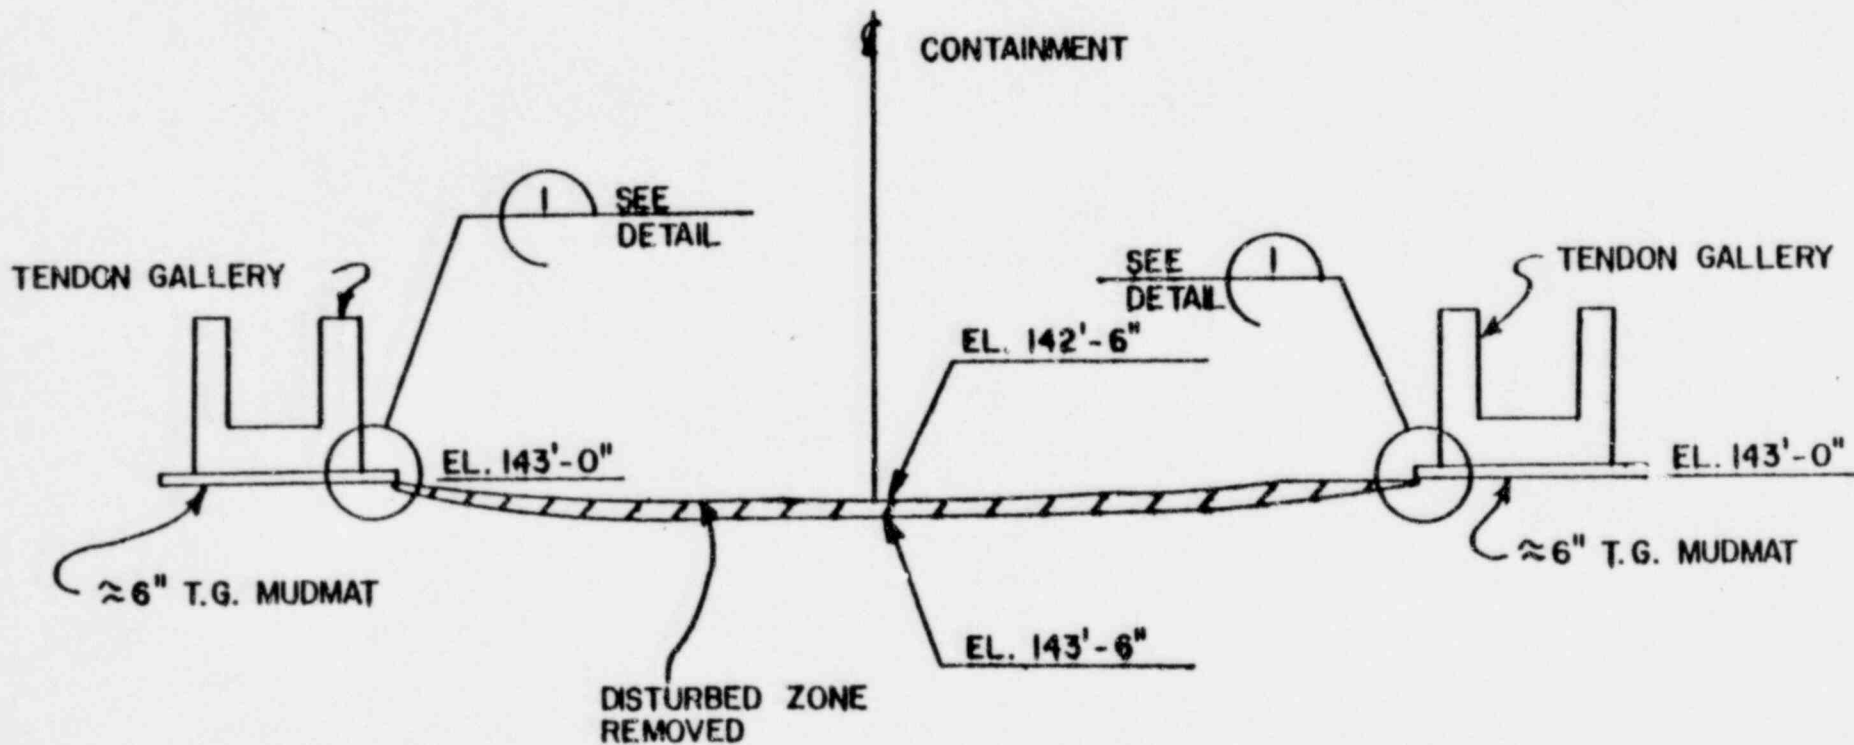
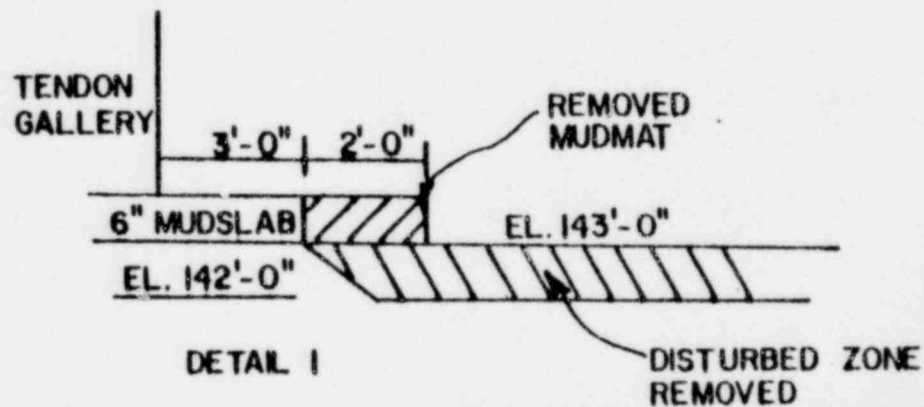
<p>GEORGIA POWER COMPANY ALVIN W. VORTLE NUCLEAR PLANT</p>		
<p>TYPICAL CROSS SECTION IN UNIT 1 CONTAINMENT AREA SHOWING EXTENT OF DISTURBED ZONE REMOVED</p>		
SCALE:	DRAWING NO.	REV.
JOM NO. 9510	FIGURE 11

Some typical cross-sections of the Containment area showing the extent of loose material removed are shown in Figure 11.

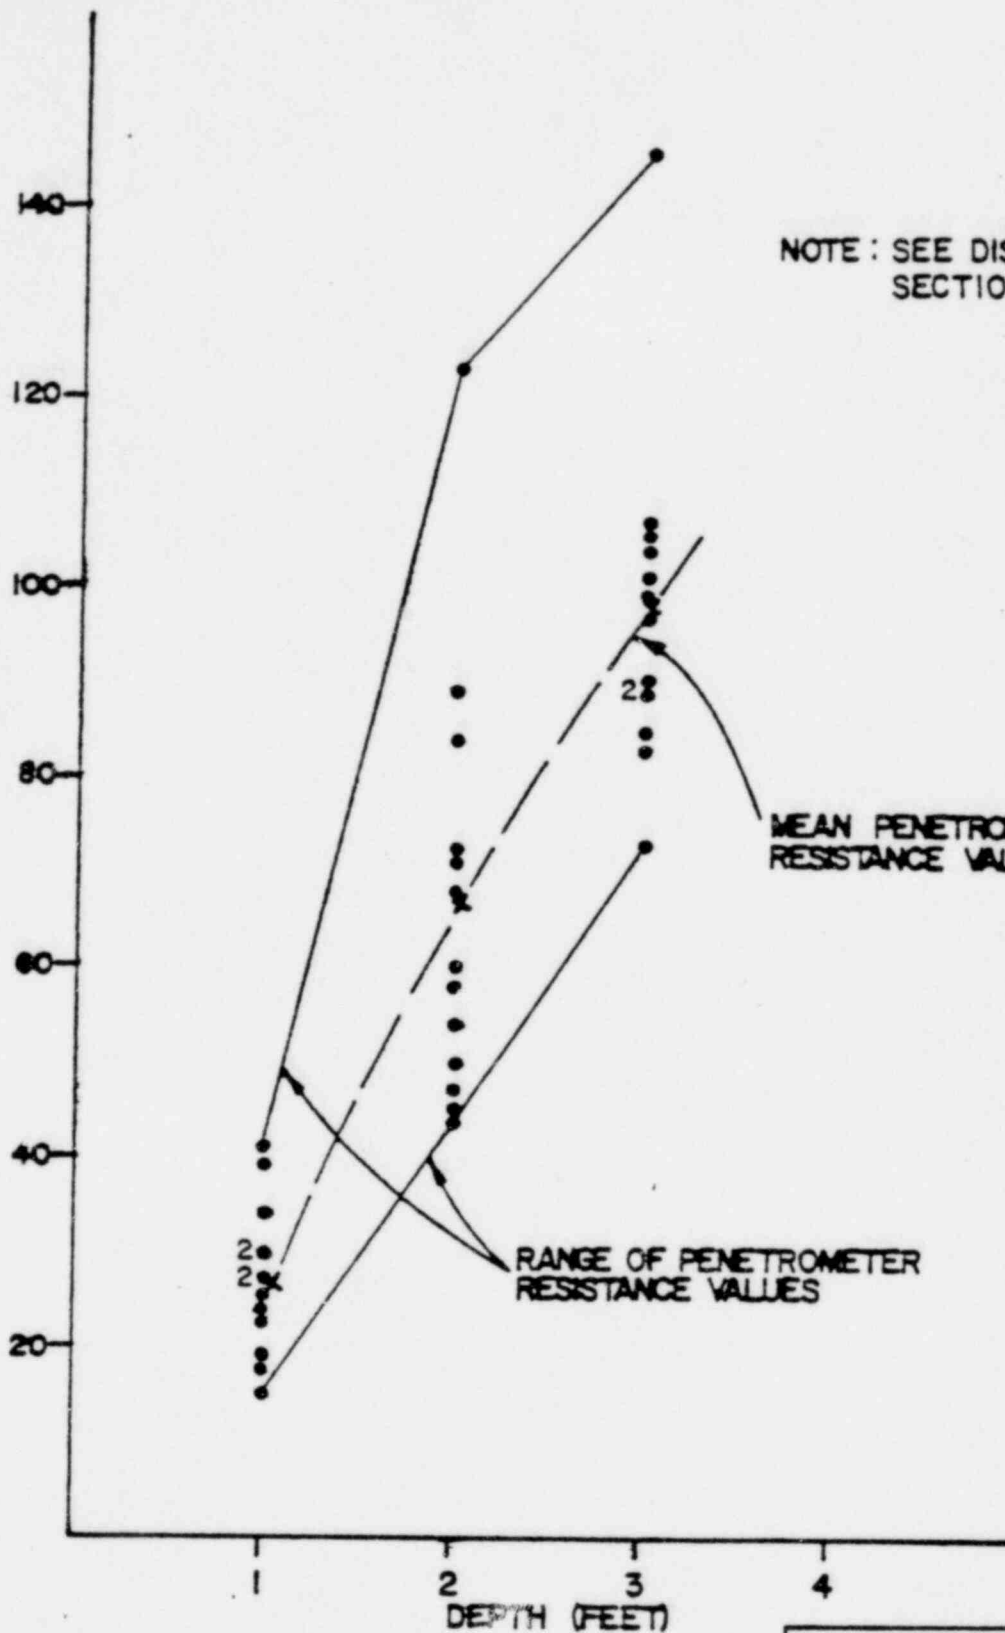
GEORGIA POWER COMPANY ALVIN W. VOITTE NUCLEAR PLANT		
DYNAMIC CONE PENETROMETER RESISTANCE VERSUS DEPTH FOR UNIT 2 TENDON GALLERY		
SCALE:	DRAWING NO.	REV.
JOB NO. 9510	FIGURE 13

Area 17 pertained to the area surrounding the completed segment of the Tendon Gallery wall foundation. Extensive testing was performed in the area adjacent to the Tendon Gallery foundation. The test data obtained showed that

the backfill adjacent to the foundation was dense. Visual inspection revealed that some erosion had occurred at the edge of the mudslab along a few sections of the inside perimeter. A portion of the mudmat was removed and by means of the proving ring penetrometer it was established that the erosion extended to approximately 18-inches from the edge of the foundation. It was concluded that this erosion was caused by run-off flowing along the periphery of the Tendon Gallery wall and flowing away toward the Auxiliary Building. The fill surface and slope against the mudslab were devoid of any erosion channels, nor was there any evidence of loss of density. It has been concluded that no piping of fines occurred below the Tendon Gallery foundation. If piping had occurred, it would have manifested itself in the form of erosion adjacent to the Tendon Gallery foundation mudslab.

Minor additional erosion occurred below the mudmat due to rainfall that occurred immediately after the evaluation tests were complete. However, the zone of disturbed material was at least 1-foot away from the Gallery foundation. The disturbed material was excavated, and the area was backfilled following approved repair procedures.

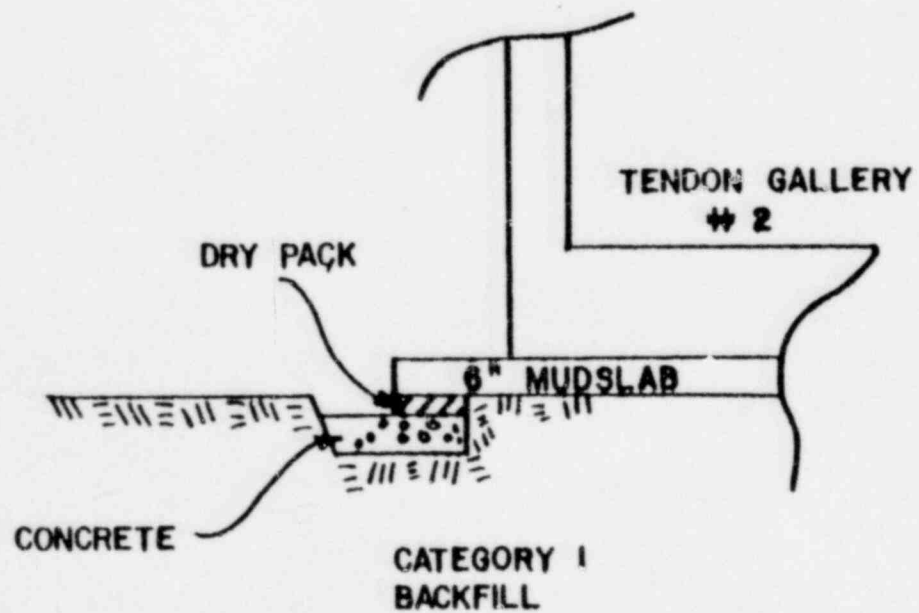
GEORGIA POWER COMPANY ALVIN W. VOYTE NUCLEAR PLANT		
SKETCH SHOWING PROCEDURE USED TO REPAIR UNIT 2 TENDON GALLERY MUDSLAB		
SCALE:	DRAWING NO.	REV.
JOB NO. 8810	FIGURE 14

Immediately after the tests were completed, minor additional erosion occurred as a result of a rainstorm. The area was retested and repaired in accordance with approved procedures. The maximum extent of disturbed backfill under the mudslab was increased to about 10-inches. This situation was remedied by the procedure illustrated in Figure 14 and outlined below.

- a. All loose material was removed from below the mudslab and 1-foot away from it. Proving ring penetrometer tests were made to assure that all disturbed material was removed.
- b. A form was placed 1-foot away from the edge of the mudslab.

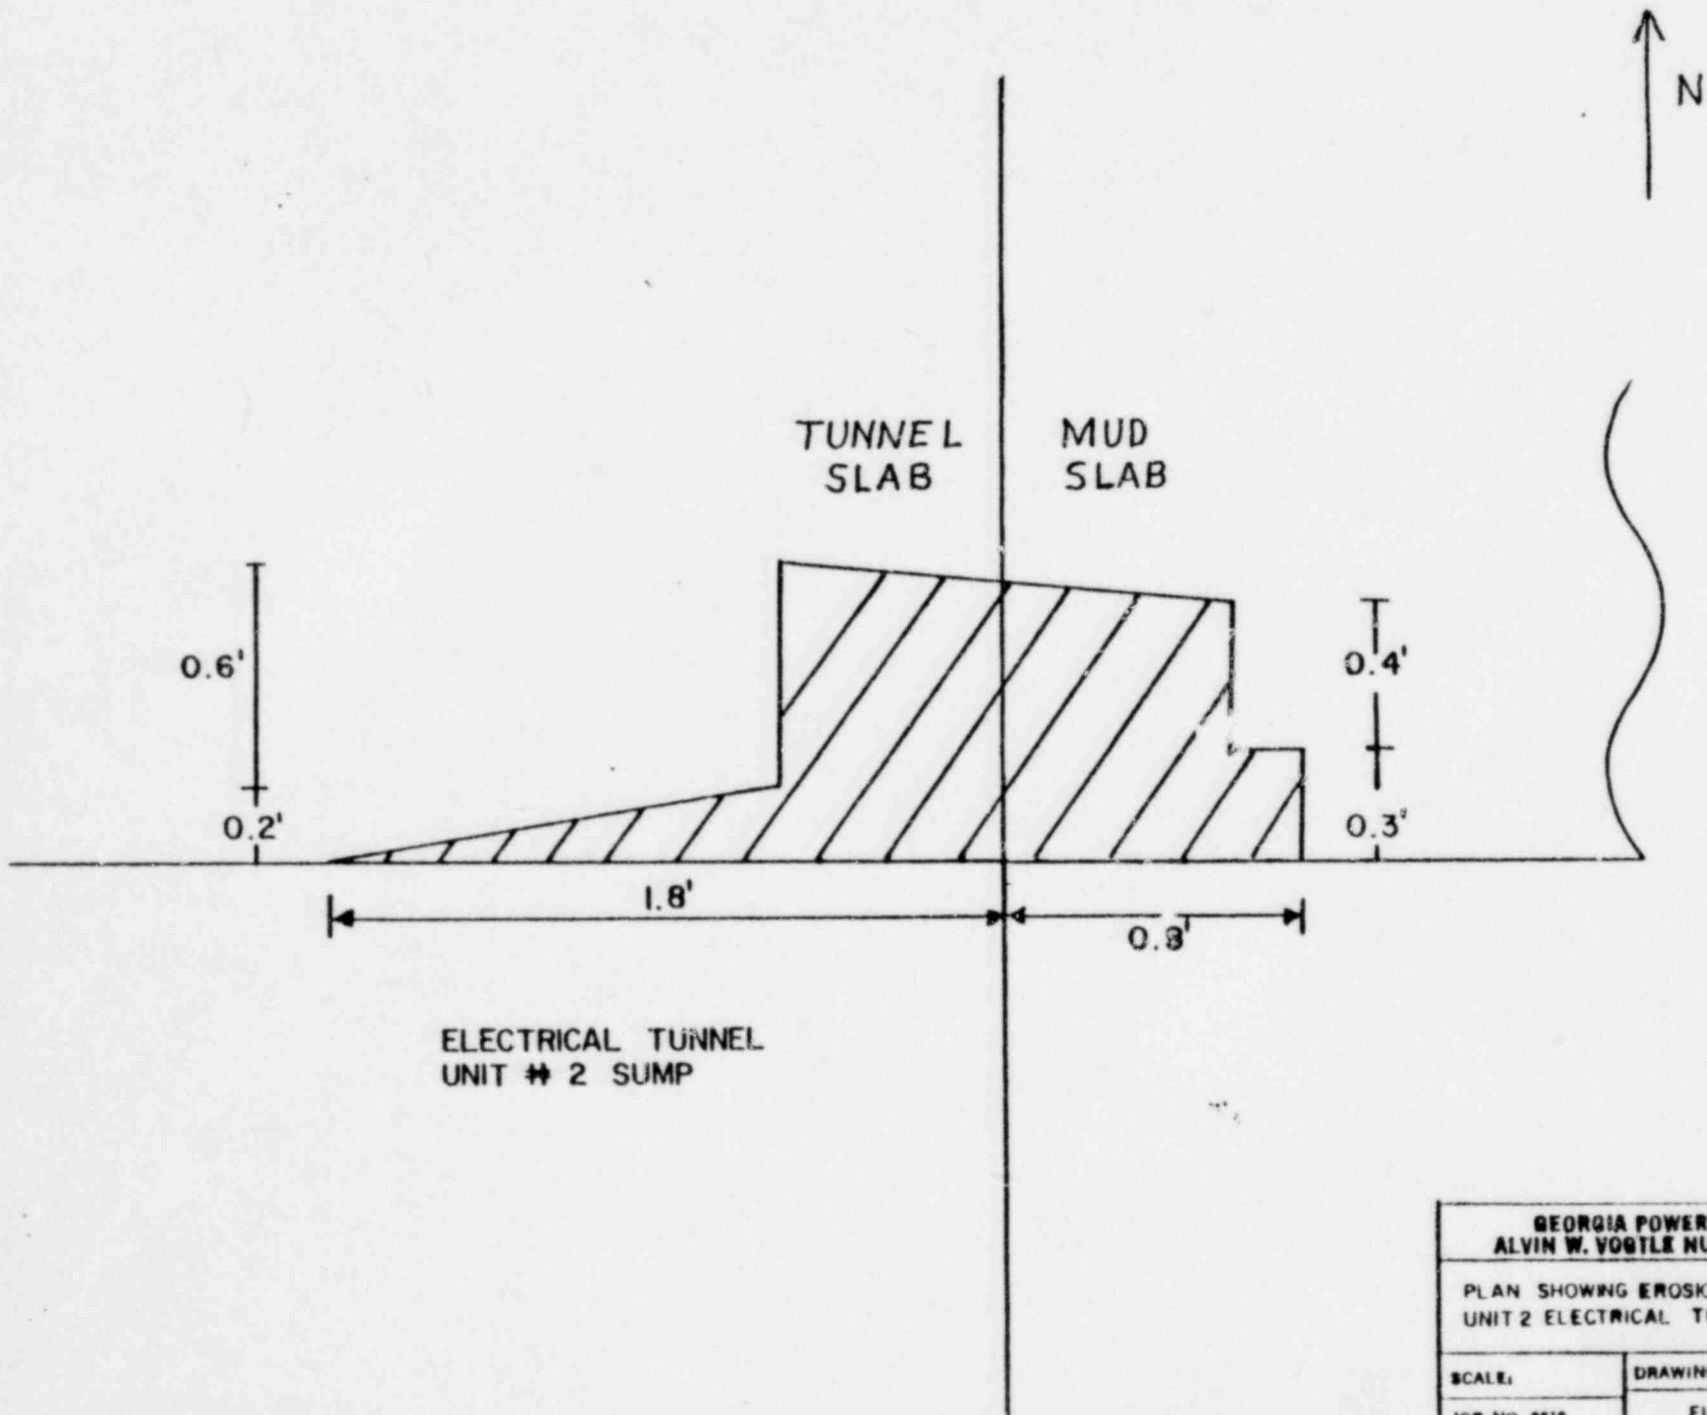
GEORGIA POWER COMPANY ALVIN W. VOGTLE NUCLEAR PLANT		
PLAN SHOWING EROSION IN JULY 1980 UNIT 2 ELECTRICAL TUNNEL MUDSLAB		
SCALE:	DRAWING NO.	REV.
JOB NO. 9510	FIGURE 15

An additional erosion area occurred below the mudslab of the Electrical Tunnel, Unit 2, in July, 1980. This erosion, was caused by construction water due to a hose failure. The maximum depth of erosion below the basemat was 0.8-feet and it extended approximately 1.8-feet below the tunnel base slab for a distance of approximately 0.8-feet. (See Figure 15). The area was repaired in accordance with approved procedures.

The erosion along the east wall which occurred in July, 1980, was evaluated and repaired in accordance with approved procedures.

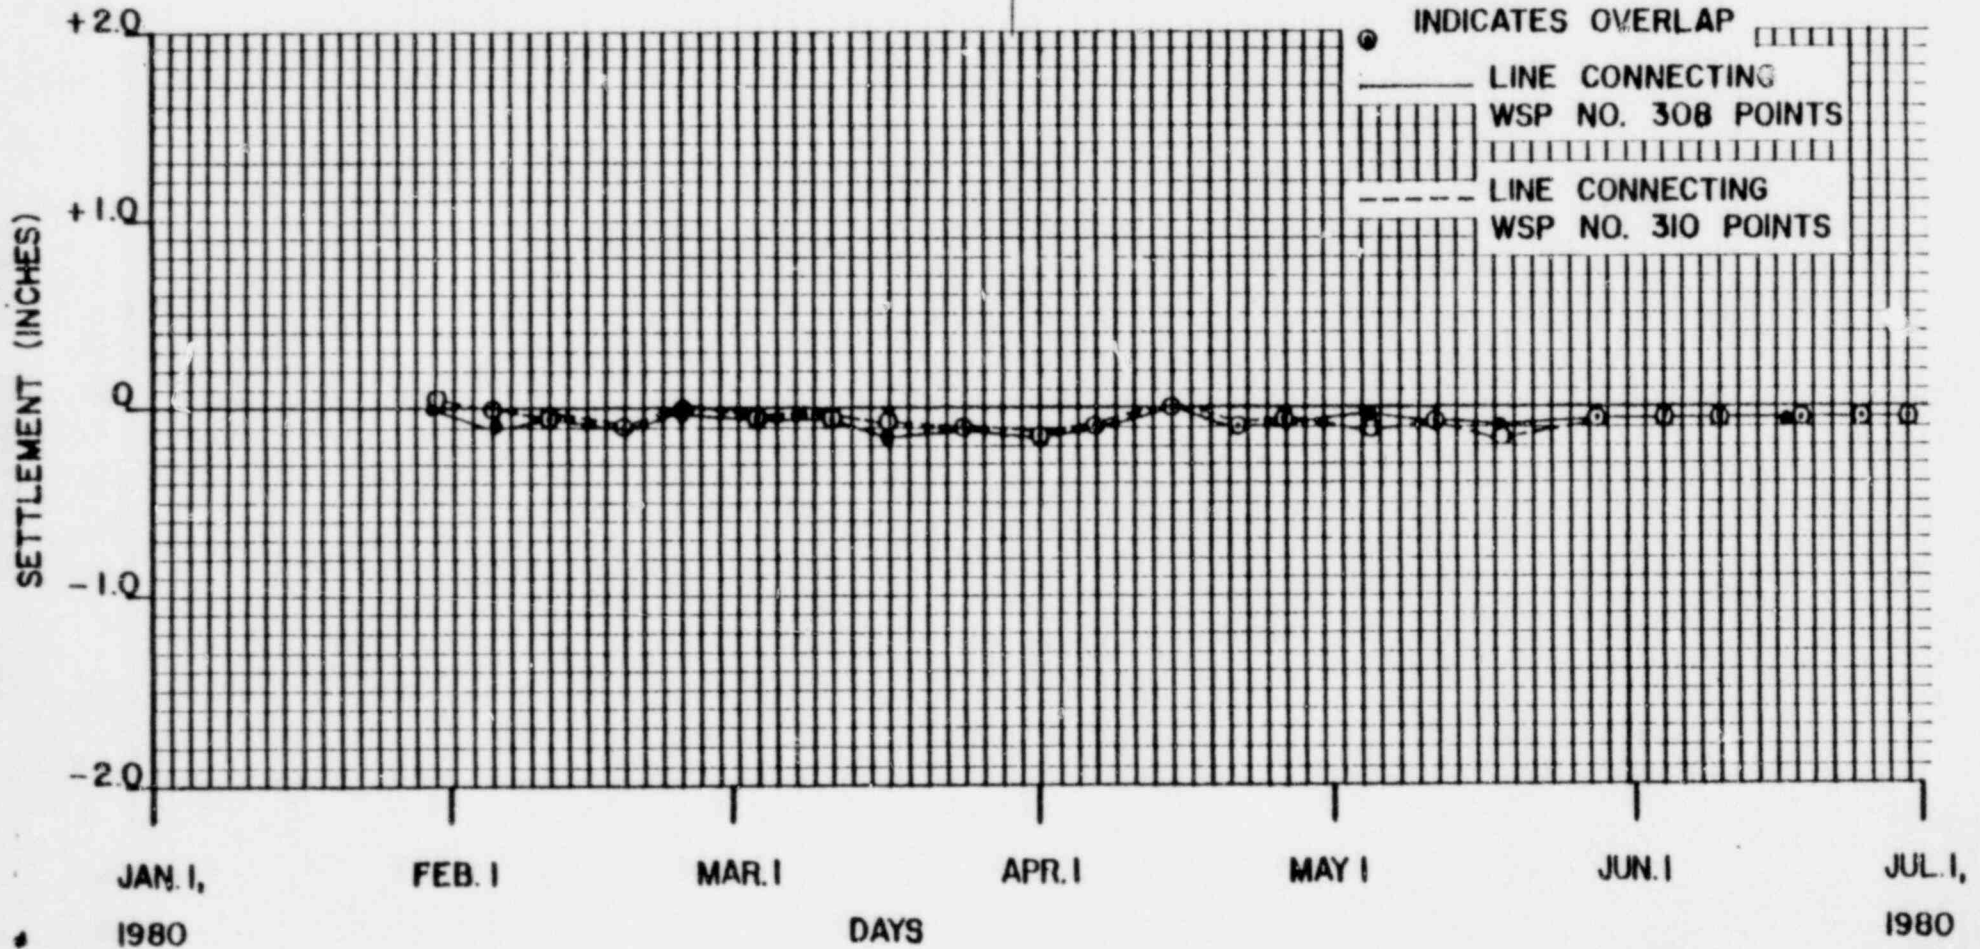
GEORGIA POWER COMPANY ALVIN W. VORTLE NUCLEAR PLANT		
SETTLEMENT VERSUS TIME FOR TURBINE BUILDING UNITS 1 & 2		
SCALE:	DRAWING NO.	REV.
JOB NO. 8810	FIGURE 16-2

Settlement of the Turbine Building base slab was monitored by two settlement markers, Nos. 308 and 310 (Figure 16). Readings were taken on a weekly basis during the period January 1 through July 1, 1980. These readings are shown plotted on Figure 16-2. The maximum observed settlement is on the order of 0.16 inch, which is reasonable considering the current loading condition and the limits of the survey accuracy.

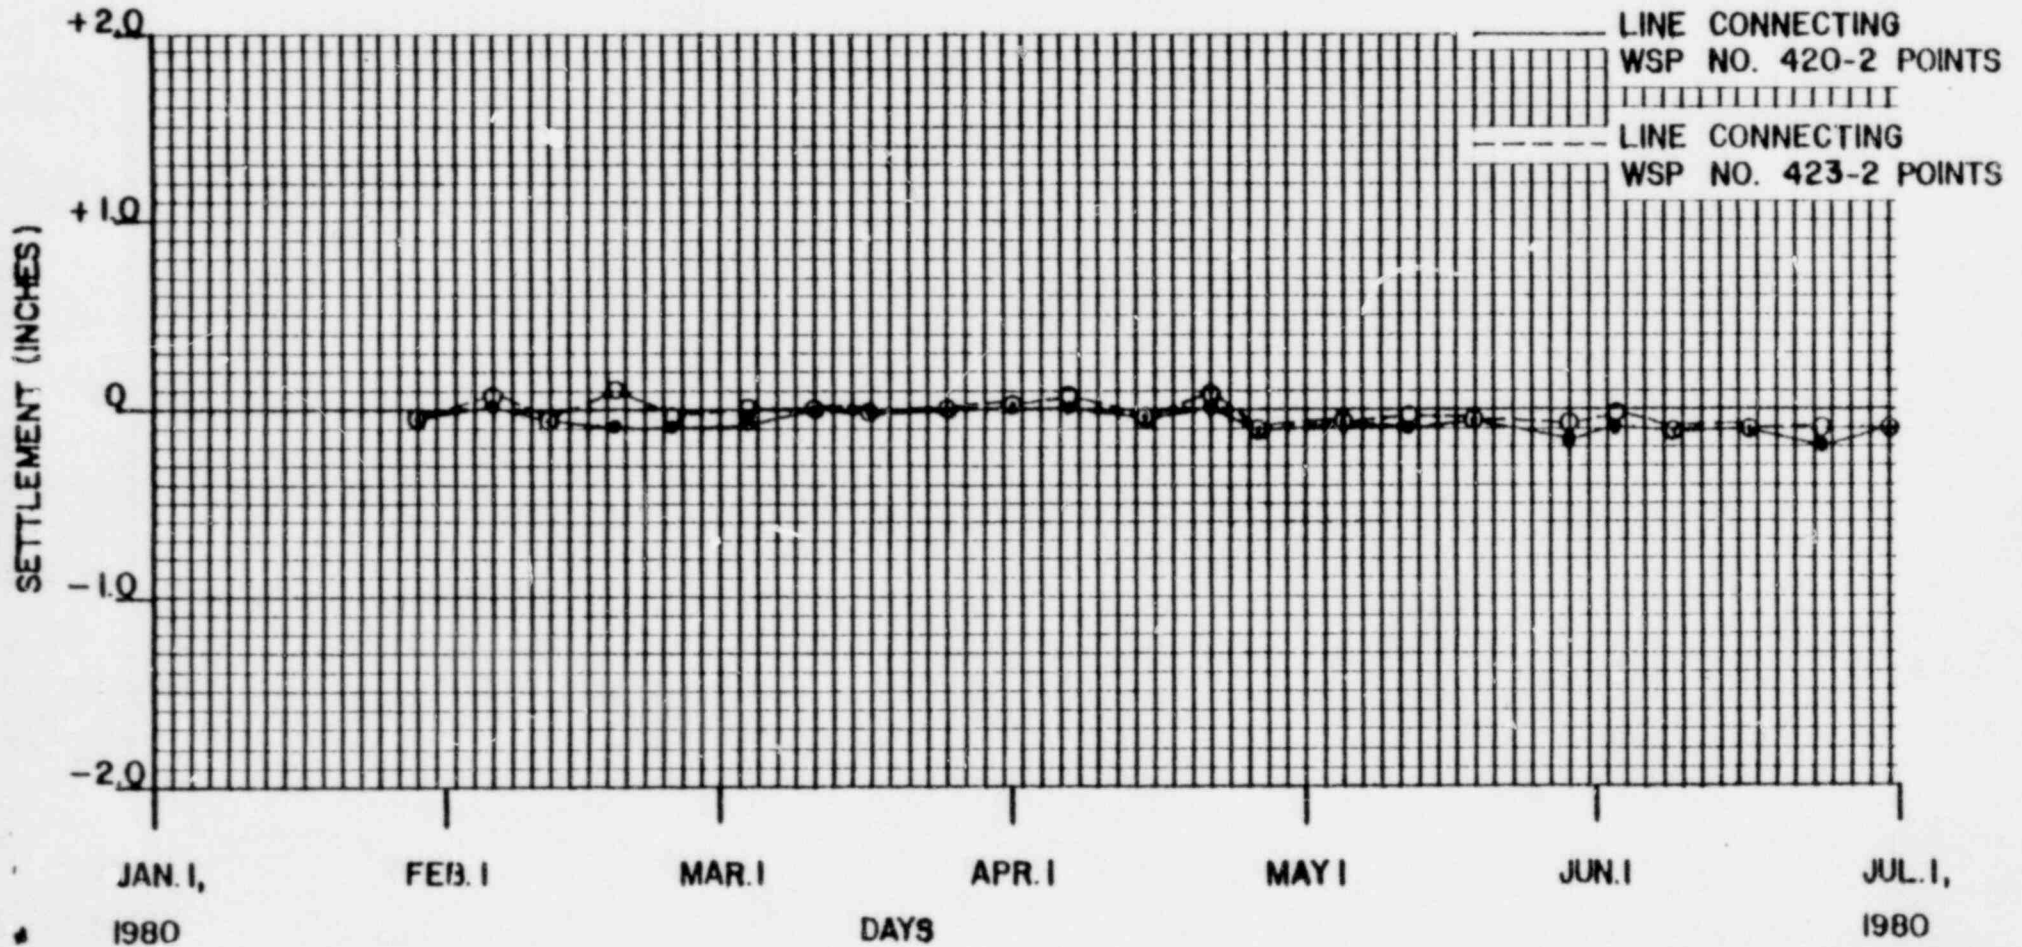
GEORGIA POWER COMPANY ALVIN W. VOSTLE NUCLEAR PLANT		
SETTLEMENT VERSUS TIME FOR ELECTRICAL TUNNEL UNIT 2		
SCALE:	DRAWING NO.	REV.
JOB NO. 9810	FIGURE 16-3

A plot of settlement versus time for the Unit 2 Electrical Tunnel foundation is shown on Figure 16-3. Small settlements, on the order of 0.2 inch, were recorded, which are reasonable considering the current loading condition and the limits of the survey accuracy.

It was concluded that the erosion had not affected the permanent foundation.
