Vogle Project

Reference: 50-424, 50-425 Final Report on Potential 10CFR50.55(e)
Dewatering and Erosion of Backfill

PLANT VOGTLE UNITS 1 AND 2

FINAL REPORT ON DEWATERING AND REPAIR OF EROSION
IN CATEGORY I BACKFILL IN POWER BLOCK AREA

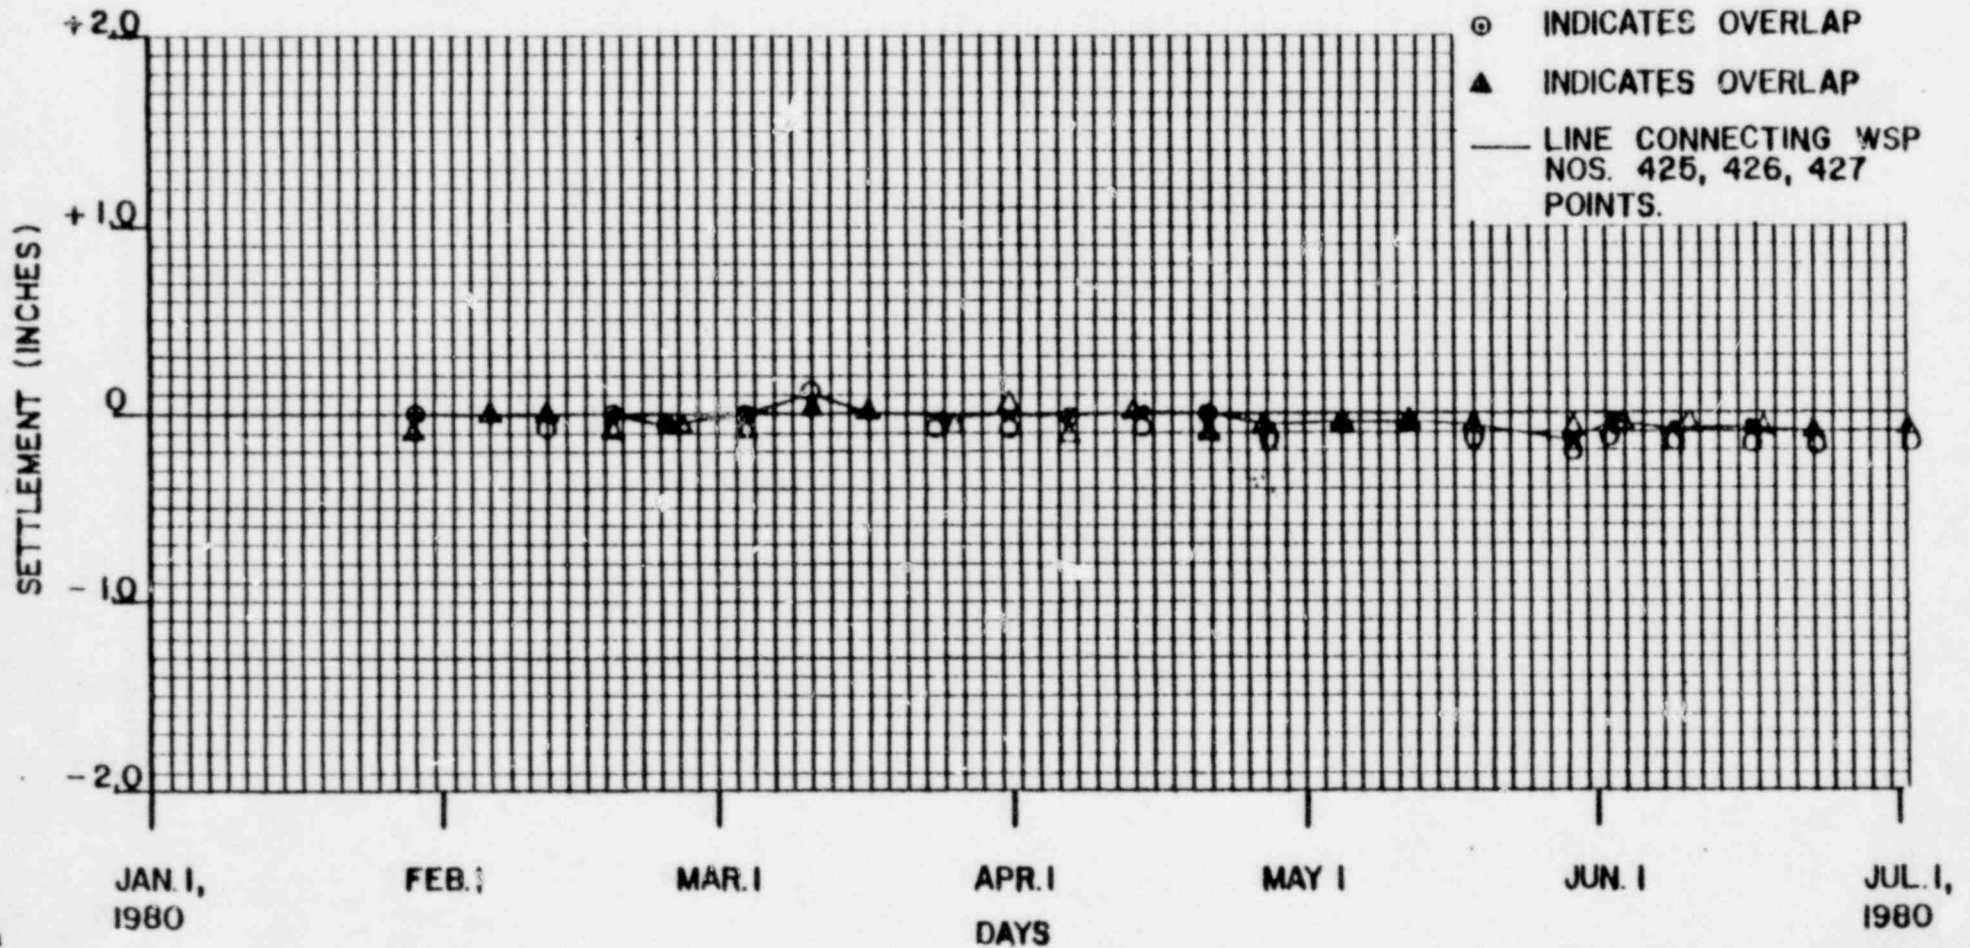
GEORGIA POWER COMPANY ALVIN W. YOSTLE NUCLEAR PLANT		
SETTLEMENT VERSUS TIME FOR CONTAINMENT UNIT 2		
SCALE:	DRAWING NO.	REV.
JOB NO. 9810	FIGURE 16-5

Three settlement markers had been installed to monitor settlement of the Tendon Gallery foundation. These markers, designated as Nos. 425, 426 and 427, were located as shown on Figure 16. A plot of settlement versus time for the period January 1, 1980, through July 1, 1980, is shown on Figure 16-5. The data indicate that a maximum settlement of 0.17 inch was recorded, which is considered reasonable for the current loading condition and the limits of the survey accuracy. It was concluded from field test data and visual observations that the Unit 2 Containment Tendon Gallery was not affected by erosion adjacent to the foundation.
