# Public Service Company of Colorado

August 27, 1980  
Fort St. Vrain  
Unit No. 1  
P-80286

REPORTABLE OCCURRENCE 80-43

REPORT NO. 50-267/80-43/03-L-0

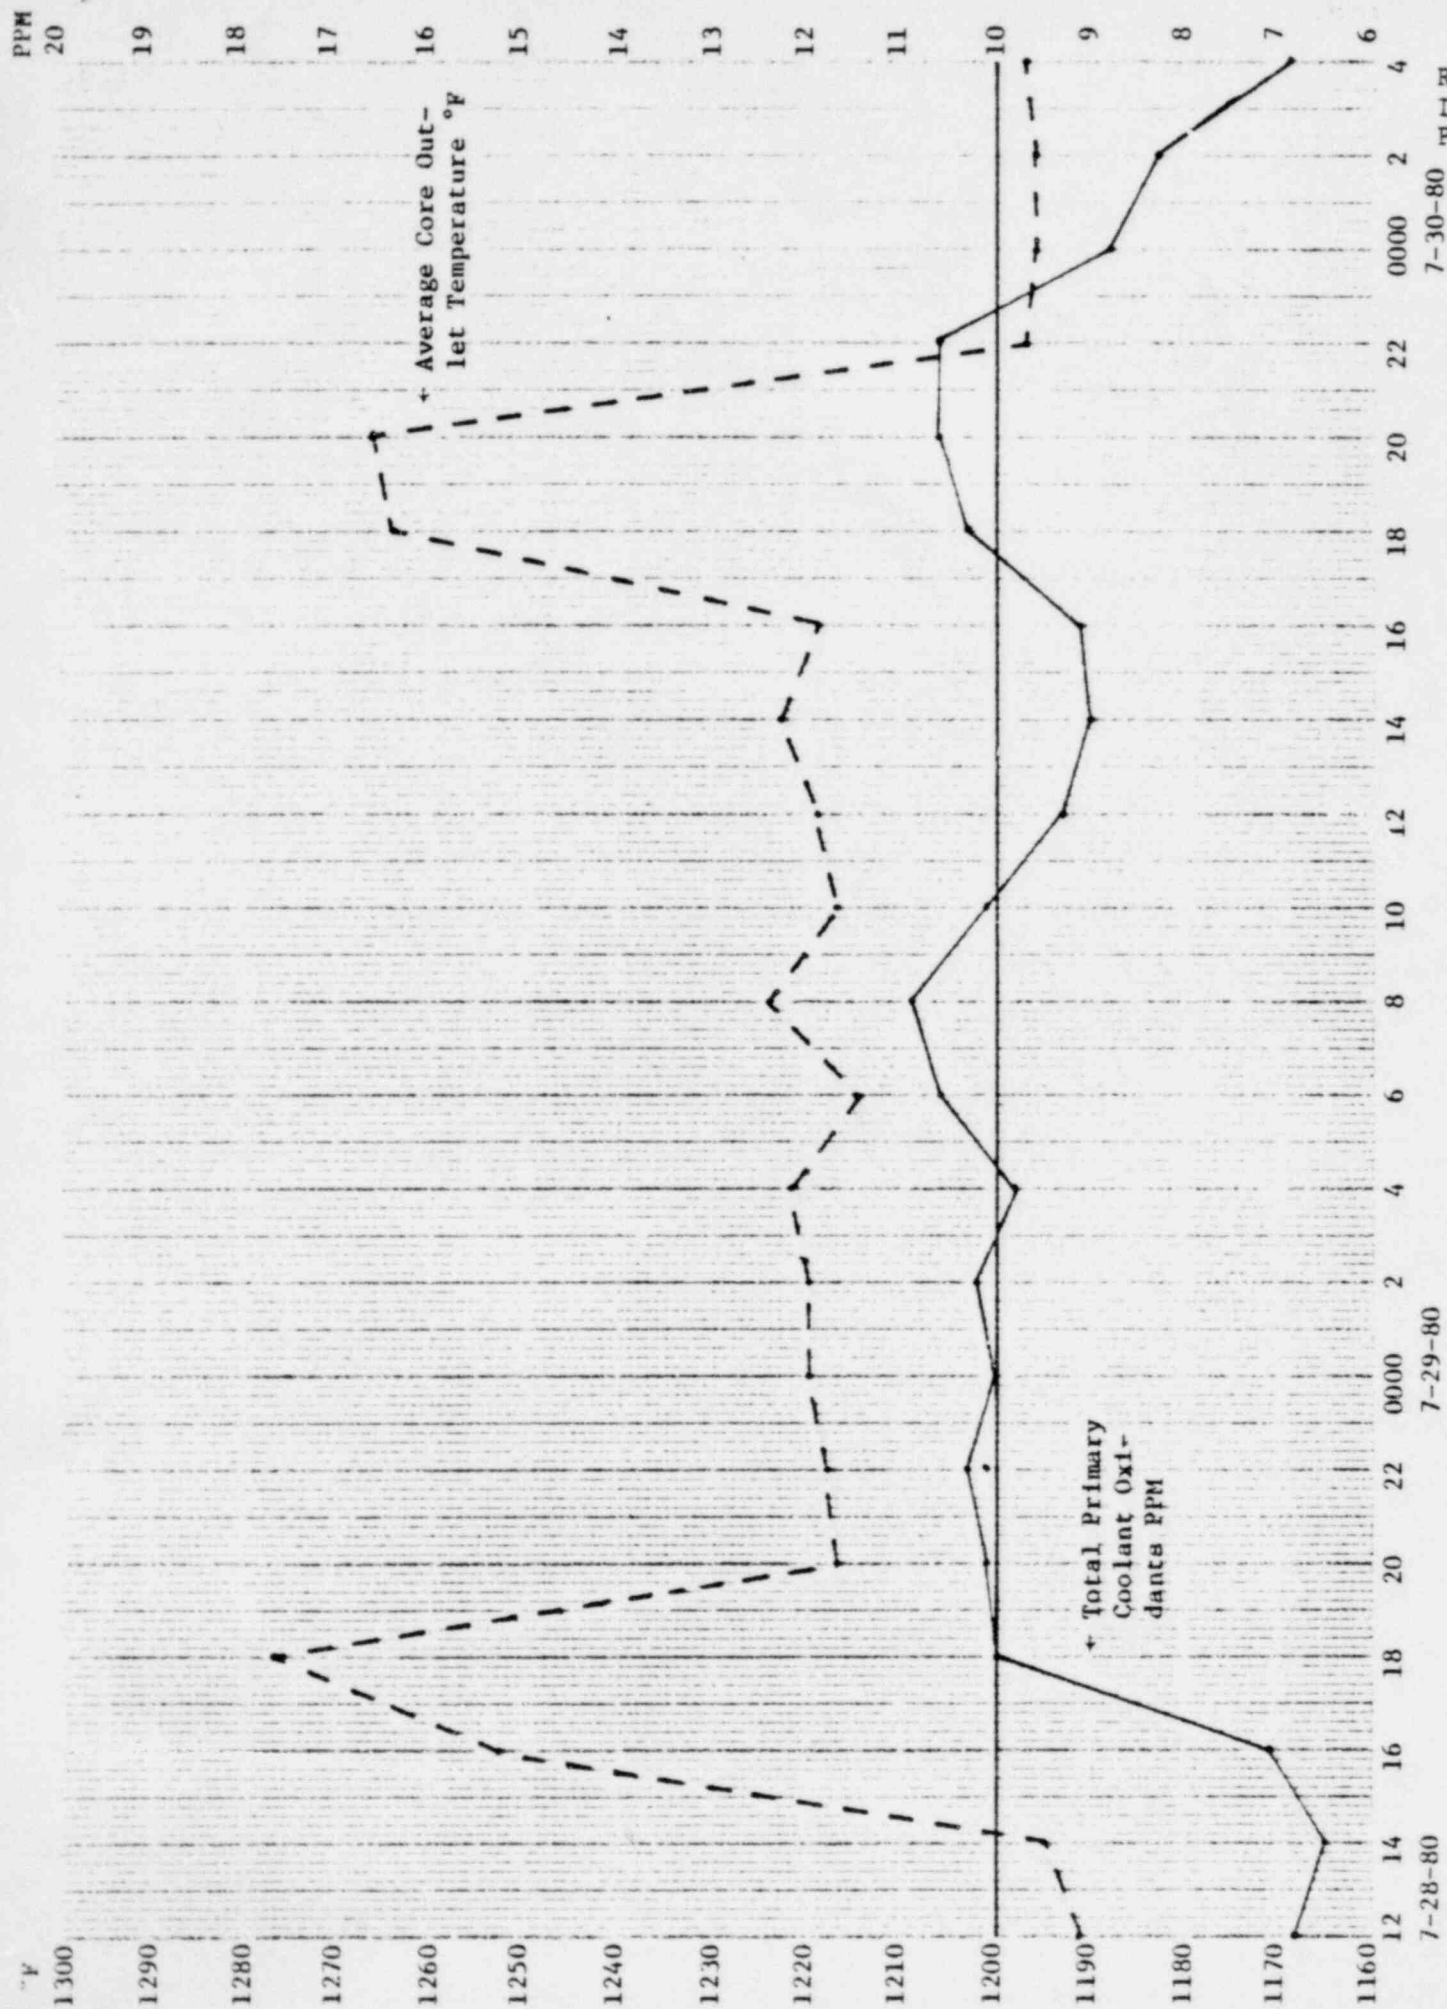
FIGURE 1

Power was steadily increased until 1800 hours when total oxidants exceeded the 10 ppm limit of LCO 4.2.10. At this time, power was reduced to stop the increase of oxidants, but the average core outlet temperature was still greater than 1200°F. Total oxidants decreased until 2400 hours, when they equaled 10 ppm, and then started to increase again. This continued until 2100 hours on July 29 when a decision was made to reduce power and lower the average core outlet temperature to less than 1200°F. By 2200 hours, average core outlet temperature was less than 1200°F and compliance with LCO 4.2.10 re-established. (See Figure 1 for graph.)
