Research Reactor Facility

Subject: Equipment Deficiency, Schrader Type 972S Series  
Three-way Solenoid Valve

Reference: Docket 50-186  
University of Missouri Research Reactor Facility  
License R-103

Description of Deficiency

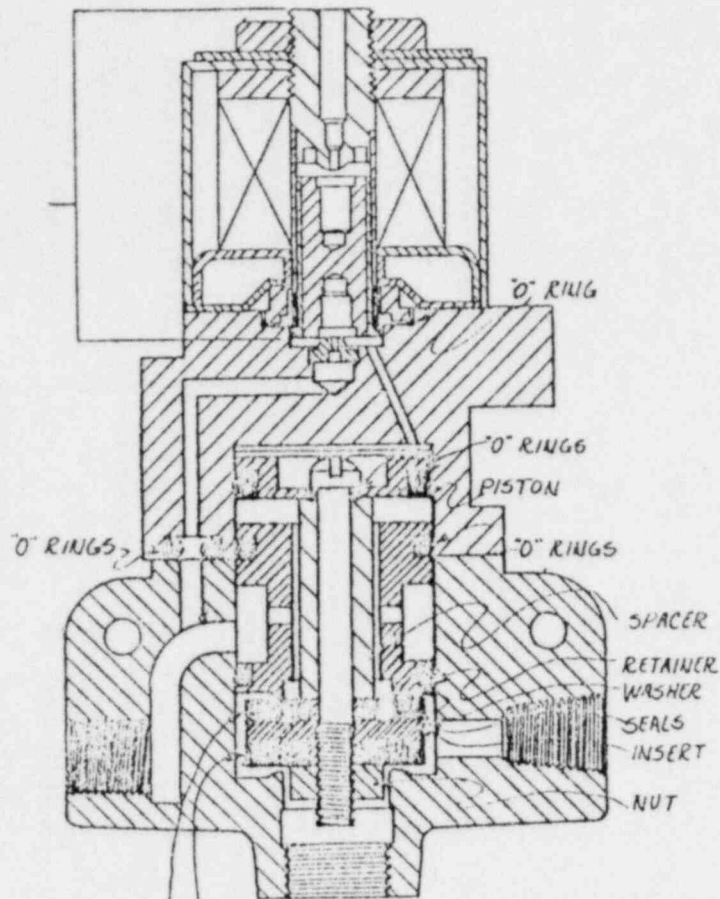
SOLENOID UNIT

Because of the past failure of some air operated valves controlled by Schrader type 972S series three-way solenoid valves, an investigation was carried out by the reactor staff. As a result of the investigation it was suspected that the above three-way solenoid valve could fail if the lower seal separated from the metal insert and thereby prevented air from being exhausted through the exhaust port when the solenoid was deenergized (see enclosed drawing). A valve suspected of having so failed was sent to the manufacturer, Scovill Fluid Power Division, Wake Forest, North Carolina, on March 13, 1975. The manufacturer replied on May 13, 1975 that as a result of their testing they concluded that the valve did fail as described above. They recommended that the problem be corrected by bonding the rubber seals to the brass insert using Loctite adhesive 300 series.

APPROX.  $\frac{3}{32}$ " CLEARANCE BETWEEN VALVE SEAT AND WASHER WHEN:  
 IN EXHAUST POSITION.  
 IN CYCLE POSITION.

On this March 7, the solenoid was de-energized but the actuator piston did not complete its travel. It appeared that the three-way valve did operate but the lower seal separated from the metal insert and prevented the actuator from venting. This failure can be duplicated by loosening the nut that holds the insert. However, the nut on the above valve was snug. This valve was cycled several times and failed on about 60% of the tries.

A modification package has been prepared to replace the seals in each Schrader type 972S three-way solenoid valve. After a favorable review by the MURR Safety Subcommittee, the seals will be replaced with ones bonded as recommended by the manufacturer.

After testing the sample valve you returned, we were able to simulate the same problem you have been experiencing. The easiest way to correct this is to use Loctite adhesive 300 series (see attached) to bond the rubber seals to the brass insert.
