TENNESSEE VALLEY AUTHORITY
400 Chestnut Street Tower II

PHIPPS BEND NUCLEAR PLANT

Fault Zone In The Rock Foundation For The Unit 1 Control And Diesel Generator (Division 1) Buildings

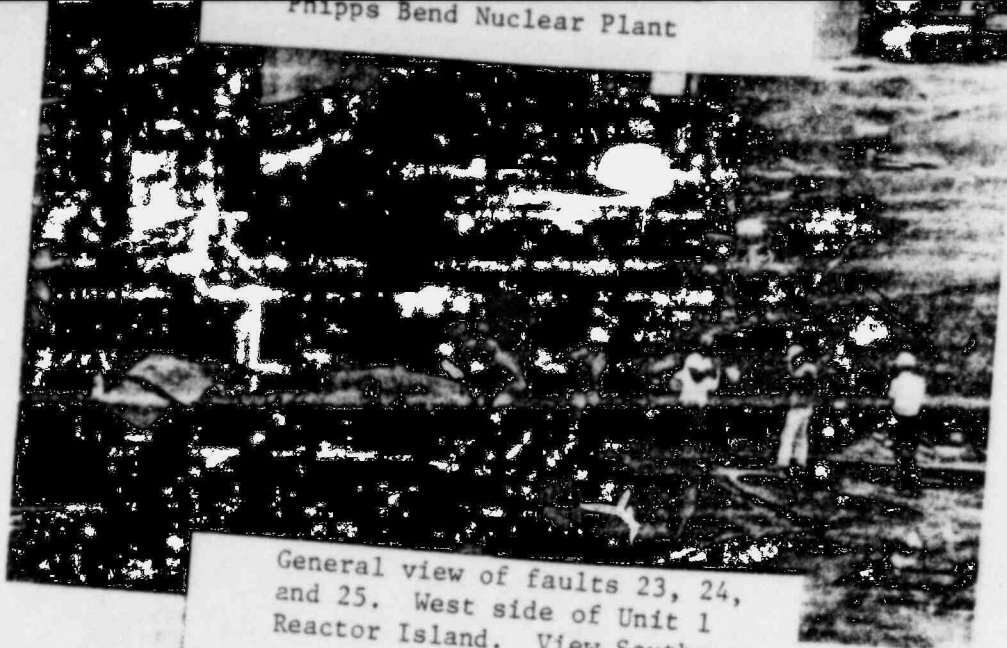
Final excavation for the unit 1 control and diesel generator (division 1) buildings has exposed a series of reverse and thrust faults near the intersection of the two buildings. The faults are described as Fault 23, Fault Zone 24, and Fault 25. (See attached photographs.)

Fault 23, which intersects station W 1+33 at station N 0+31.5, extends from the west wall of the fuel building eastward, across the excavation (see attached map). The fault, which strikes N. 40° E. and dips 84° SE., truncates the south limb of an overturned anticline. The fault plane is defined by a tight calcite-filled fracture that displays minimal deformation of adjacent beds.

These are typical faults for the immediate area of the Phipps Bend Nuclear Plant, and represent a continuation of faults already reported to NRC (Fault 3, May 8, 1979).

These faults were formed by stress relief due to tectonic pressure from the northwest and southeast during formation of the Saltville Fault Family (250 mybp). Having been stable for approximately 250 million years, these faults are not considered to be capable of producing ground offsets or generating earthquakes. Therefore, we do not classify them as capable faults, within the meaning of Appendix A to 10 CFR part 100.

General view of faults 23, 24, and 25. West side of Unit 1 Reactor Island. View Southeast
