Docket No. 50-285

IE Bulletin No. 80-20  
Date: July 31, 1980  
Page 1 of 2

FAILURES OF WESTINGHOUSE TYPE W-2 SPRING RETURN TO NEUTRAL CONTROL SWITCHES

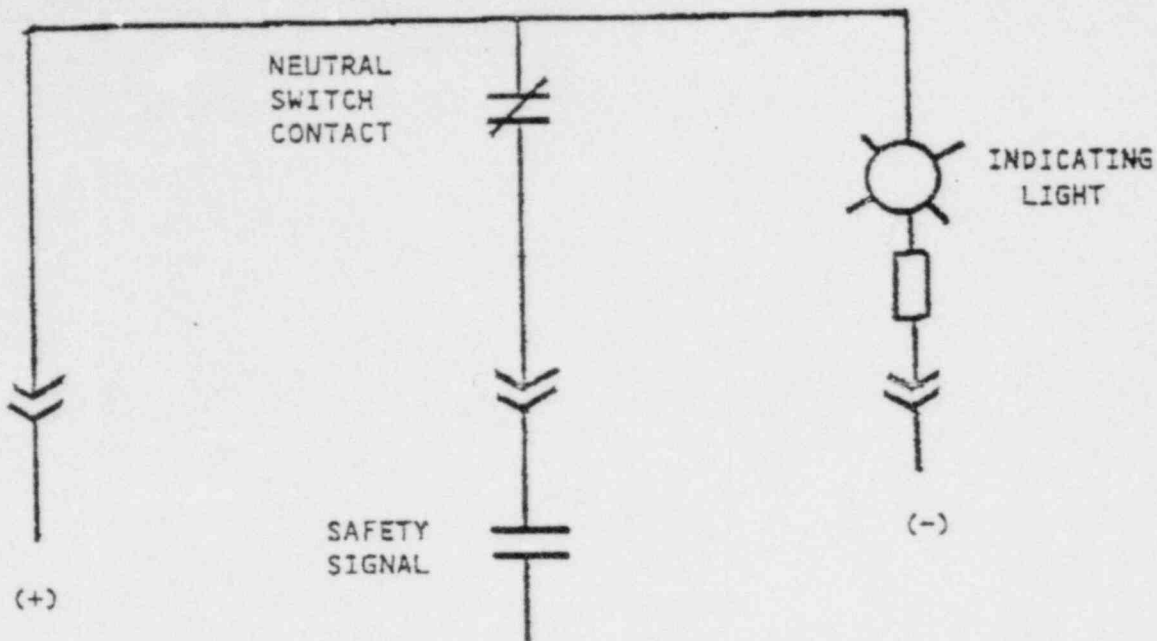
EXISTING INDICATING LIGHT CIRCUIT (TYPICAL)

Depending on how the indicating light circuit is wired, loss of continuity thru the neutral position contact of a W-2 switch could remain undetected until the equipment associated with the switch were called upon to operate. Since such a failure would be equivalent to by-passing the system associated with the switch, consideration should be given to rewiring the switches used in safety-related applications as shown in Figure 1. Such rewiring would provide an acceptable means for detecting contact failure, provided the indicating light is in the control room and readily visible by the operator. If the indicating light is not so located, consideration should be given to annunciating the neutral position contact failures at the control room to alert the operator of the inoperable status of a safety-related system. In addition, consideration should be given to adding redundant contacts to the W-2 switches or to replacing the W-2 switches with others having a more positive contact wiping action.

A review of this matter by Westinghouse led to the issuance of NSD Technical Bulletin No. NSD-TB-80-9 to the utility owners of all Westinghouse operating plants. The recommendations contained in the Westinghouse technical bulletin include: (i) testing the neutral position contacts of the subject W-2 switches for continuity, and (ii) rewiring of the indicating light circuit to permit the early detection of a neutral contact failure as shown in Figure 1.

3. Licensees of operating plants and holders of construction permits shall describe the longer term corrective measures planned and the date by which such measures will be implemented by actual installation or by design change, as appropriate. As a minimum, the longer term corrective measures should include rewiring the indicating light as shown in Figure 1 provided the light is readily visible to the control room operator. If not, failures of the neutral position contacts should be annunciated in the control room.

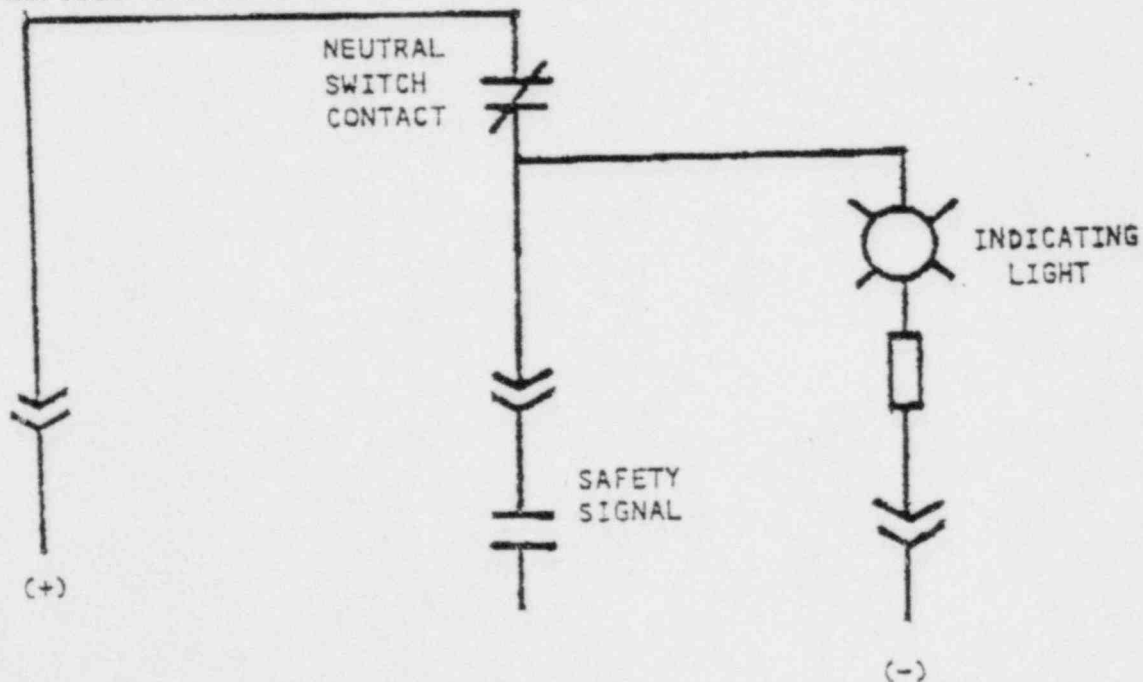
PROPOSED REWIRING OF INDICATING LIGHT CIRCUIT (TYPICAL)

REWIRING OF INDICATING LIGHT CIRCUIT OF W-2 SWITCHES  
AS RECOMMENDED BY WESTINGHOUSE TECHNICAL BULLETIN NSD-TB-80-9
