LICENSEE: Connecticut Yankee Atomic Power Company
FACILITY: Haddam Neck Plant
SUBJECT: MID-OUTAGE STATUS MEETING

CONNECTICUT YANKEE ATOMIC POWER COMPANY

MID-OUTAGE STATUS MEETING

OCTOBER 25, 1989

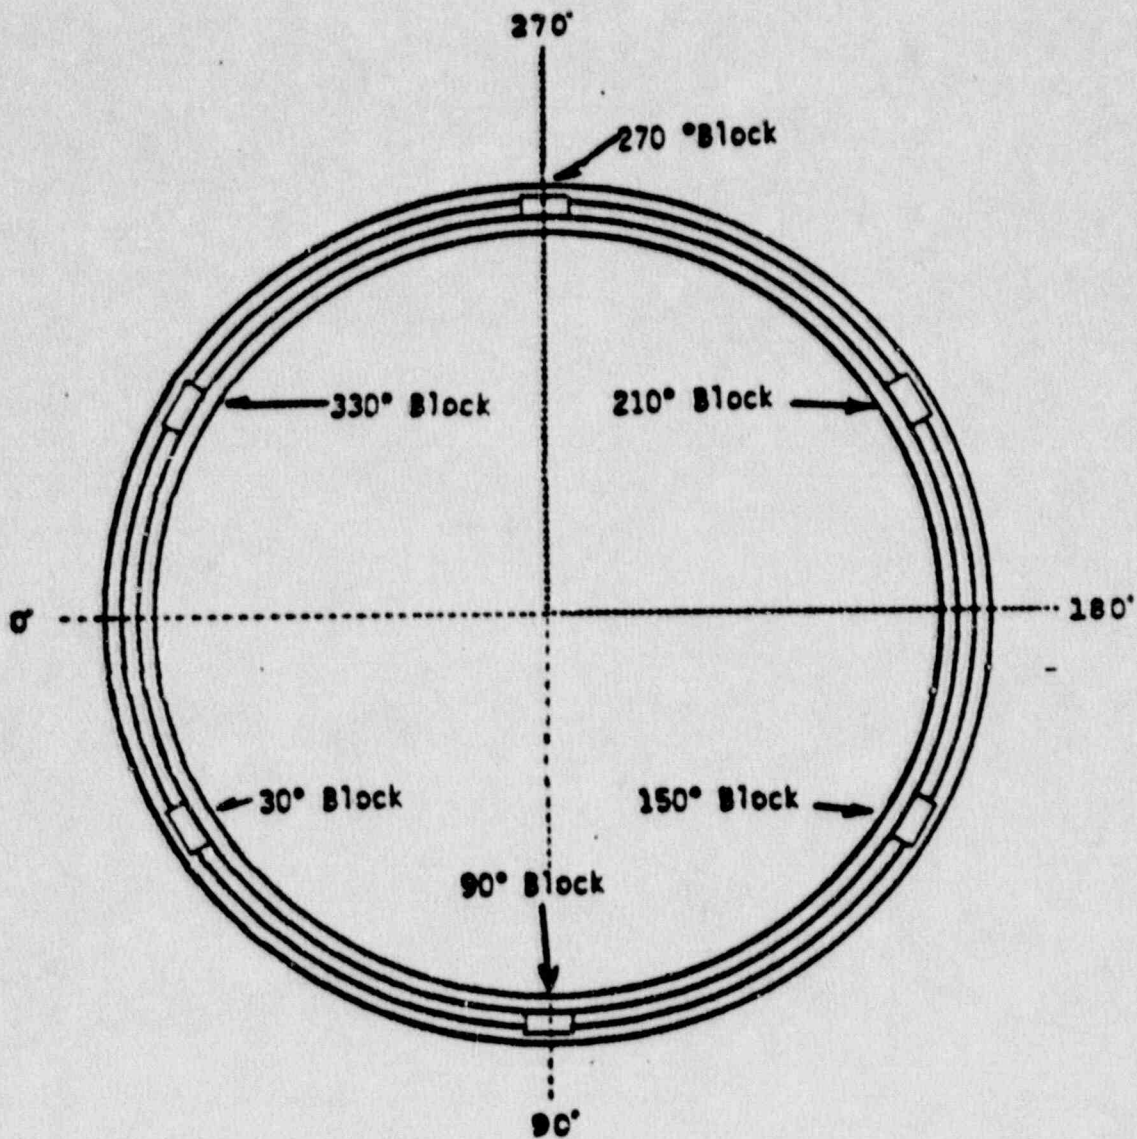
Figure 2-4. Thermal Shield Support Block Locations

Thermal Shield Lower Support Blocks from ID

30° All 3 dowel pins recessed

90° All 3 dowel pins recessed

150° All 3 dowel pins recessed, lower center bolt, upper right bolt recessed

210° All 3 dowel pins recessed, upper right bolt recessed

270° All 3 dowel pins recessed, upper right bolt missing

330° Lower 2 dowel pins and lower bolt appear recessed

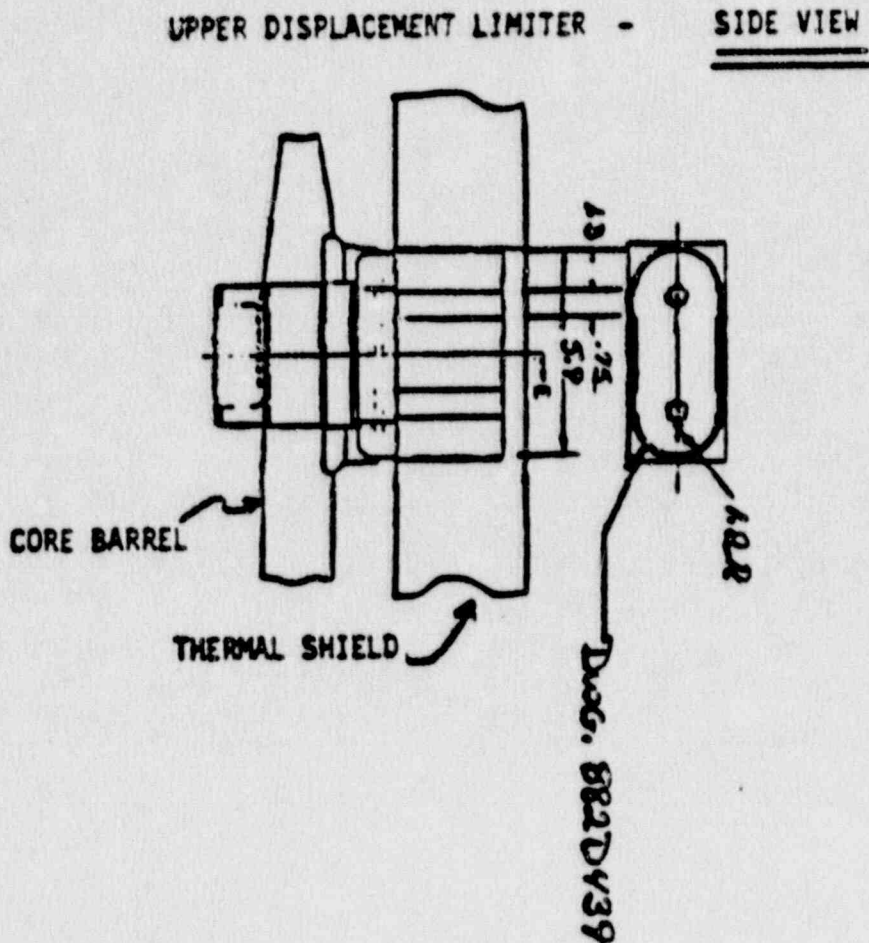
Figure 2-9. Upper Displacement Limiter

Thermal Shield Displacement Limiter 128°
Lower Block All 3 dowel pins backed out

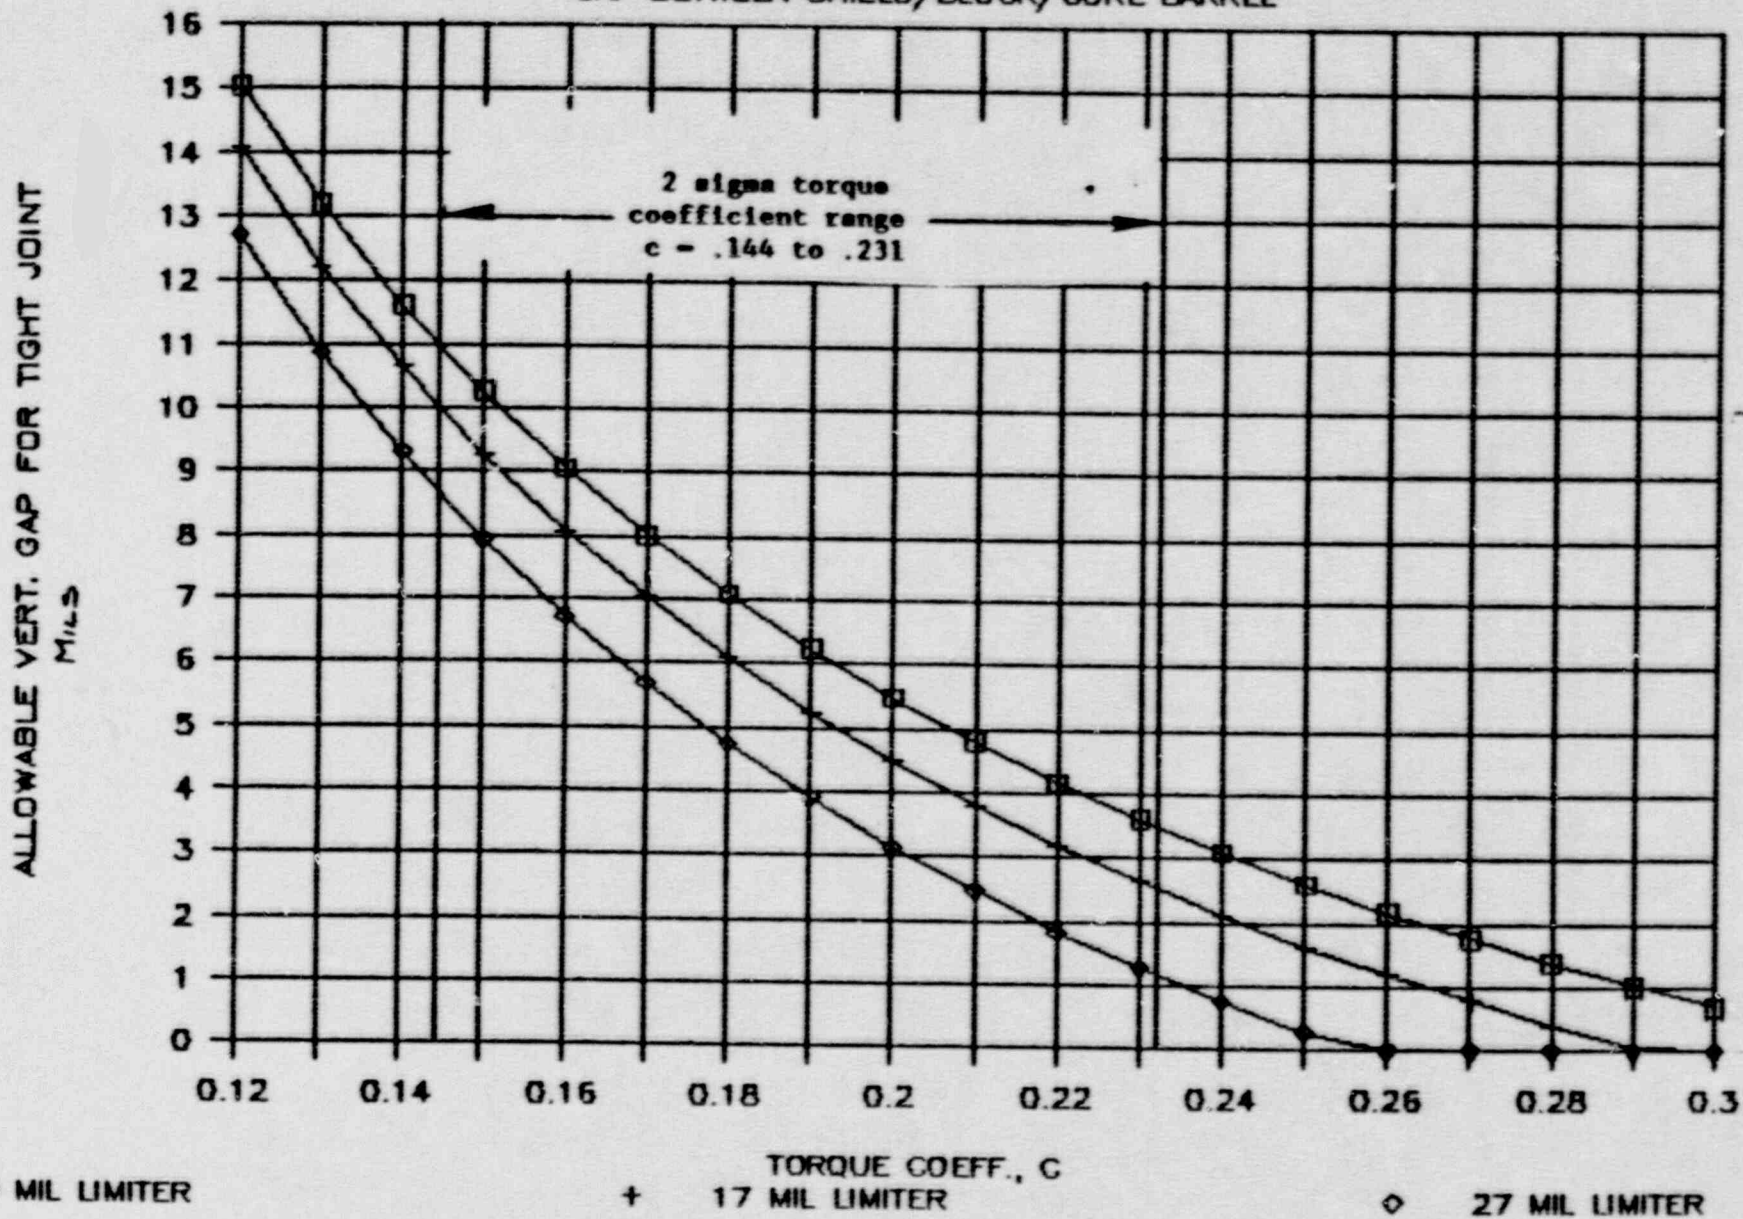
ALLOWABLE VERTICAL GAP vs TORQUE COEFF.

A. Vertical Gap Between Shield/Support Block and Support Block/ Core Barrel May Be Larger Than Initial As-Built Value of .000/.002 Inch

1. A Larger Gap will Reduce the Effective Preload Needed for a Tight Joint and Increase Top Bolt Loads. Using the Nominal Torque Coefficient ($c = .177$) the Calculated Preload may not be Sufficient to Close a Gap of 14 mils or Greater

Increased Radial Loads at the 270 degree Block Coupled with an Increased Vertical Gap Between the Shield/Block/Core Barrel Could Degrade a Top Bolt
