WCAP-12294

INDIAN POINT UNIT 2
STEAM GENERATOR GIRTH WELD/
FEEDWATER NOZZLES REPORT
SPRING, 1989 OUTAGE
CONSOLIDATED EDISON OF NEW YORK

OCTOBER 1989

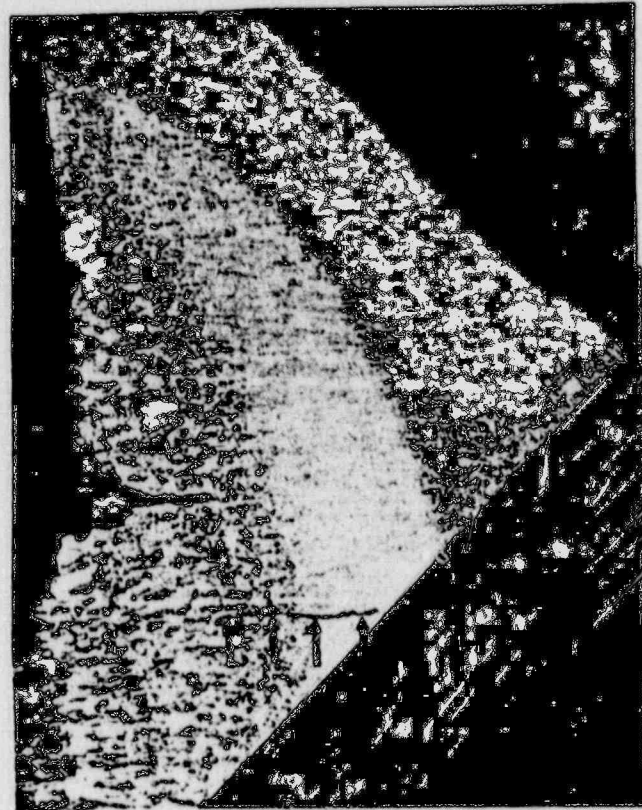
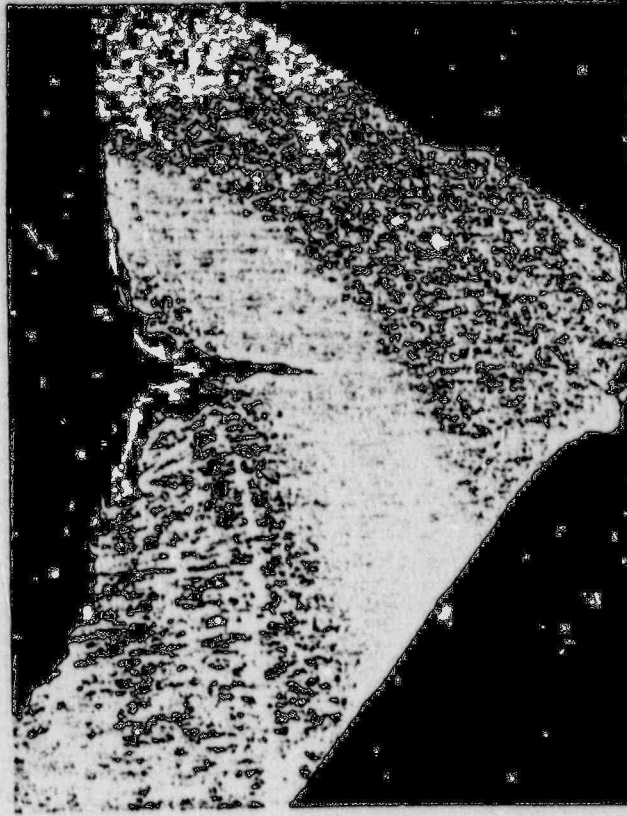
The results of the metallographic examinations (illustrated in Figures 2.2-3 to 2.2-10) showed evidence of multiple crack initiation sites originating from the surface pitting. The maximum size of the pits where cracking was initiated corresponded to approximately 25 mils. The cracking was initiated at the knee of the weld metal to base metal interface, where stress concentration due to geometric discontinuity is likely to be present. The cracks were extensively covered with oxide deposits all the way up to the crack tip regions. The cracking measured approximately 0.20 in. and 0.09 in. deep at their deepest locations in boats 1 and 2, respectively. The cracking was relatively straight and transgranular and disregarded the local microstructure of the material. No evidence of branching was seen in the cracks. For the most part, the heat affected zone microstructure where cracking was situated corresponded to quenched and tempered martensite-bainite aggregate. A hardness traverse measurements through the these regions showed a peak hardness level of 38 Rockwell "C" number suggesting that adequate toughness existed in the material. Boat 1 also revealed the presence of a tight secondary crack, below the main crack. Close examination of the crack however confirmed that the crack contained oxide deposits and hence is an extension of the main crack, perhaps connected at a different location along the crack length.

Figure 2.2-3 Metallographic examination results illustrating the cracking morphology and microstructure seen in Boat 1.

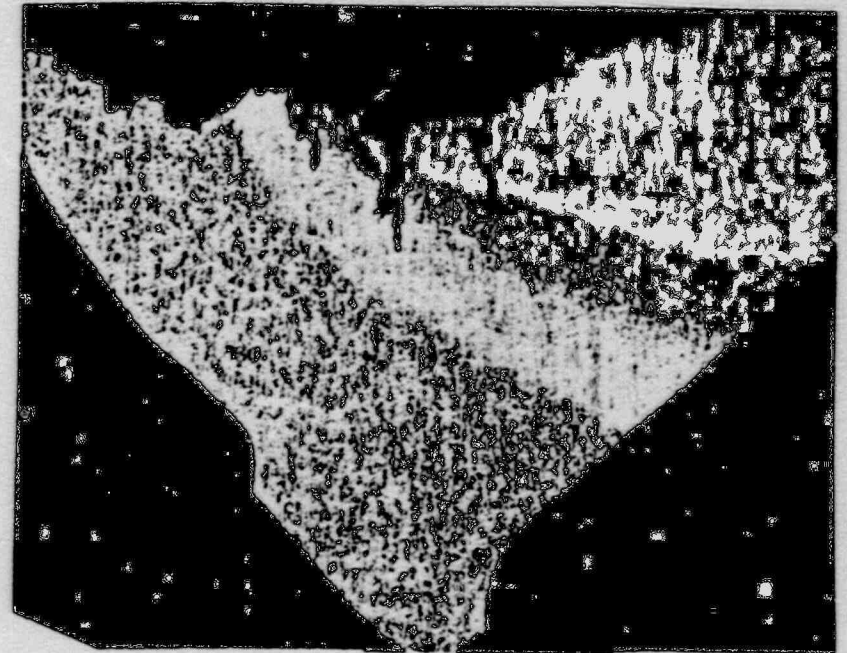
Figure 2.2-4 Metallographic examination results illustrating the cracking morphology and microstructure seen in Boat 1.

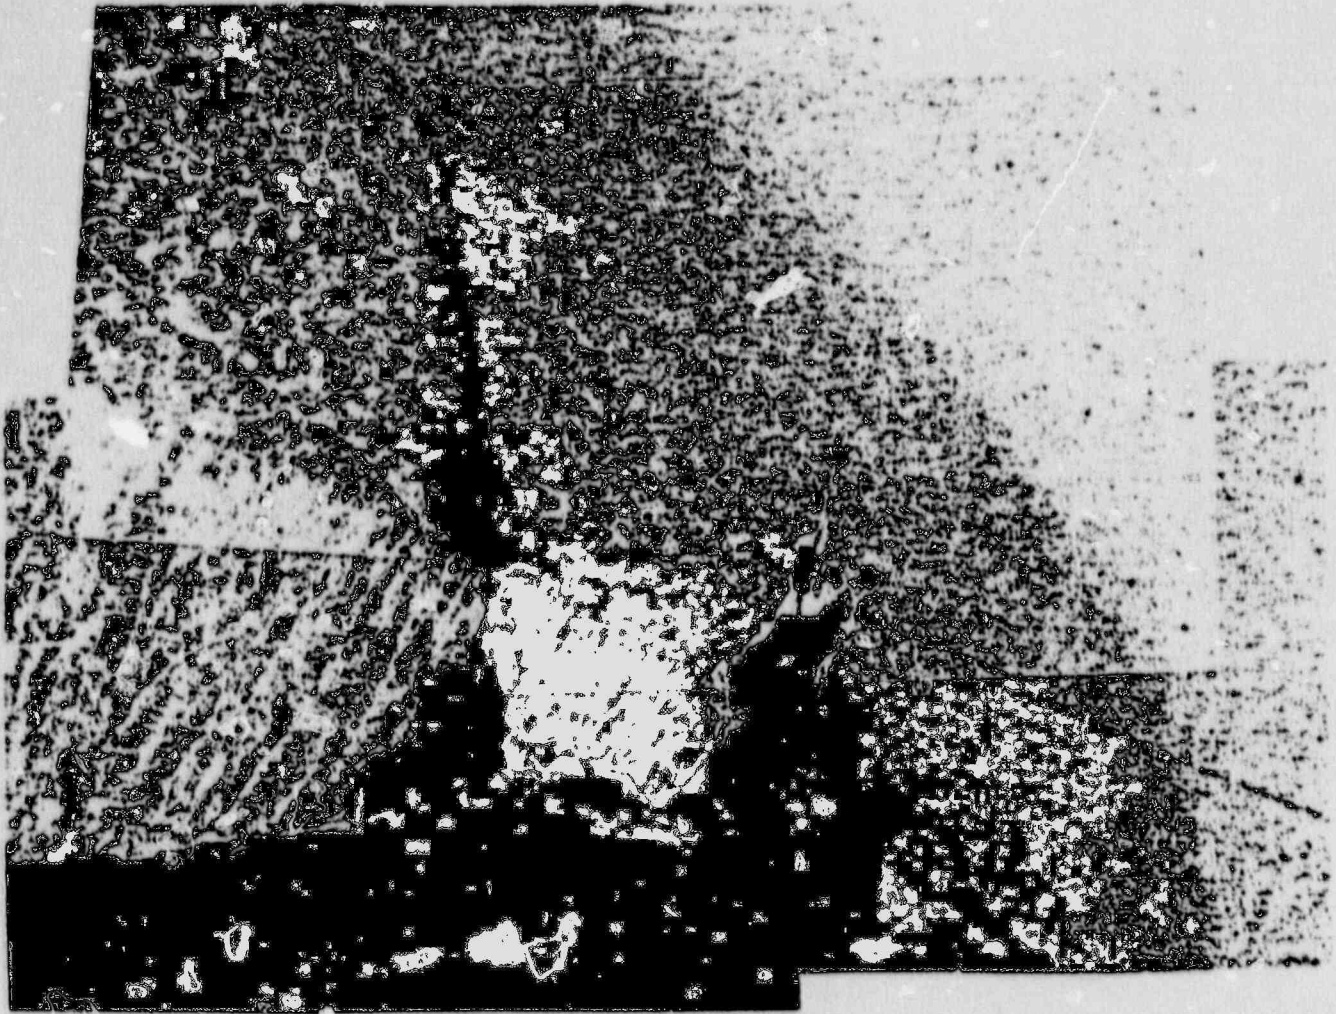
BOAT -1
SECTION A-2
50X

Figure 2.2-5 Metallurgical examination results illustrating the pitting and oxide deposits at the crack initiation in Boat 1.

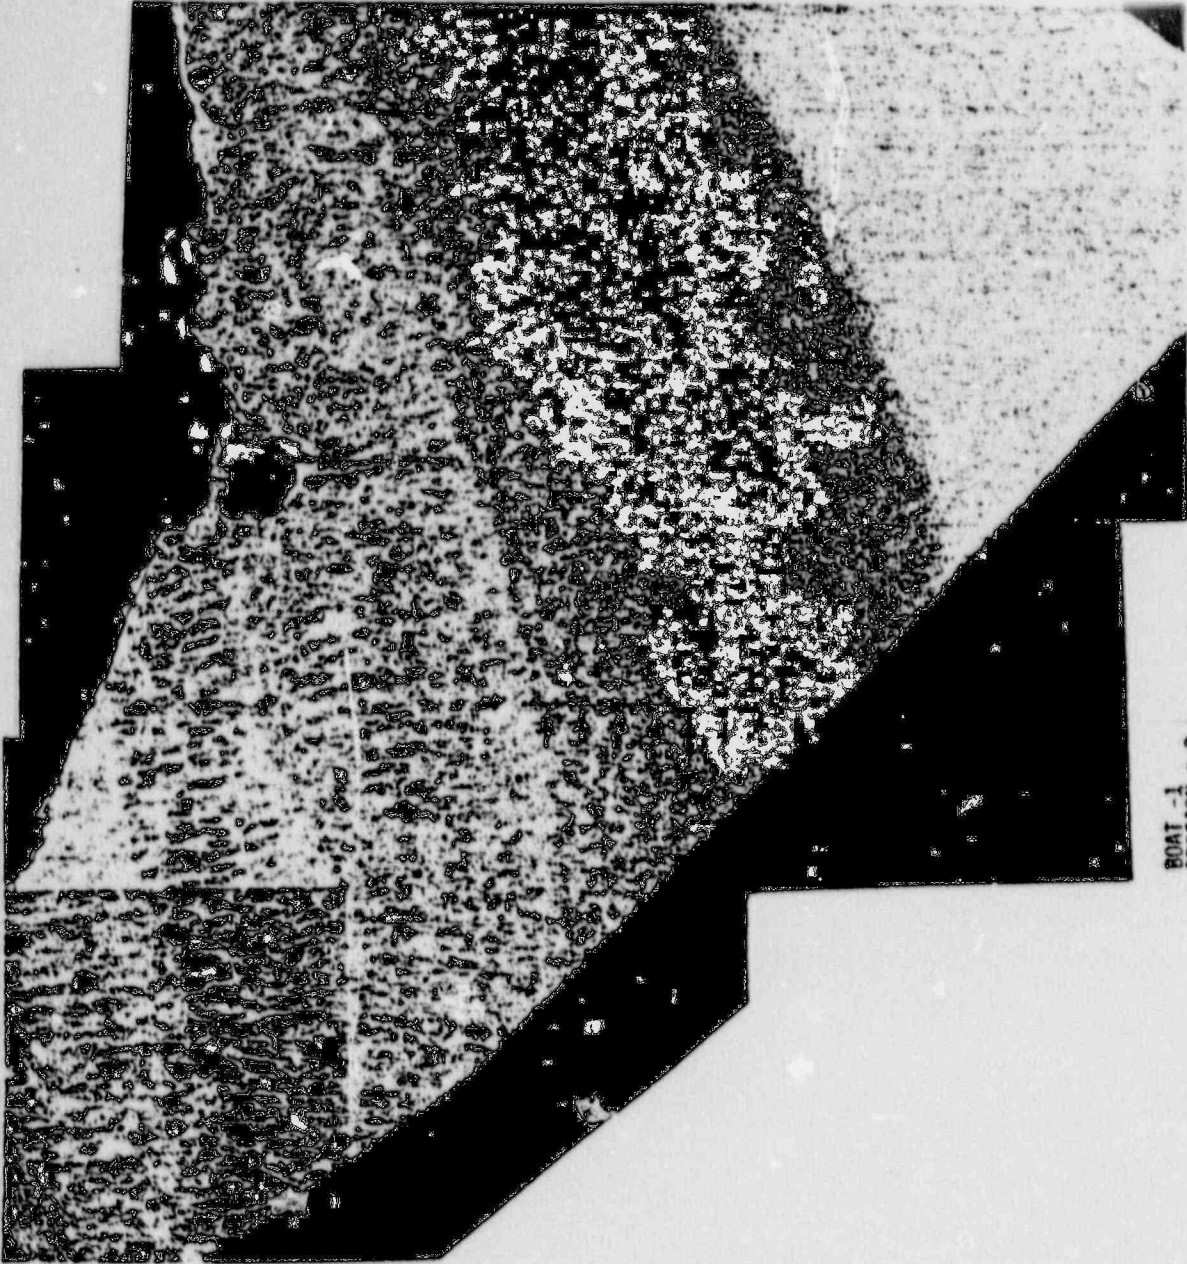
BOAT -1
SECTION B-2
50x

Figure 2.2-6 Metallographic results illustrating the pitting, crack initiation and the presence of a secondary crack seen in Boat 1.

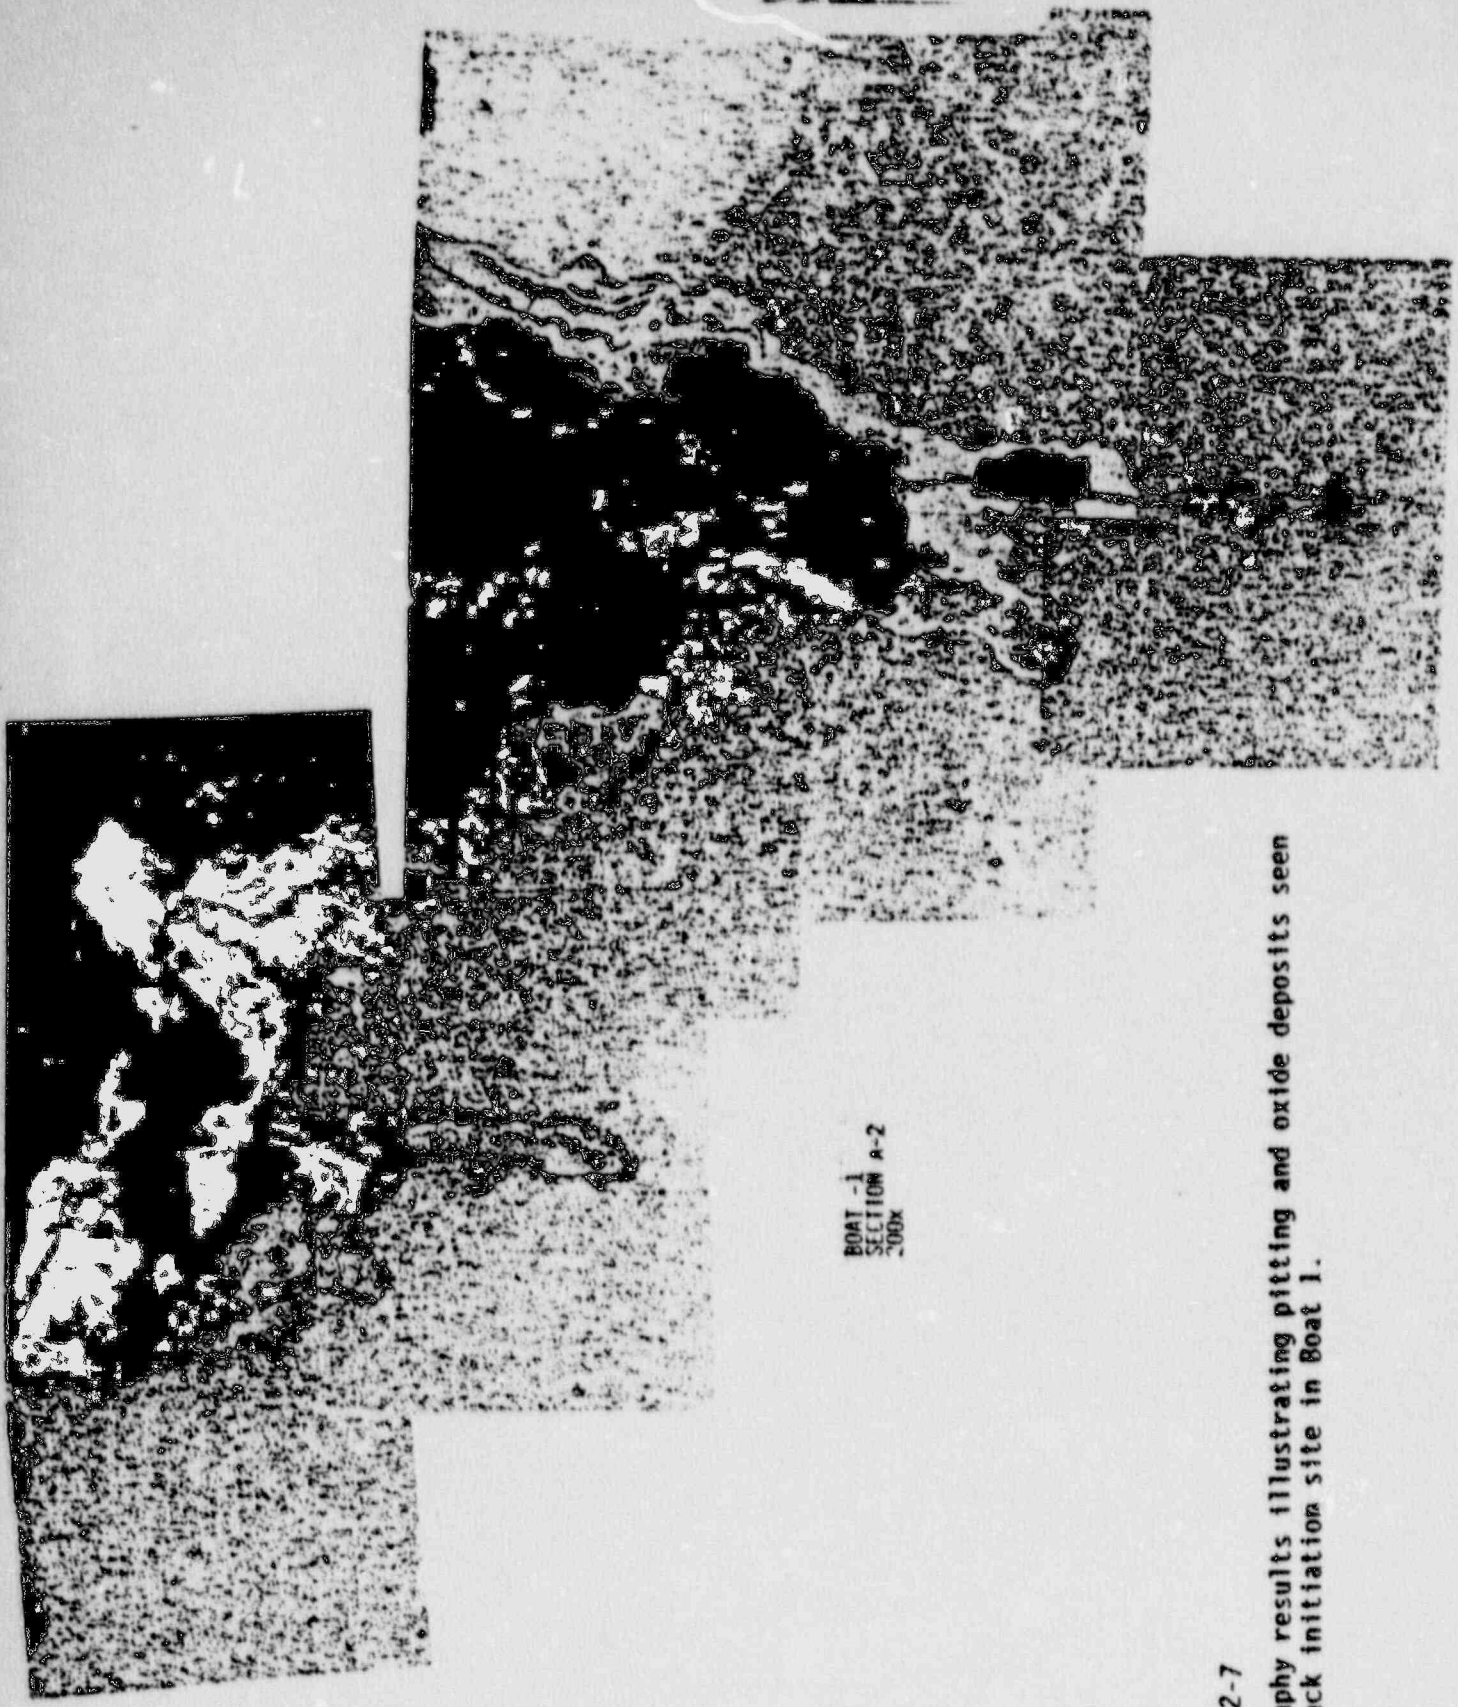
BOAT -1
SECTION A-2
200X

Figure 2.2-7
Metallography results illustrating pitting and oxide deposits seen
at the crack initiation site in Boat 1.

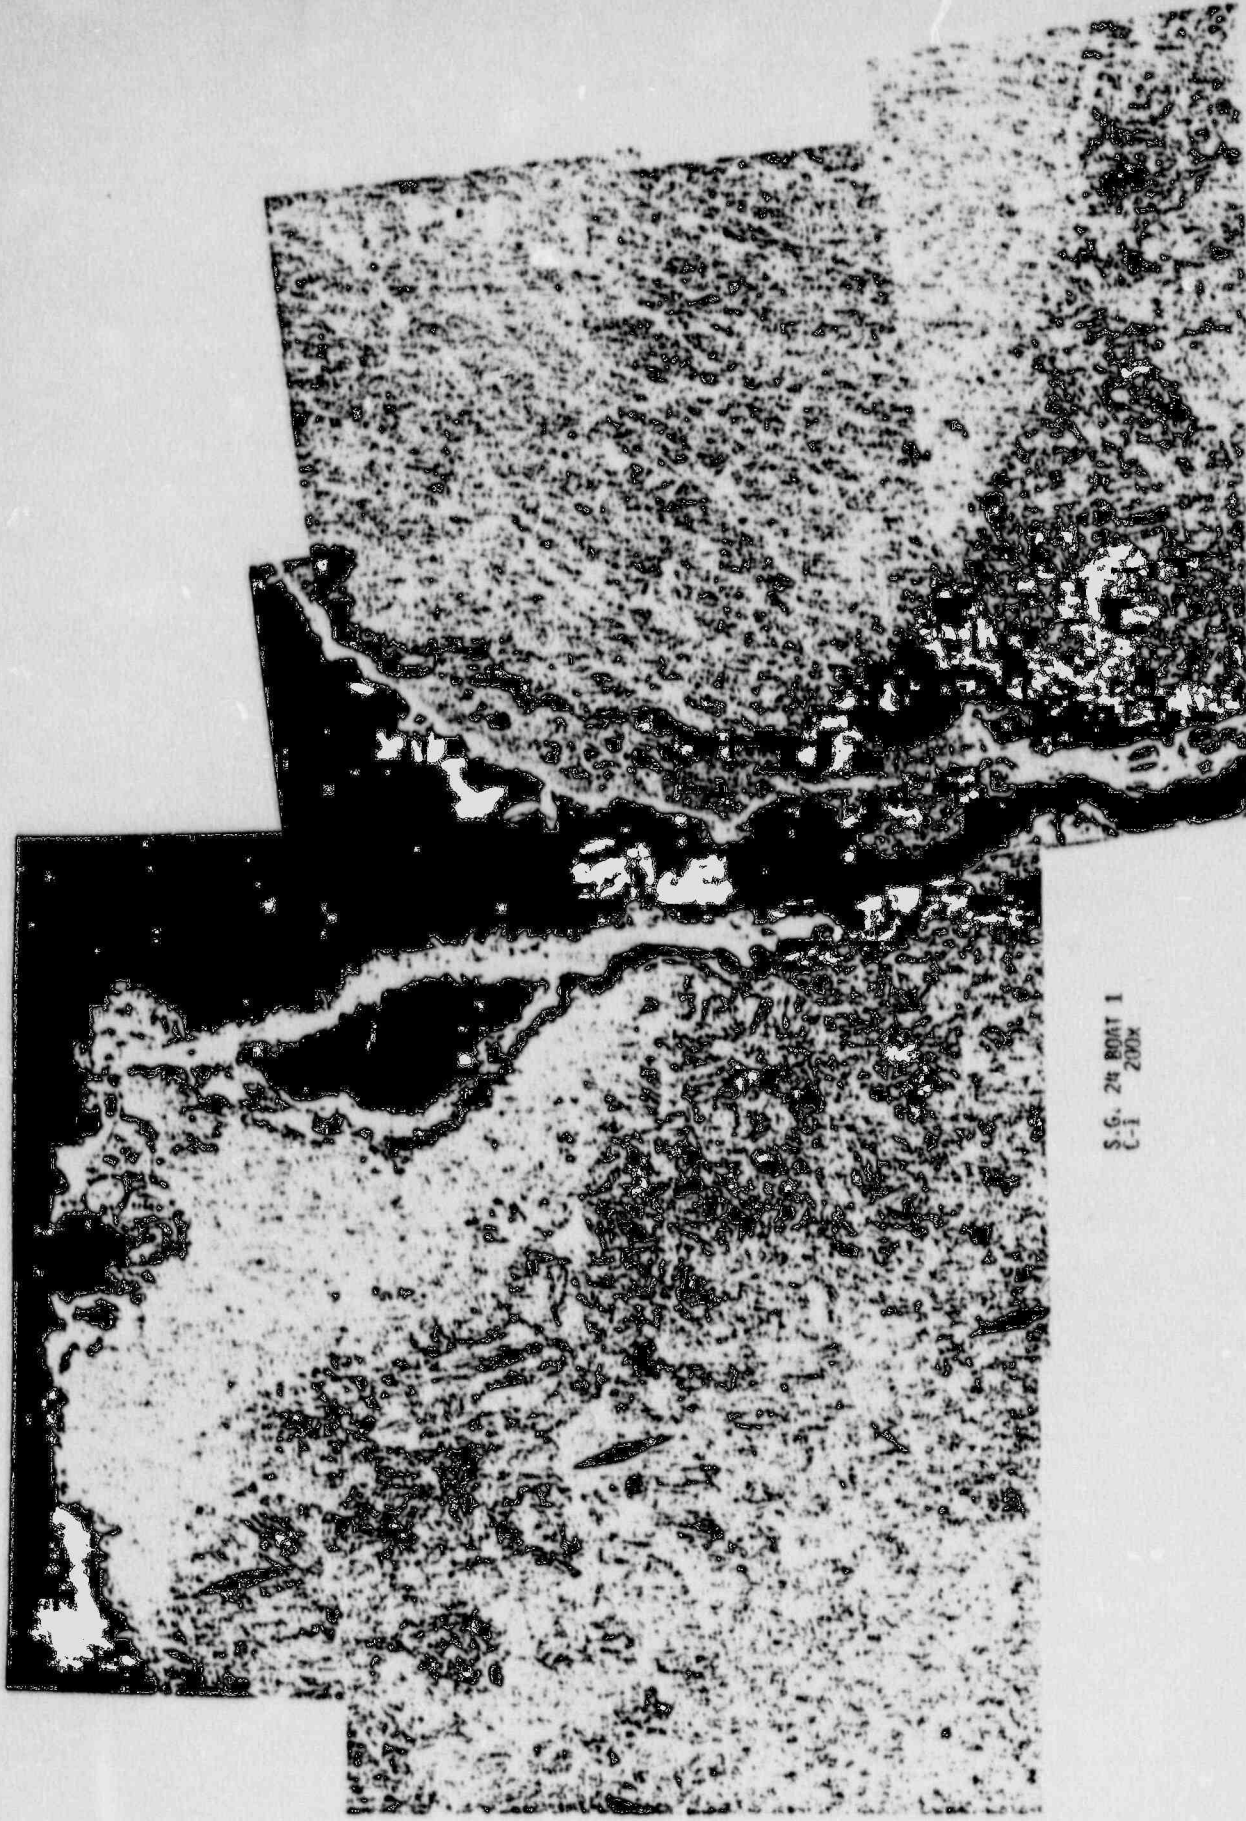
S.G. 24 BOAT 1
C-1 200x

Figure 2.2-8 Metallography results illustrating the pitting and oxide deposits seen at the crack initiation site in Boat 1.

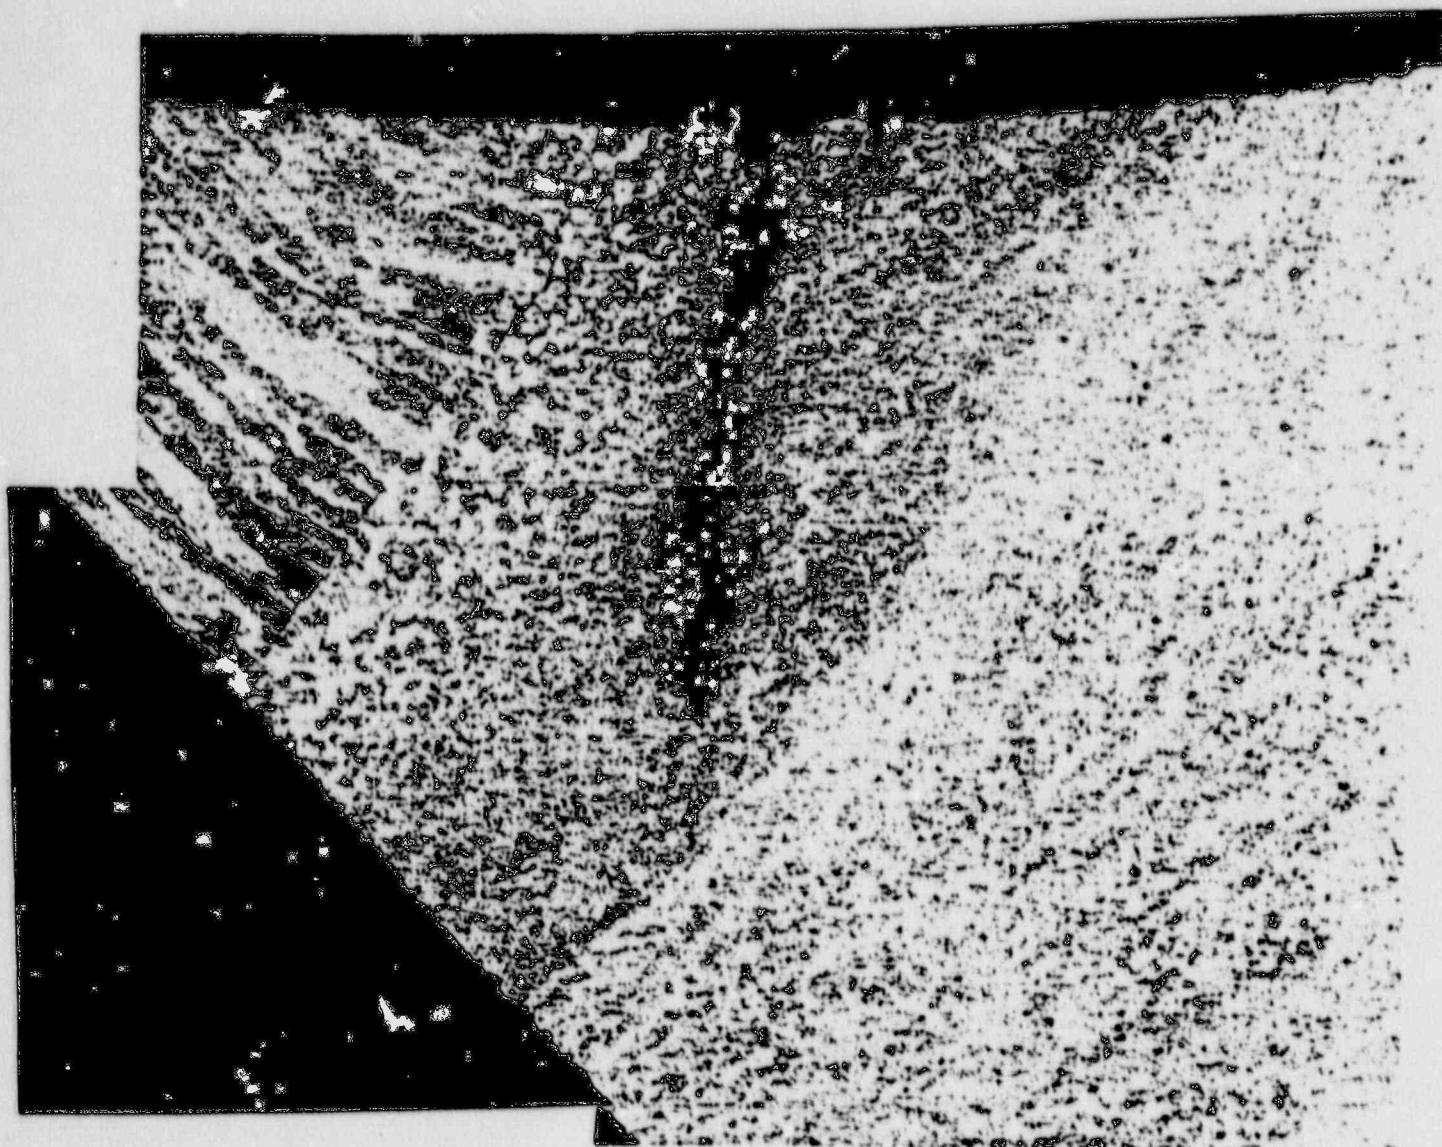
BOAT -2
CRACK 50x

Figure 2.2-9 Metallography results illustrating the cracking morphology and material microstructure seen in Boat 2.

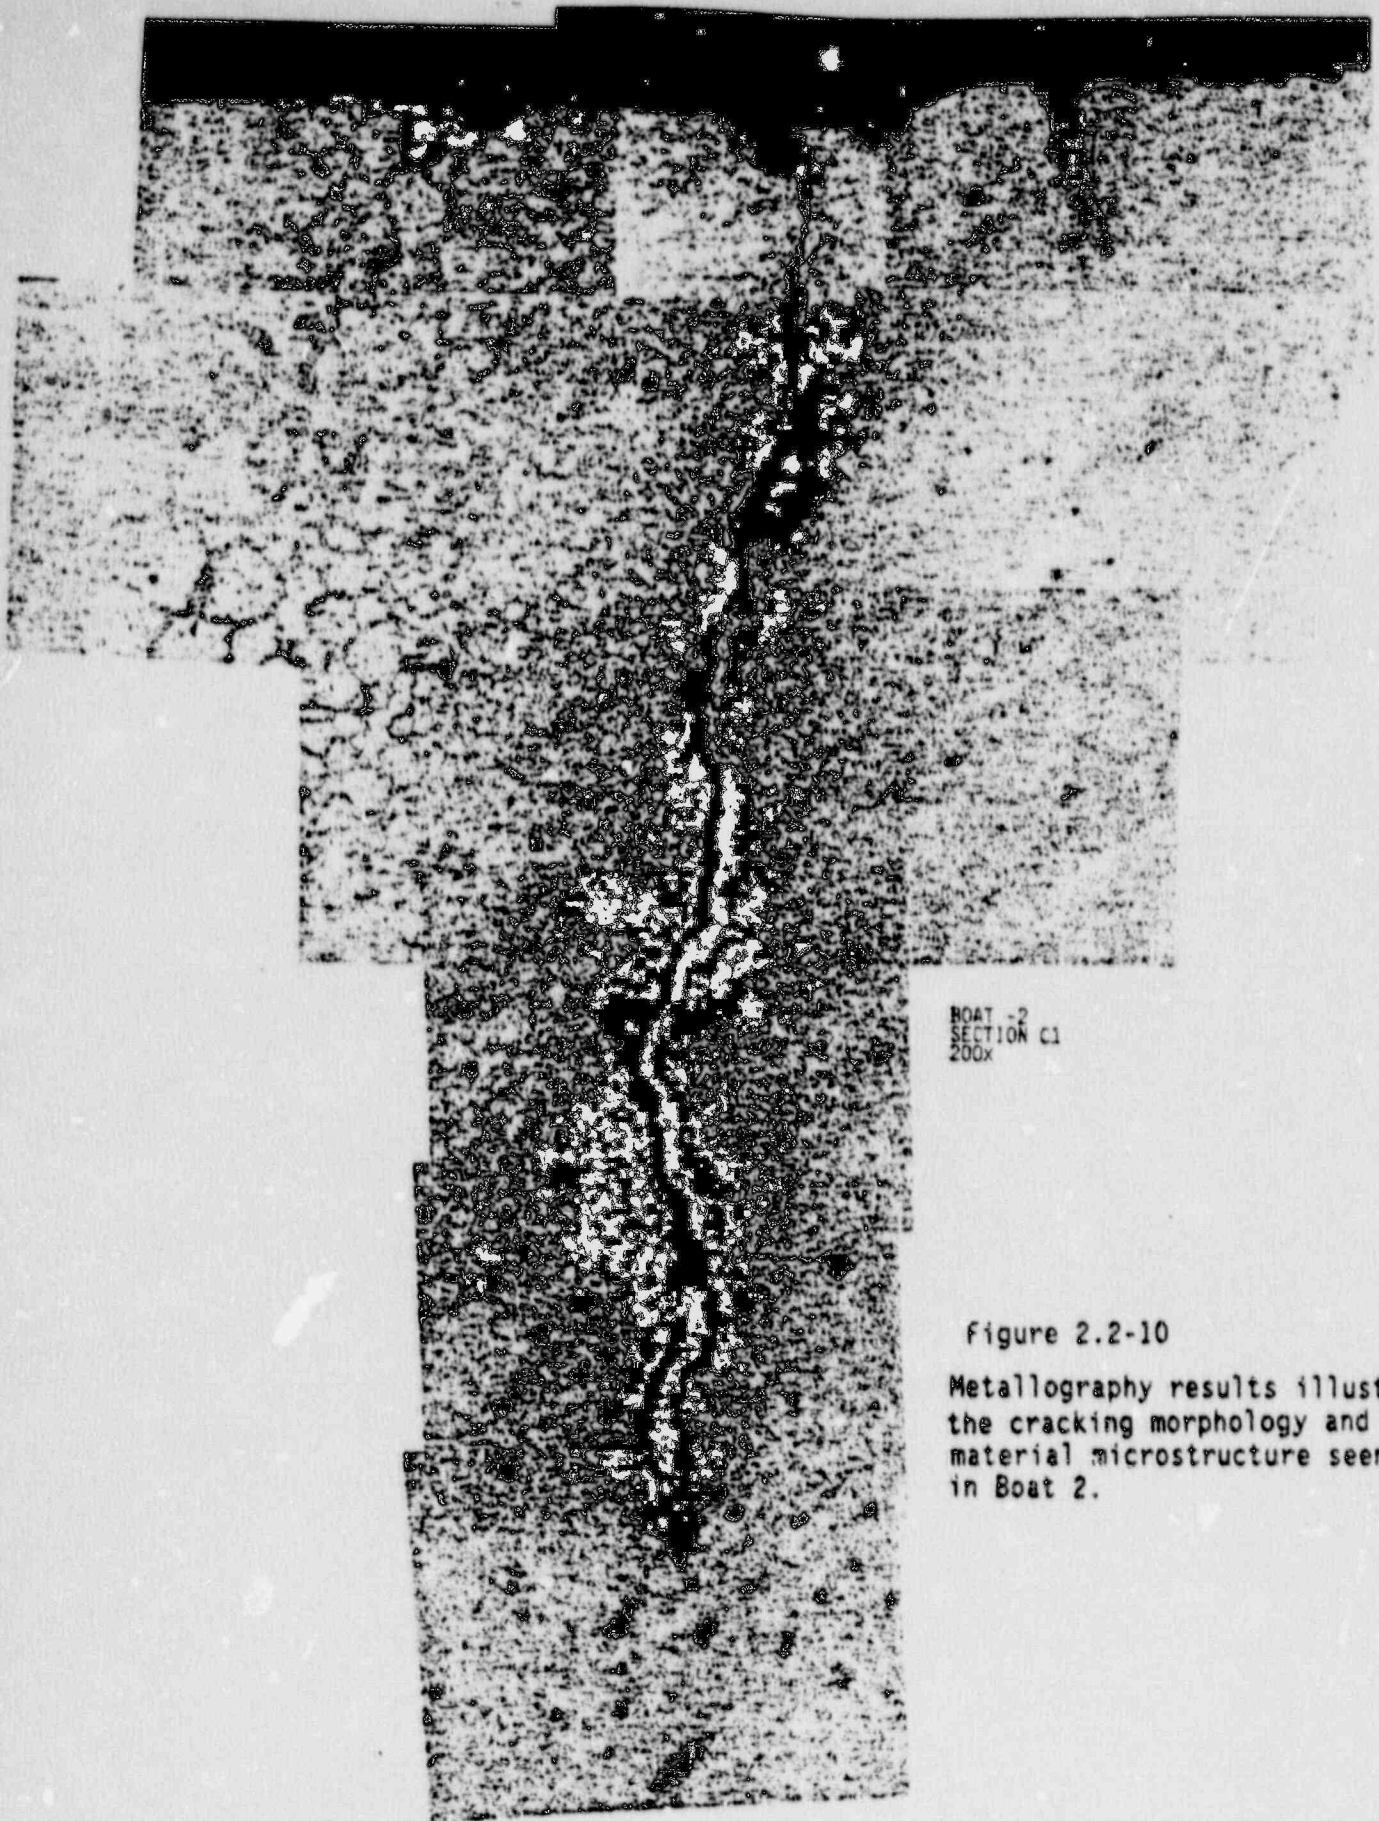
BOAT -2
SECTION C1
200x

Figure 2.2-10
Metallography results illustrating
the cracking morphology and
material microstructure seen
in Boat 2.

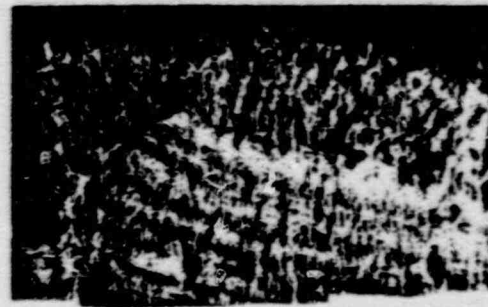
faces showed clear evidence of crack initiation sites corresponding to pits on the boat surface with typical thumb nail patterns (Figures 2.2-11 and 2.2-12). Evidence of numerous beach marks were seen at the crack-tip regions suggesting that changes in the load and/or environment occurred during the life of the crack. Scanning electron fractographic examination of the Endoxed cracks confirmed the presence of finely spaced crack arrest lines and corroded base metal.

Figure 2.2-11 Light optical fractography results illustrating the beach marks seen in the endoxed fracture face in Boat 1.

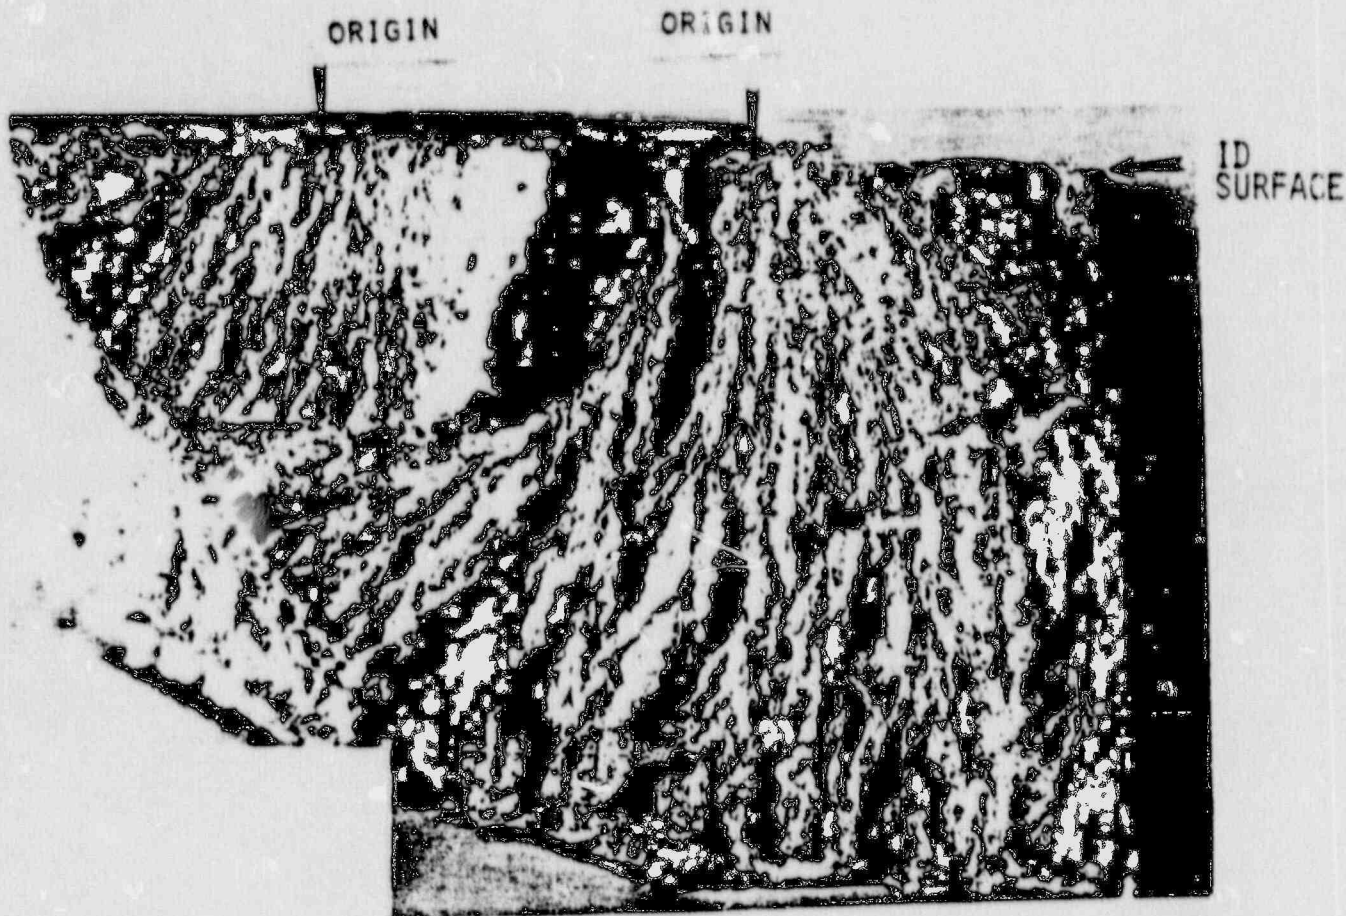
BOAT 2
SECTION C-2
(32X)

Figure 2.2-12 Light optical fractograph illustrating the fracture morphology seen in Boat 2.

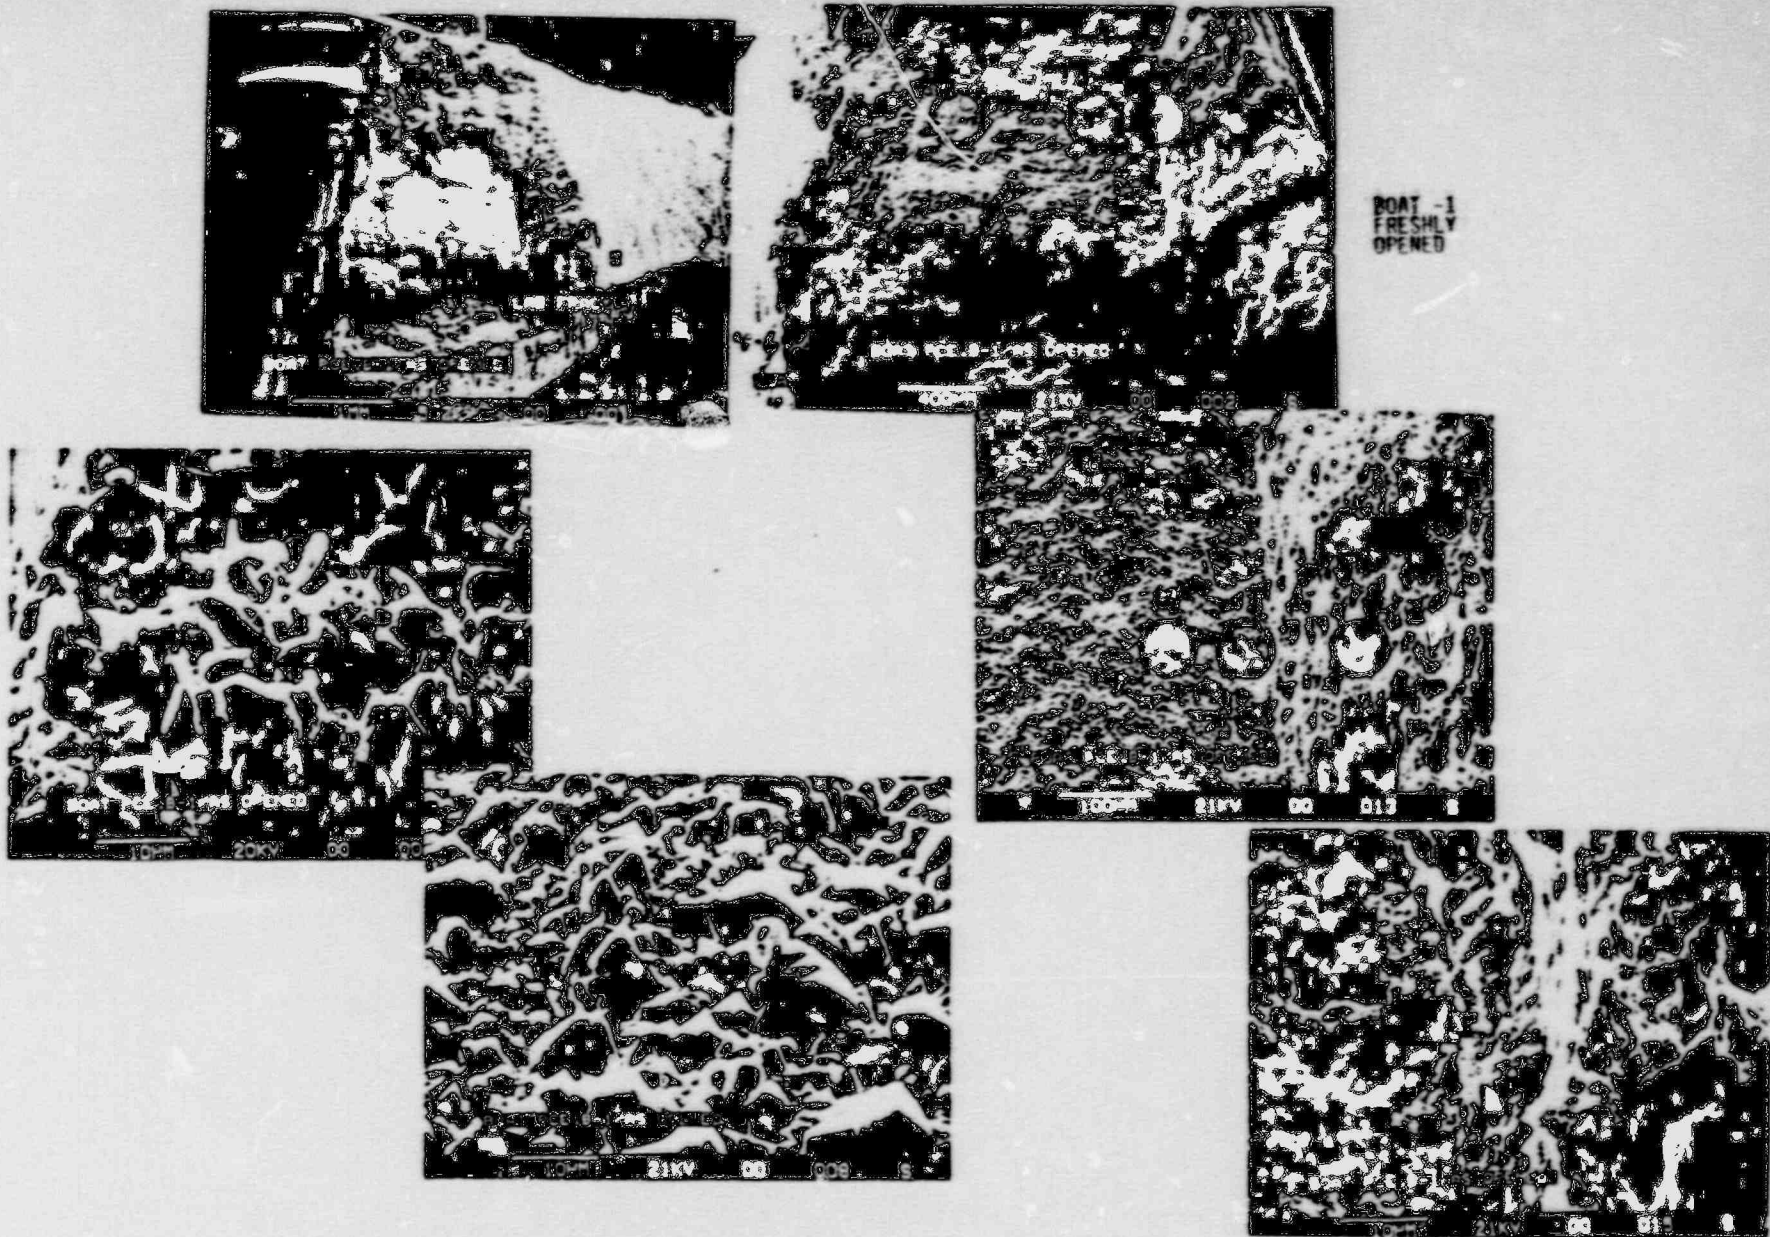
Fractographic examination of the freshly opened cracks by scanning electron microscopy (Figures 2.2-13 through 2.2-15) showed evidence of oxide deposits covering the entire fracture face. Energy dispersive X-ray analysis of the crack deposits confirmed the presence of copper, sulfur and zinc at the crack mouth regions where pitting was seen (Figures 2.2-16 through 2.2-18). The remainder of the crack however is free from any aggressive elements. Light optical fractographic examination of the freshly opened and Endoxed fracture

Figure 2.2-13 Scanning electron fractography results of the freshly opened crack in Boat 1 illustrating the oxide covered service fracture and dimpled laboratory fracture.

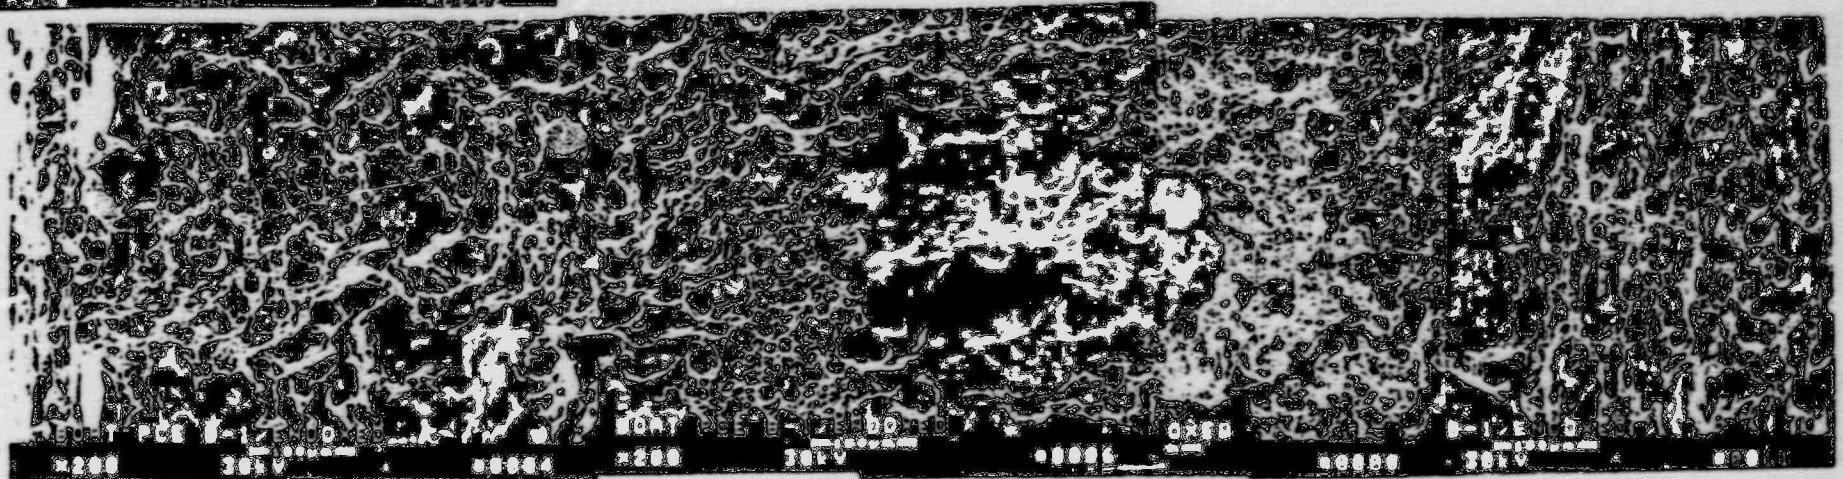
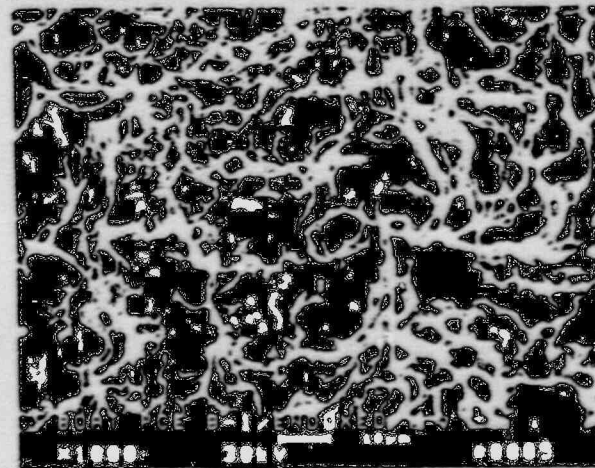
Figure 2.2-14

Scanning electron fractographs illustrating the morphology of endoxed field fracture face in Boat 1.

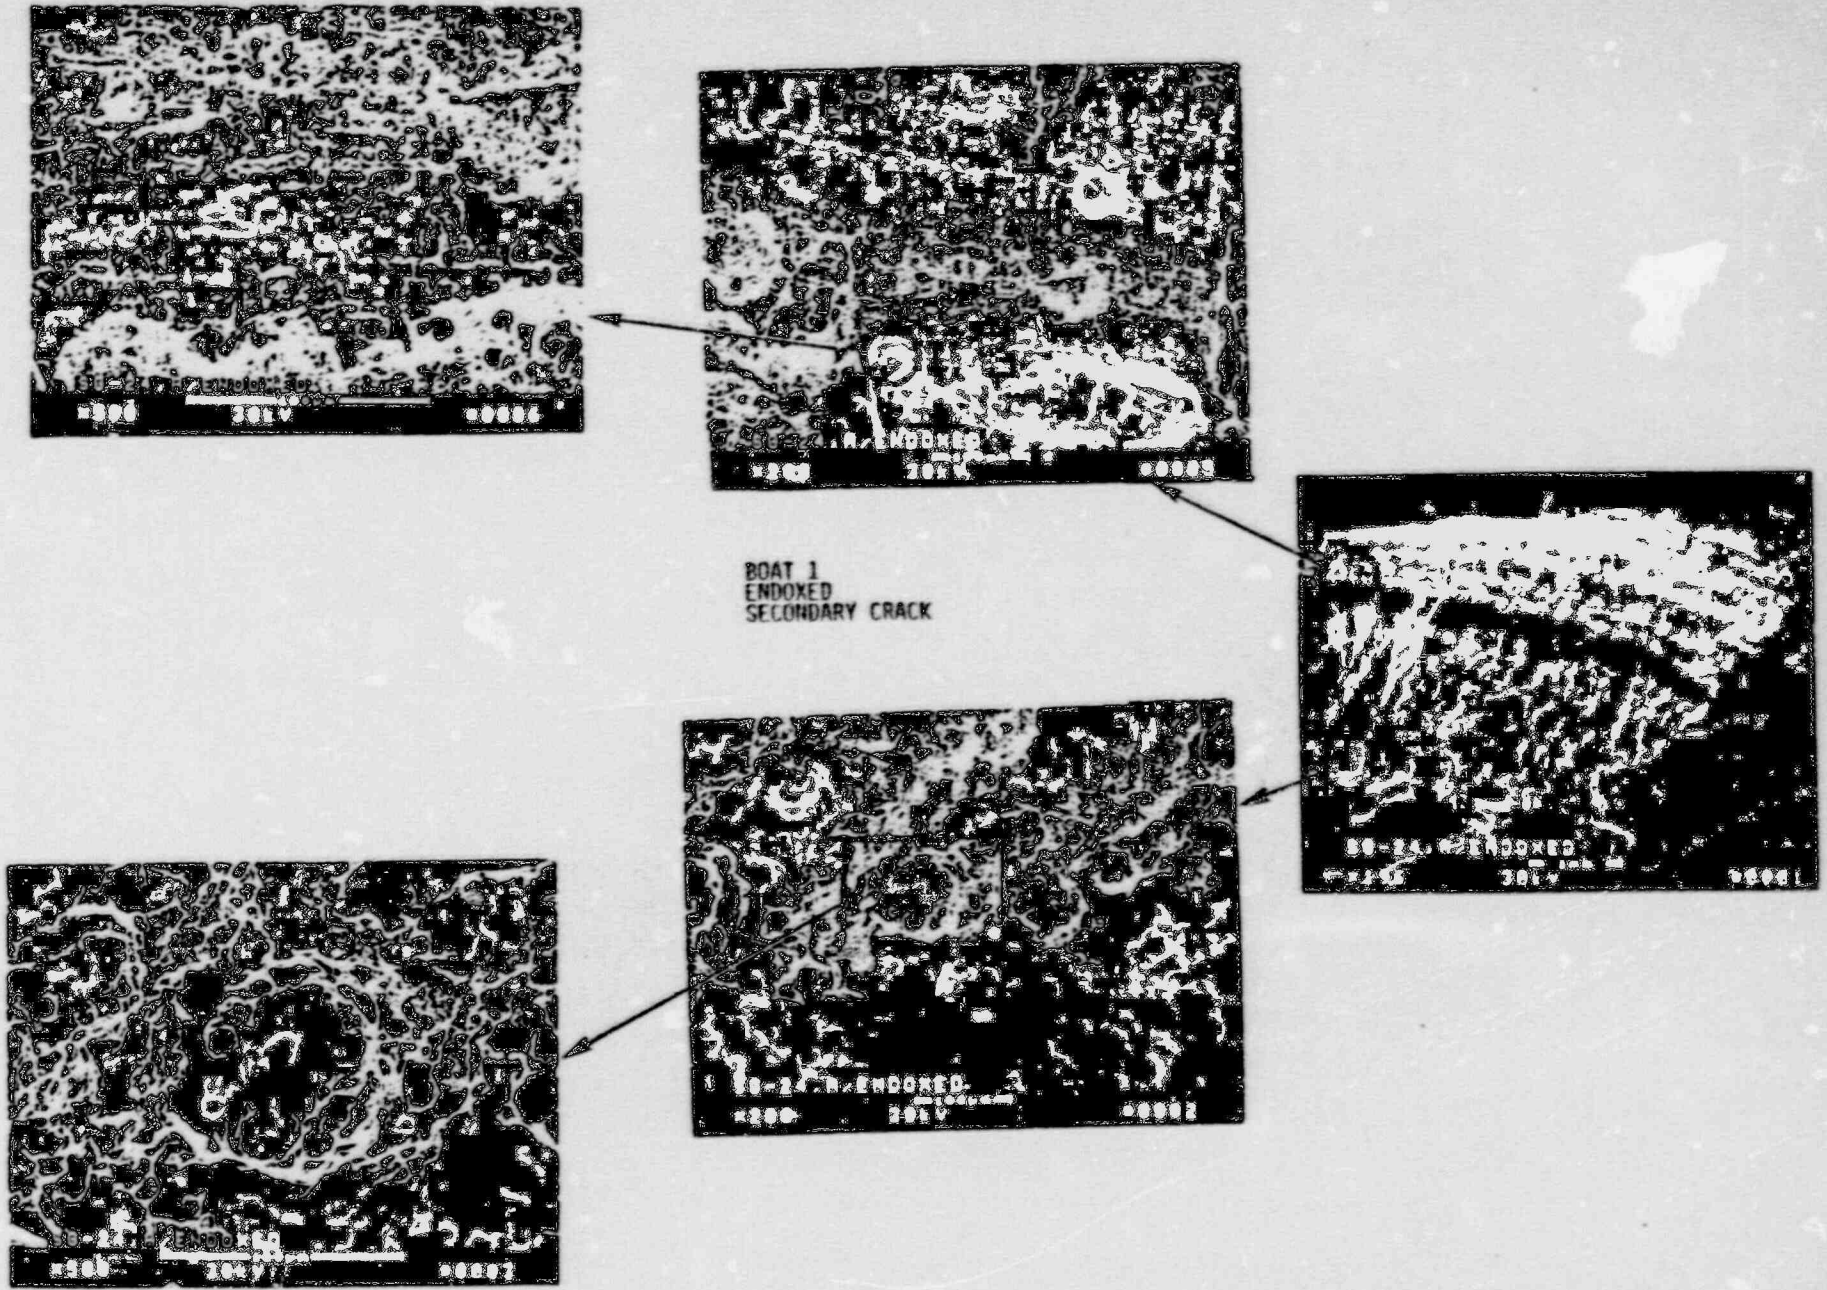
Figure 2.2-15 Scanning electron fractograph of the endoxed fracture face in Boat 1 illustrating the presence of fatigue striations.

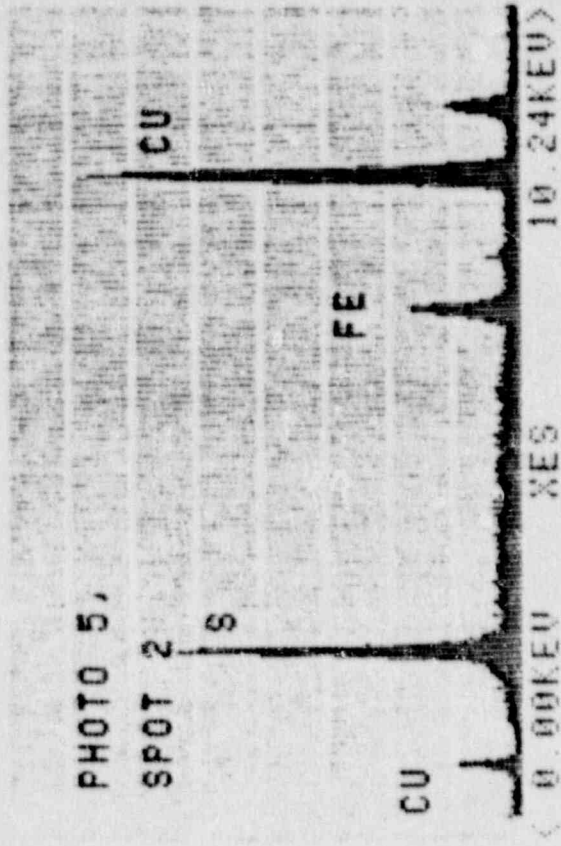
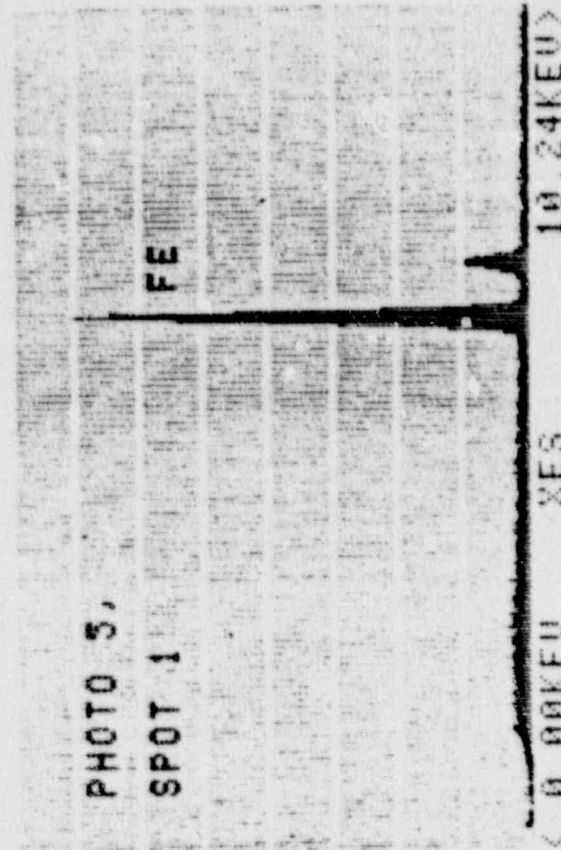
Figure 2.2-16 Energy dispersive X-ray analysis results of the crack deposits in Boat 1.
