WCAP-12294

INDIAN POINT UNIT 2
STEAM GENERATOR GIRTH WELD/
FEEDWATER NOZZLES REPORT
SPRING, 1989 OUTAGE
CONSOLIDATED EDISON OF NEW YORK

OCTOBER 1989

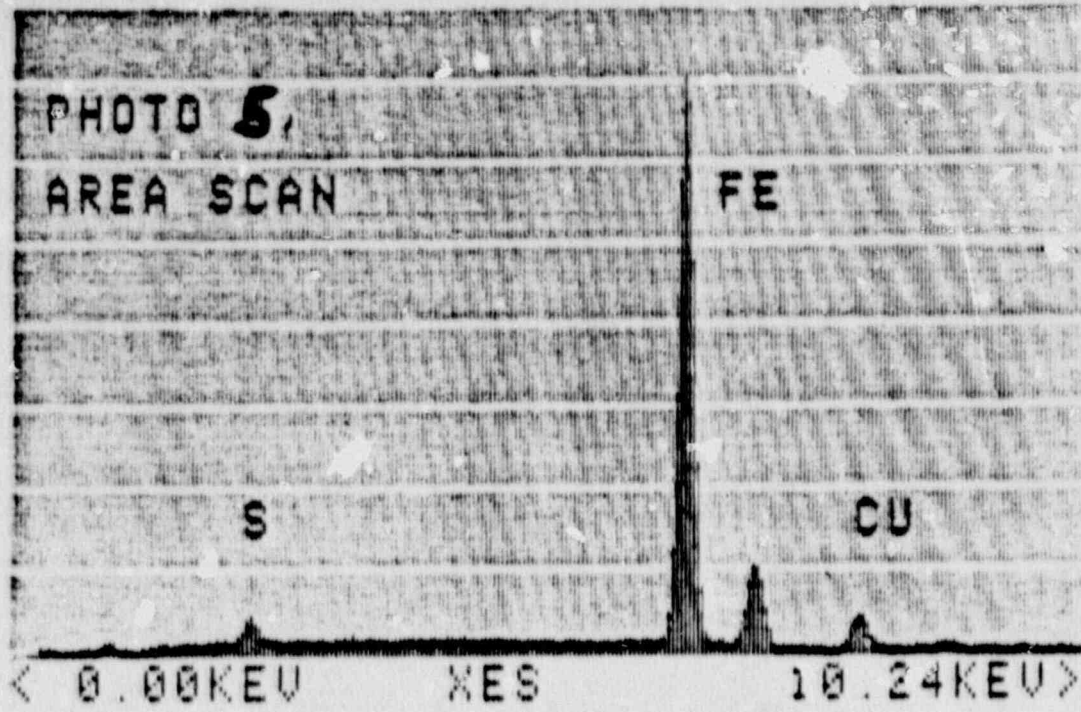
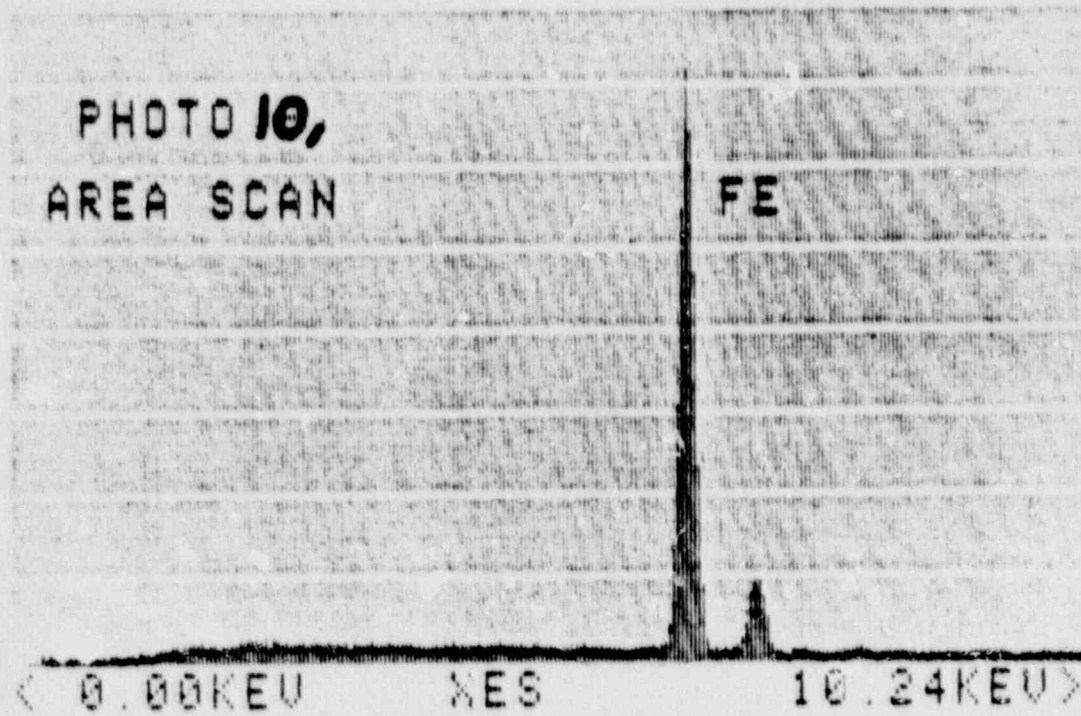
Figure 2.2-17 Energy dispersive X-ray analysis results of the crack deposits in Boat 1.

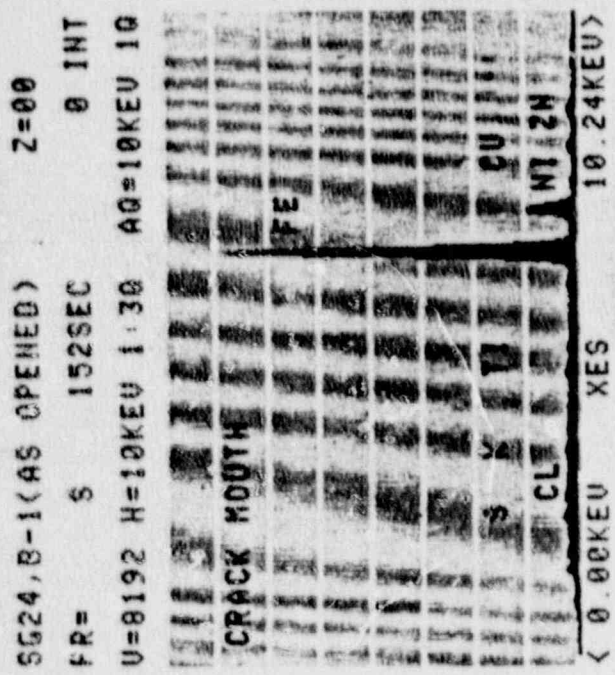
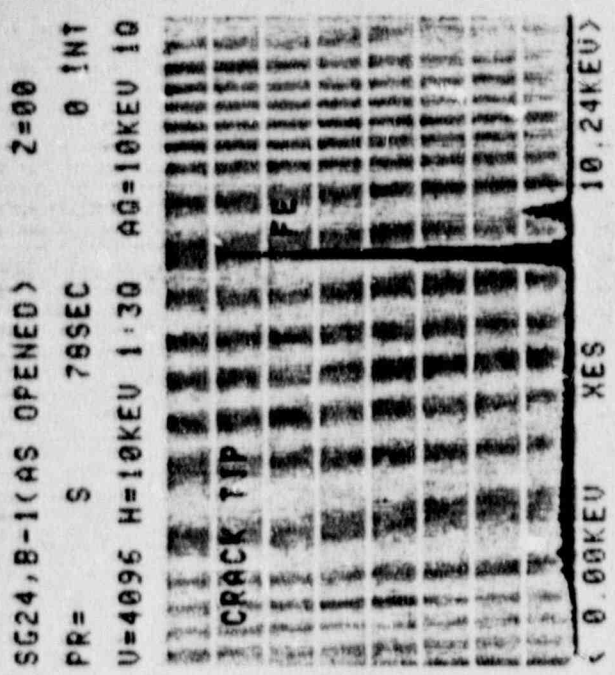
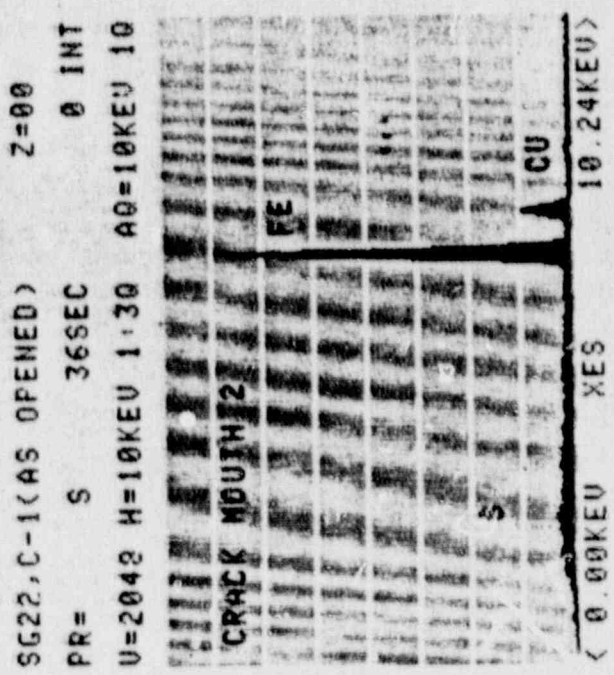
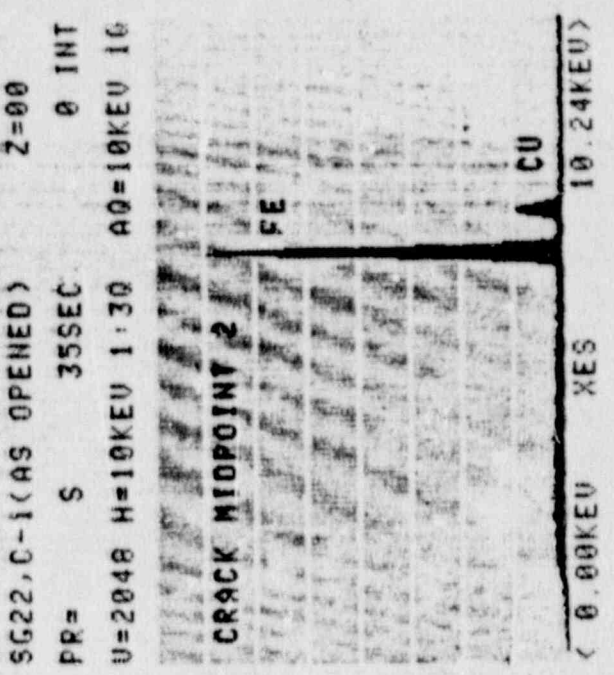
BOAT -2 CRACK DEPOSITES

Figure 2.2-18 Energy dispersive X-ray analysis results of the crack deposits in Boat 2.

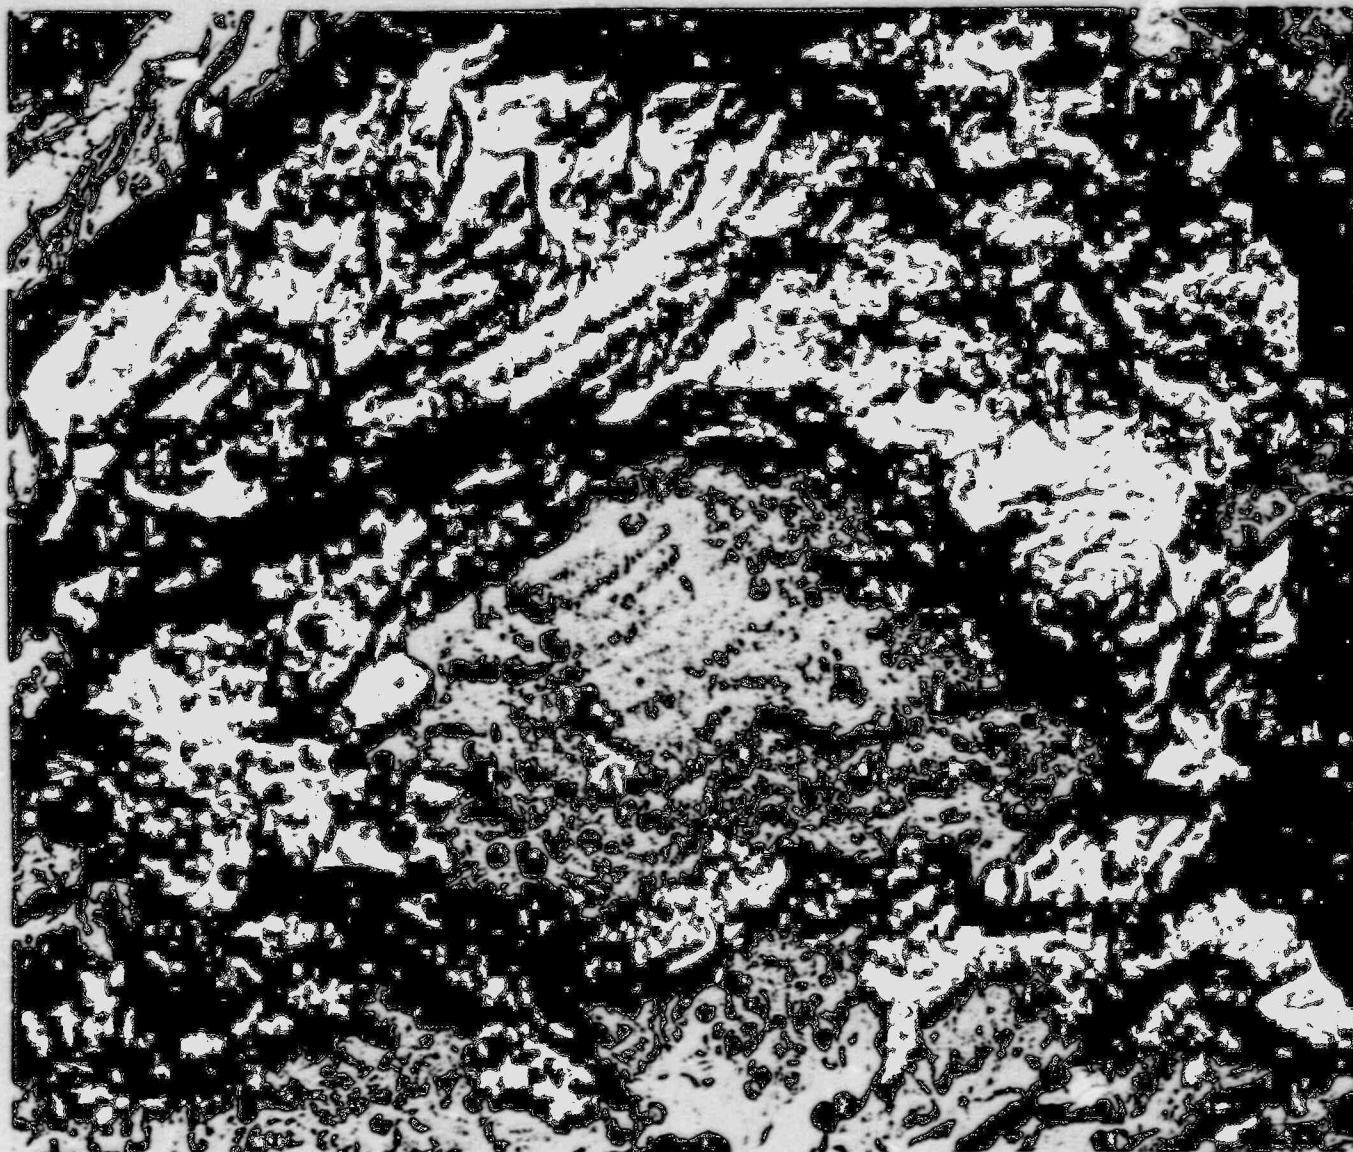
Replica transmission electron microscopy examination of the crack tip regions showed some areas resembling the appearance of fatigue striations on the freshly opened and Endoxed faces of the subsurface crack seen in boat #1 (Figures 2.2-19 and 2.2-20). The formation of the oxides in the crack probably consumed much of the evidence of fine fatigue striations.

Figure 2.2-19 Replica transmission electron fractograph illustrating the presence of fatigue striations at the crack-tip.

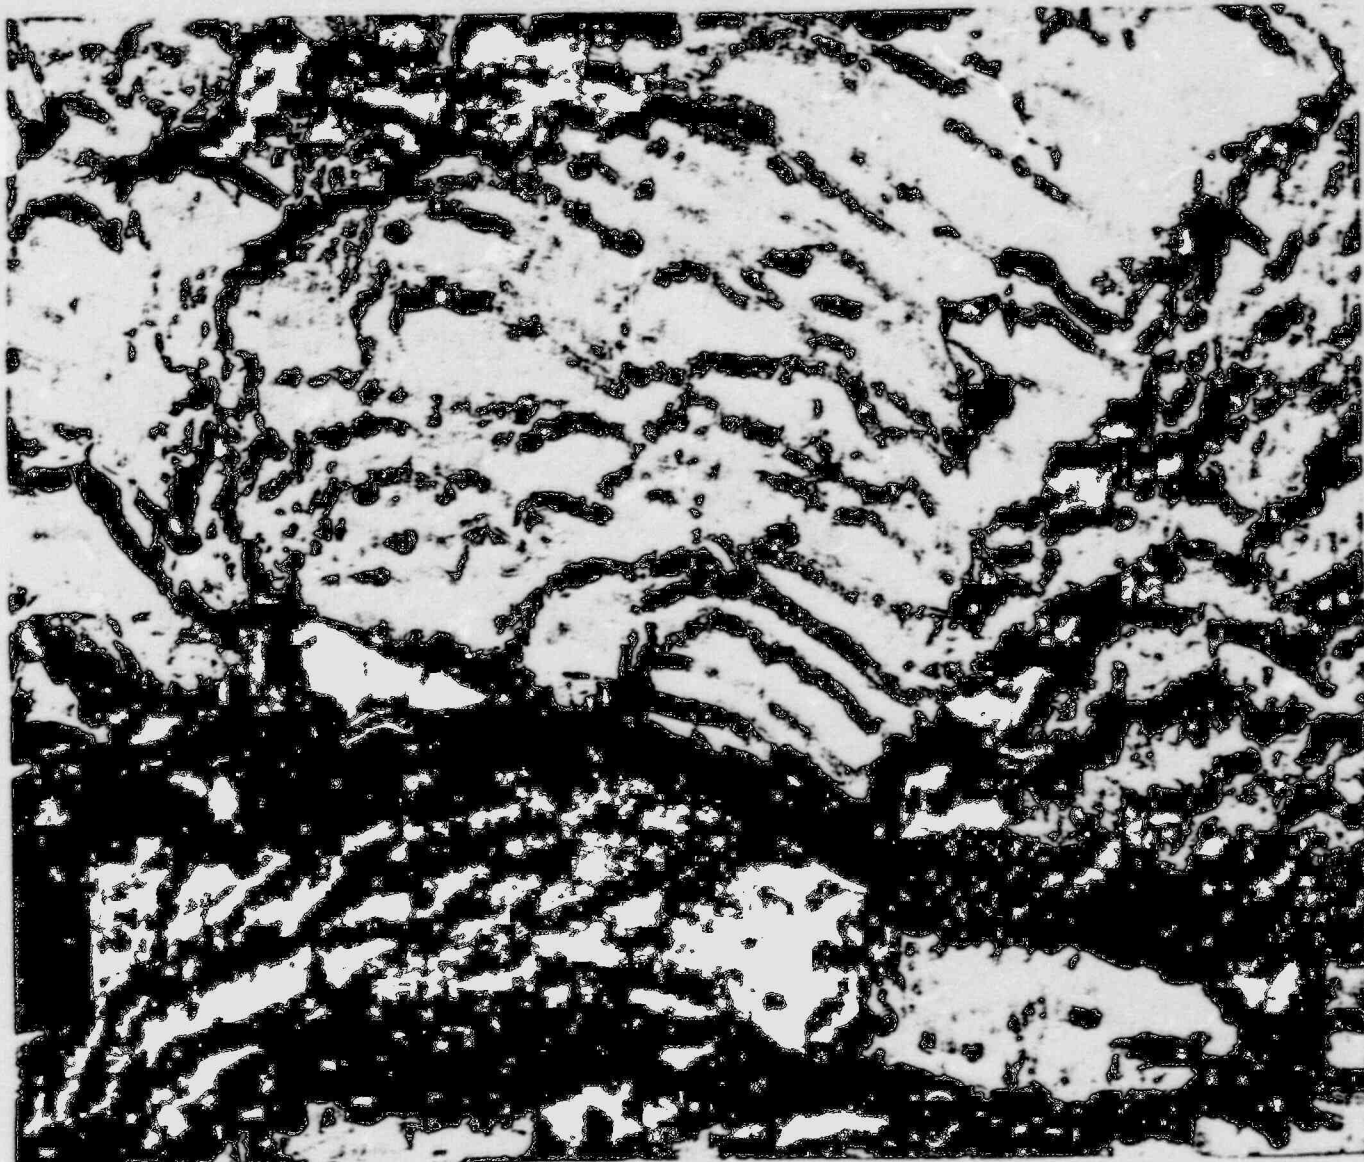
Figure 2.2-20 Replica transmission electron fractograph illustrating the presence of fatigue striations at the crack-tip.
