POWER RESOURCES, INC.

Re: Docket No. 40-8851 : SUA - 1511
Reporting Pursuant to License Condition No. 44

Section 14N Wellfield
PC Pipeline Failure

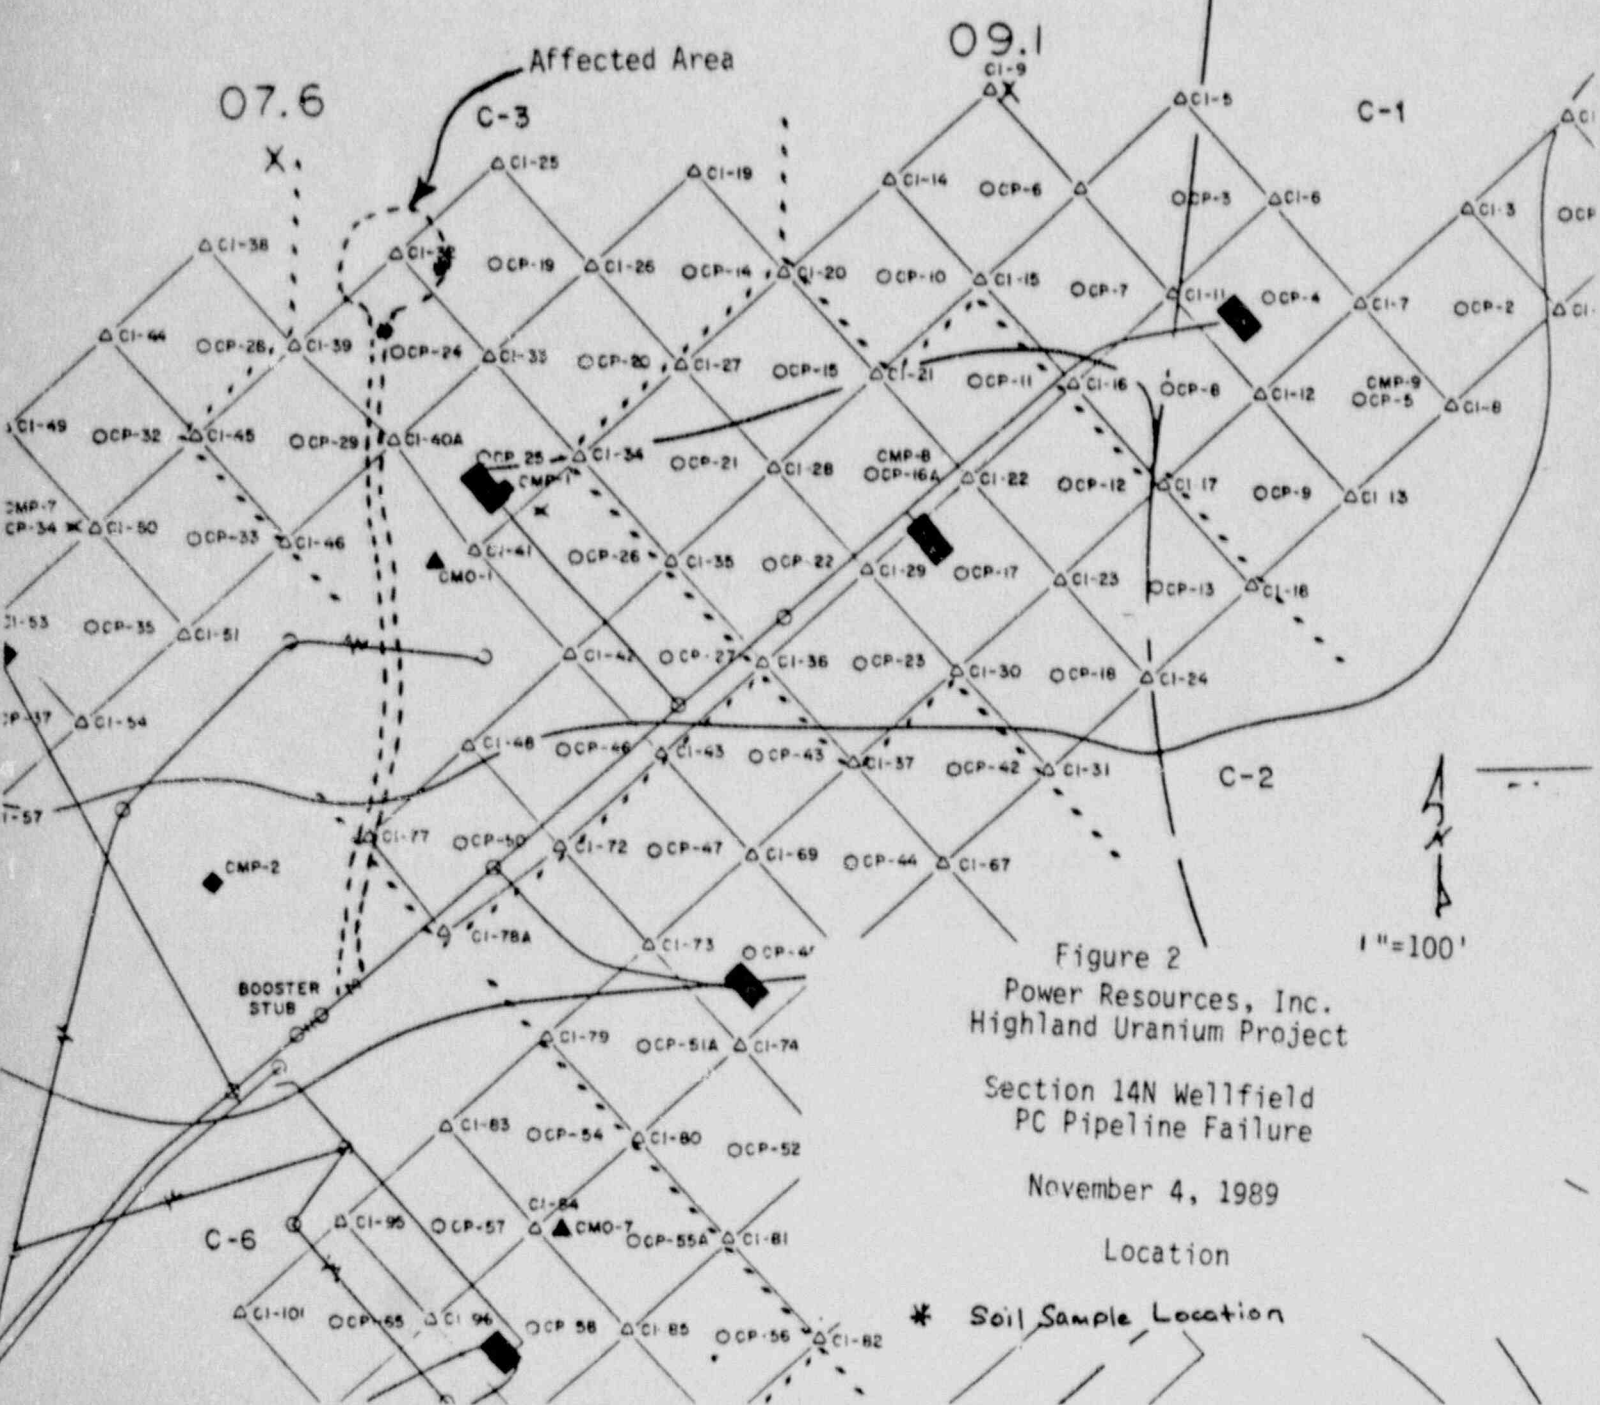
Figure 2
Power Resources, Inc.
Highland Uranium Project

Review of the production flow meter recorder chart indicated that approximately 3850 gallons of production fluid containing approximately 200 mg/l U₃O₈ had escaped from the break in the pipe. Most of the fluid was contained within the two steel lined valve boxes where the leak occurred. Approximately 1000 gallons of the fluid overflowed the valve boxes and flowed down-gradient approximately 350 feet to an existing small playa depression which contained rain water and ice. The attached Figure 1 shows the location of the incident in relation to the permit area, and Figure 2 shows the actual extent of the affected area.

A gamma survey performed over the area on November 6 indicated no gamma response above background (ie, 15-20 uR/hr). Representative soil samples have been collected and are being analyzed for Radium-226 and uranium. The location

of these samples are shown on Figure 2. Analytical results will be reported to you upon receipt from the laboratory. Because the ground within the area was already saturated due to recent storms and snow melt, no significant volume of fluid penetrated into the soil. Because of the fast response of the Satellite operators, the small affected area and volume of fluid released, and the immediate mitigative action taken to dispose of the released fluid, this incident did not result in a significant adverse environmental impact. Any residual contamination will be removed during decommissioning.

At about 9 A.M. on November 4, a vacuum truck arrived on site to remove the fluid from the valve boxes and the playa depression. The recovered fluid was treated at the Satellite No. 2 facility for uranium and radium recovery and piped to the radium ponds, which is the normal method of treatment for wellfield purge water. Inspection of the pipe in the valve boxes indicated that the cause of the failure was a cracked fusion joint in a section of a ten inch diameter black polyethylene pipe. Repair was effected and the production line was back in service by the afternoon of November 6.
