# Severe Accident Testing of Electrical Penetration Assemblies

Prepared by D. B. Clauss

Sandia National Laboratories

NUREG/CR-5334  
SAND89-0327  
RD, R1

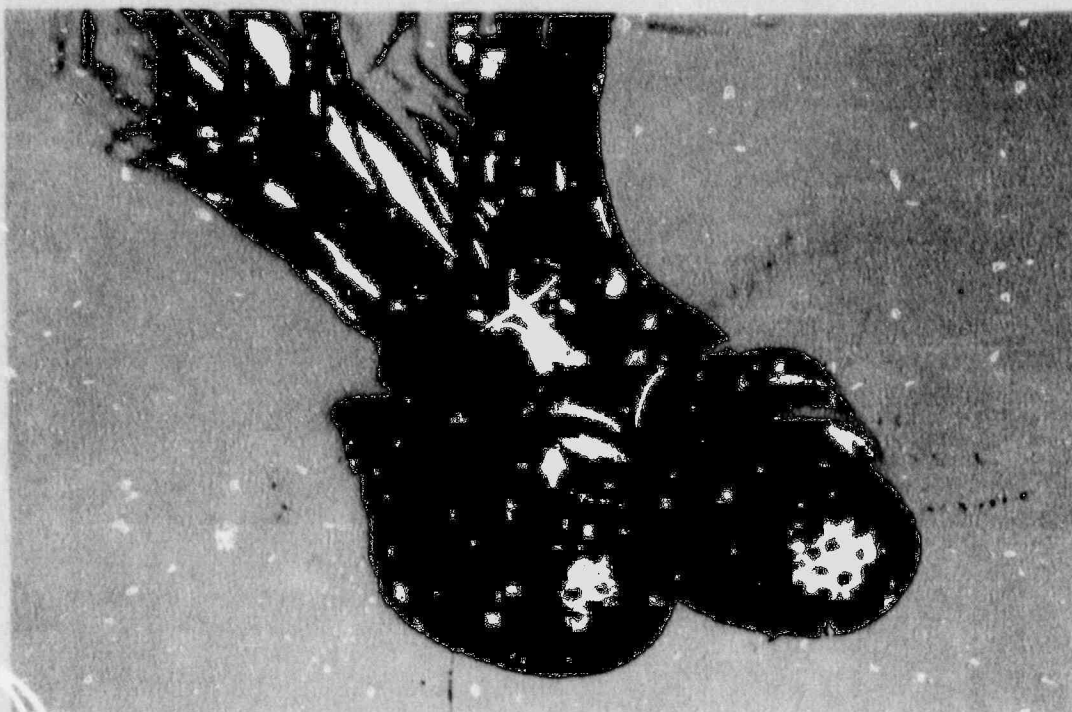
The electrical performance of the EPA modules degraded over the first 2 days of the test to the point that the insulation resistance to ground for all conductors was less than 1 M $\Omega$ , and after 10 days, five out of the eight circuits were passing 0.5 amp to ground, which was the maximum current possible in this test. The earliest short to ground occurred about 13 hours into the test. Insulation resistances fell below 1 k $\Omega$  before the shorts to ground occurred. The posttest inspection showed that all but one module was electrically faulty because of moisture that had traveled through the connector and provided a ground between the module pins and the metal mask that surrounds each pin. This bridging with moisture or contaminants is believed to have caused the electrical shorts to ground.

Figure 4-65 Post-SAC Test : Signs of Moisture Intrusion on M16 Connectors

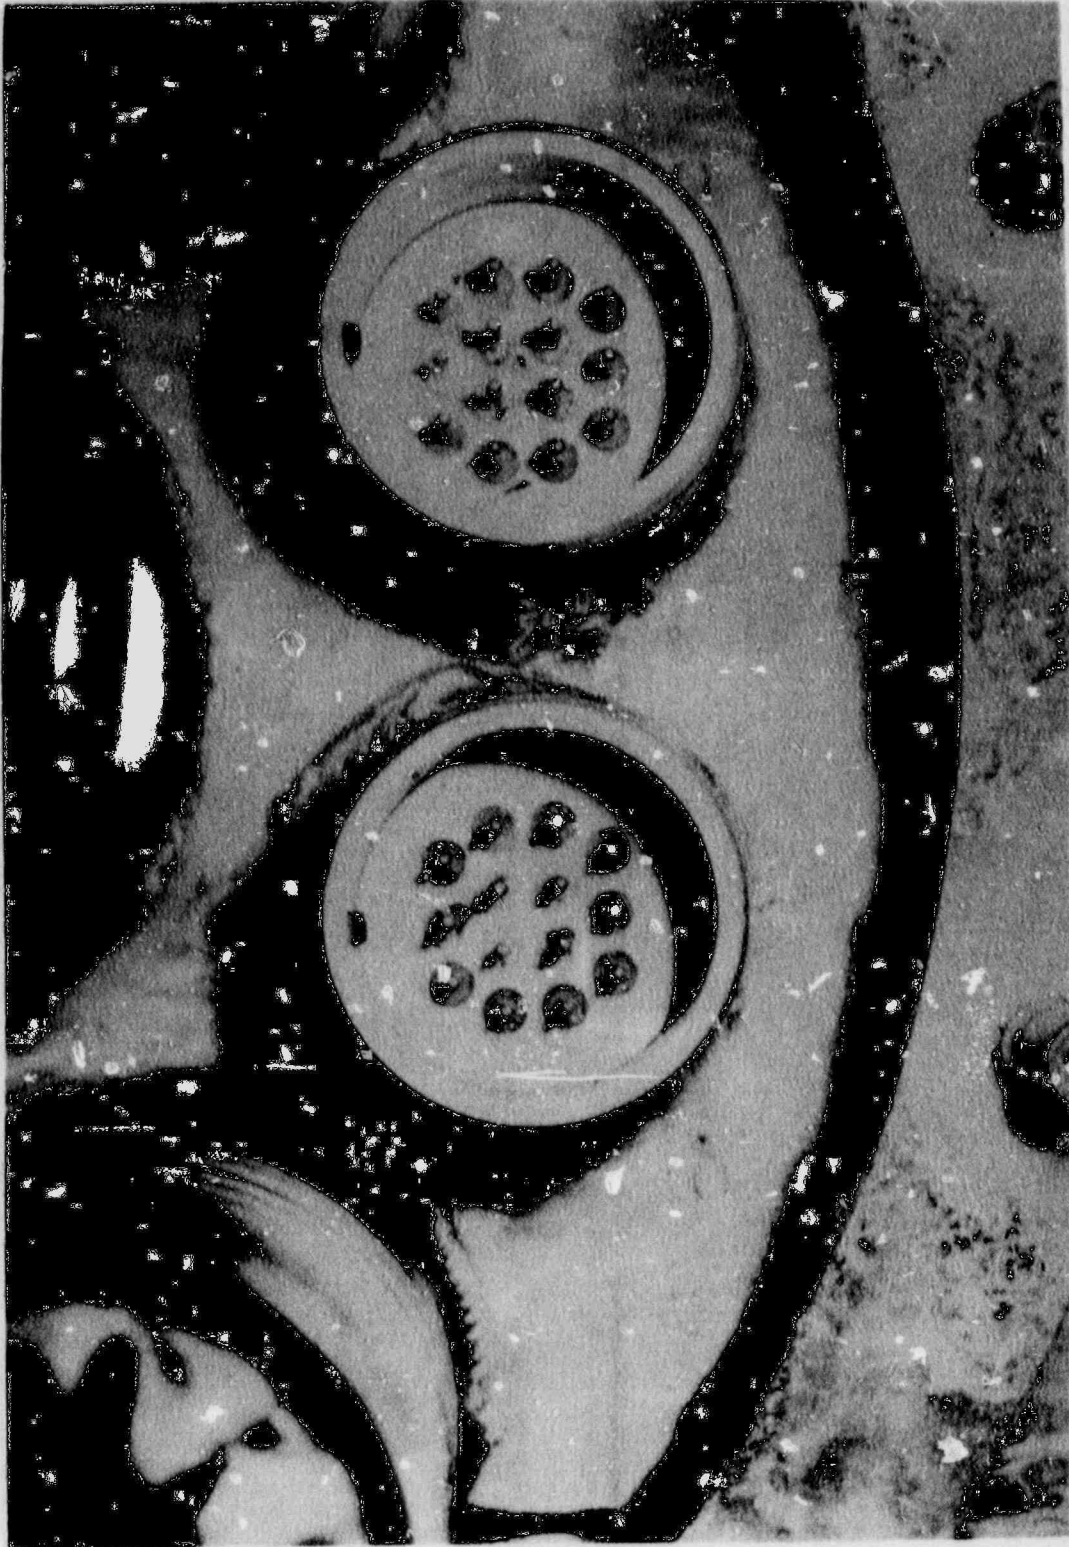
Figure 4-66 Post-SAC Test : Contaminants Around Pins of M16 Modules

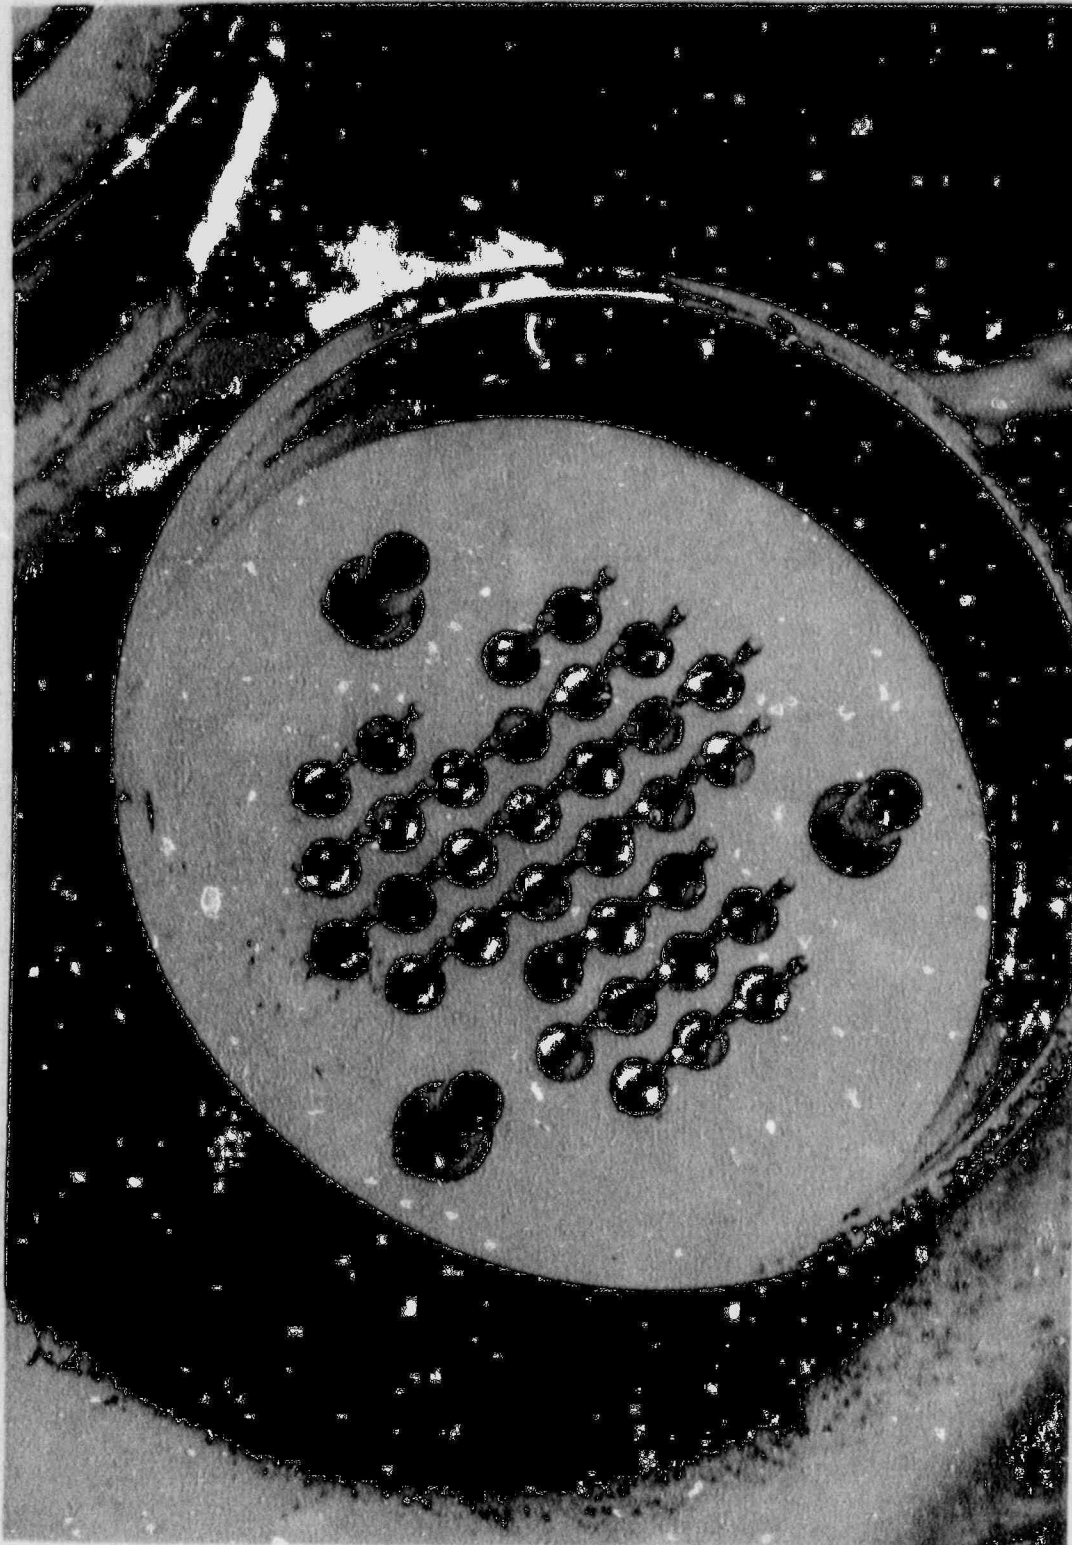
Figure 4-67 Post-SAC Test : Contaminants Around Pins of M19 Module
