*PDR* WM-43  
Lowman ID site,  
DOE Remedial Action  
Plan

SUMMARY OF RADIOLOGICAL CHARACTERIZATION  
OF THE STATE OF IDAHO DEPARTMENT OF PARKS  
AND RECREATION HEADQUARTERS SITE  
2271 Warm Spring Avenue, Boise, Idaho

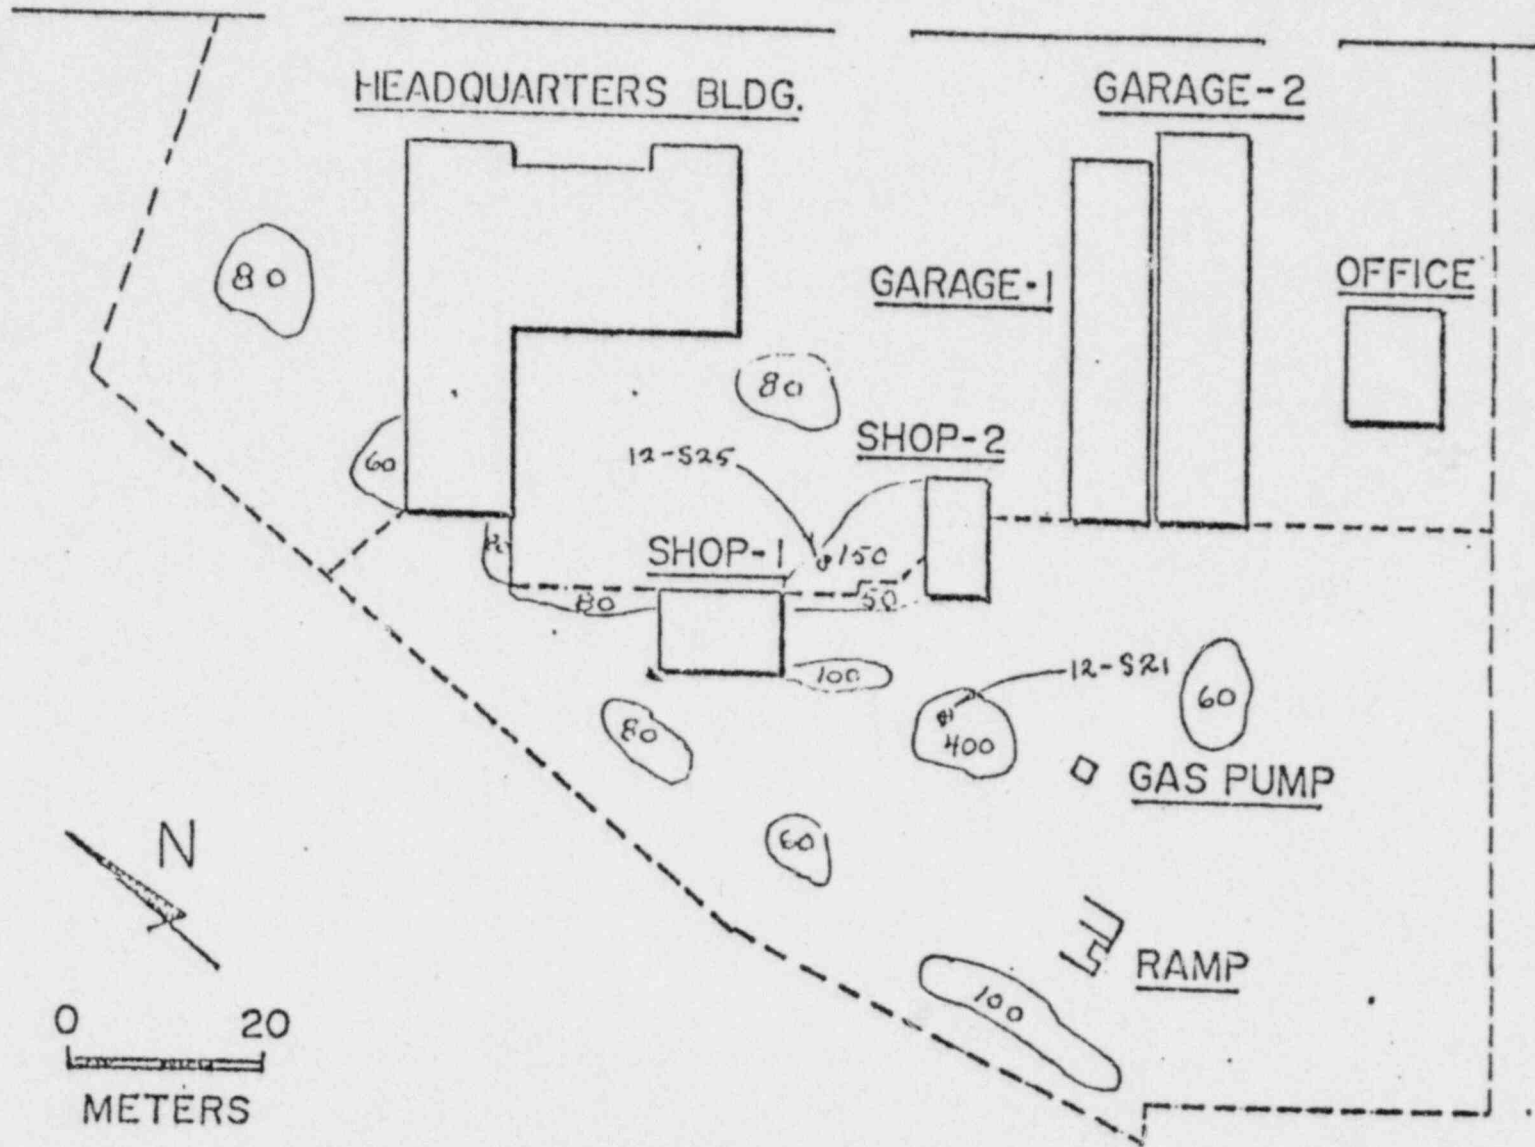
WARM SPRINGS AVE.

General "ambient background" readings in the open areas of the Facility, ranged from 12  $\mu$ R/h to 400  $\mu$ R/h. Numerous areas of elevated readings were found in the vicinity of Shops 1 and 2 and west of the loading ramp (see attached map). The highest contact reading was 2 mR/h in an area 40 feet southwest of Shop 2.

Bore hole numbers 12-S21 and 12-S25 (see attached map) were drilled to a depth of four feet where cobble was encountered. Split spoon samples were taken in 1 foot increments to the 4 foot depths. All soil samples indicated elevated readings from portable instrumentation, as well as from the bore hole logging technique (2" x 2" NaI(ti) gamma spectroscopy). Although most of the bore holes taken, indicated some anomalies, bore holes 12-S21 and 12-S25, were the highest. All core holes (environmental) and bore hole samples will be submitted for radiochemical analyses to determine the type and quantity of the radioactive material involved. A total of seven (7) peripheral core holes and eleven (11) biased random bore holes were taken at the Facility. In addition, four (4) background soil corings were taken; two at Lucky Peak Dam and two at Veterans Memorial Park.

In addition to the standard subsurface investigation, it was noted that "black sand" was evident in several ant hills in the area between Shops 1 & 2. A survey of this black sand revealed elevated readings. The sand appeared similar to that found at the Lowman Site.
