# Equipment Response at the El Centro Steam Plant During the October 15, 1979 Imperial Valley Earthquake

Manuscript Completed: September 1980  
Date Published: October 1980

Prepared by  
R. C. Murray, T. A. Nelson, Lawrence Livermore Laboratory  
R. D. Campbell, Structural Mechanics Associates  
J. A. Young, EGC, Inc.  
H. A. Levin, J. A. Martore, L. Reiter, USNRC

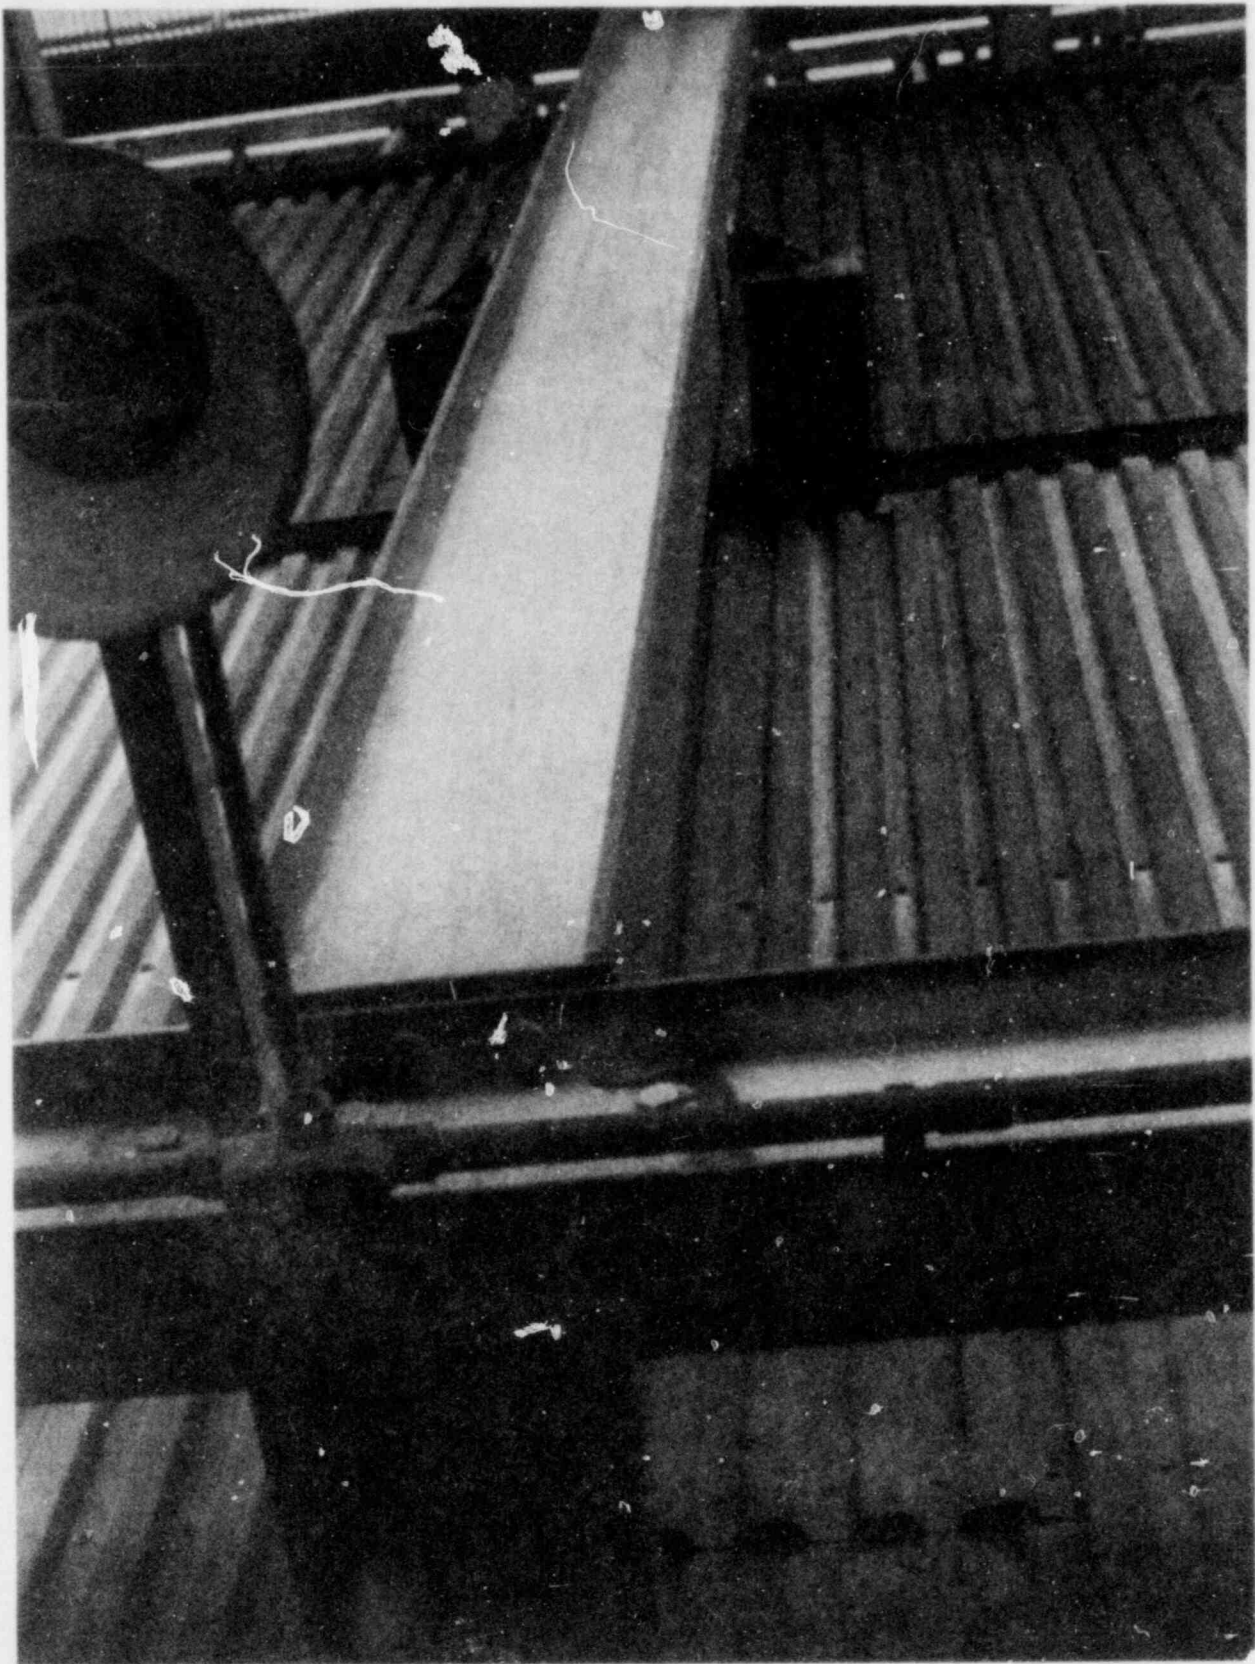
One of the few areas where structural damage was observed was the Unit 4 boiler, which is hung in a pendulum fashion using rods supported by a braced frame. Lateral seismic restraints are mounted on the braced frame to minimize excessive motion of the freely supported boiler. Travel through the restraint gap was evidenced by paint chipping in the area and permanent deformation of the restraint (Fig. 6). In addition, three diagonal bracing members on the boiler frame buckled (Fig. 7), apparently due to excessive compressive loads. These diagonals were later replaced.

Fig. 6. Earthquake-induced motion of the Unit 4 boiler--which is suspended from a support structure--widened this seismic restraint on the east side approximately 2 in. by bending the cantilever beams (from Ref. 6).

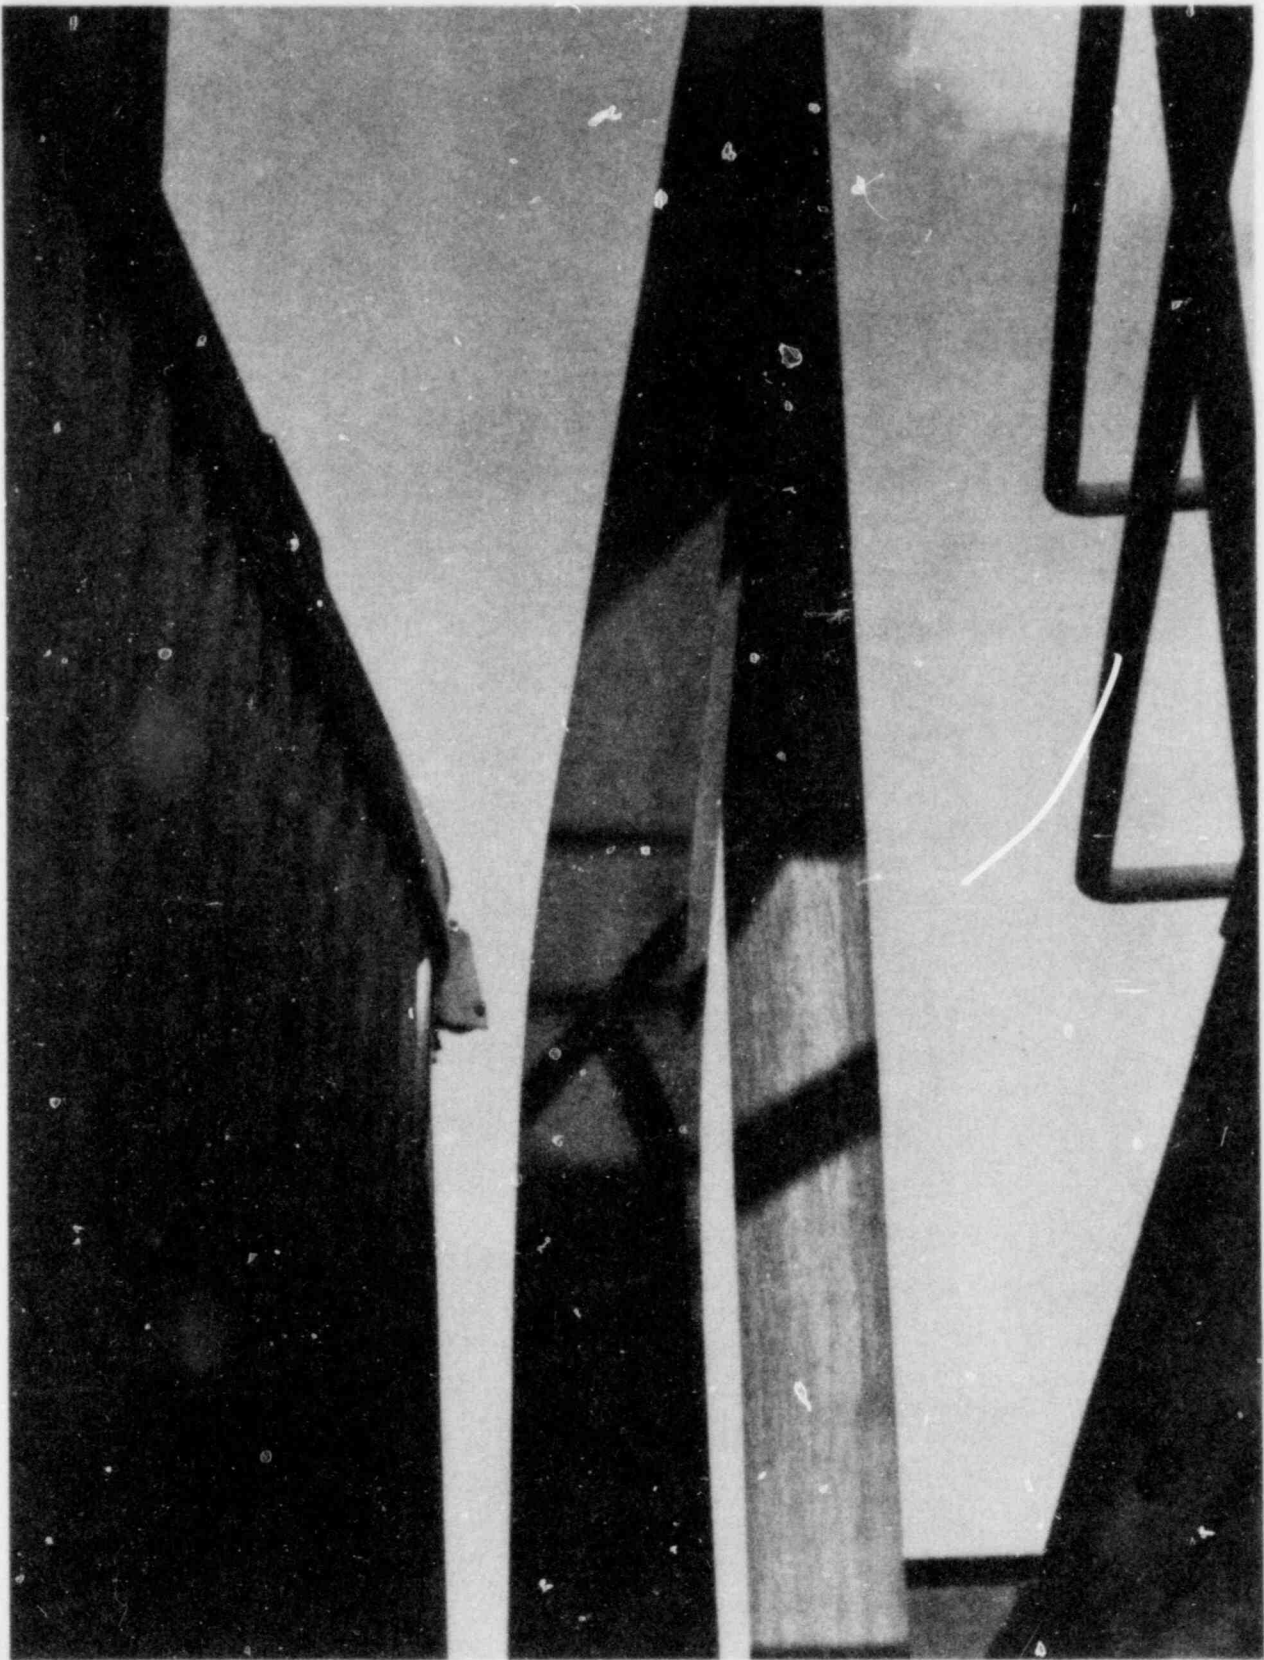
Fig. 7. Diagonal braces on the Unit 4 boiler support frame buckled and had to be replaced.

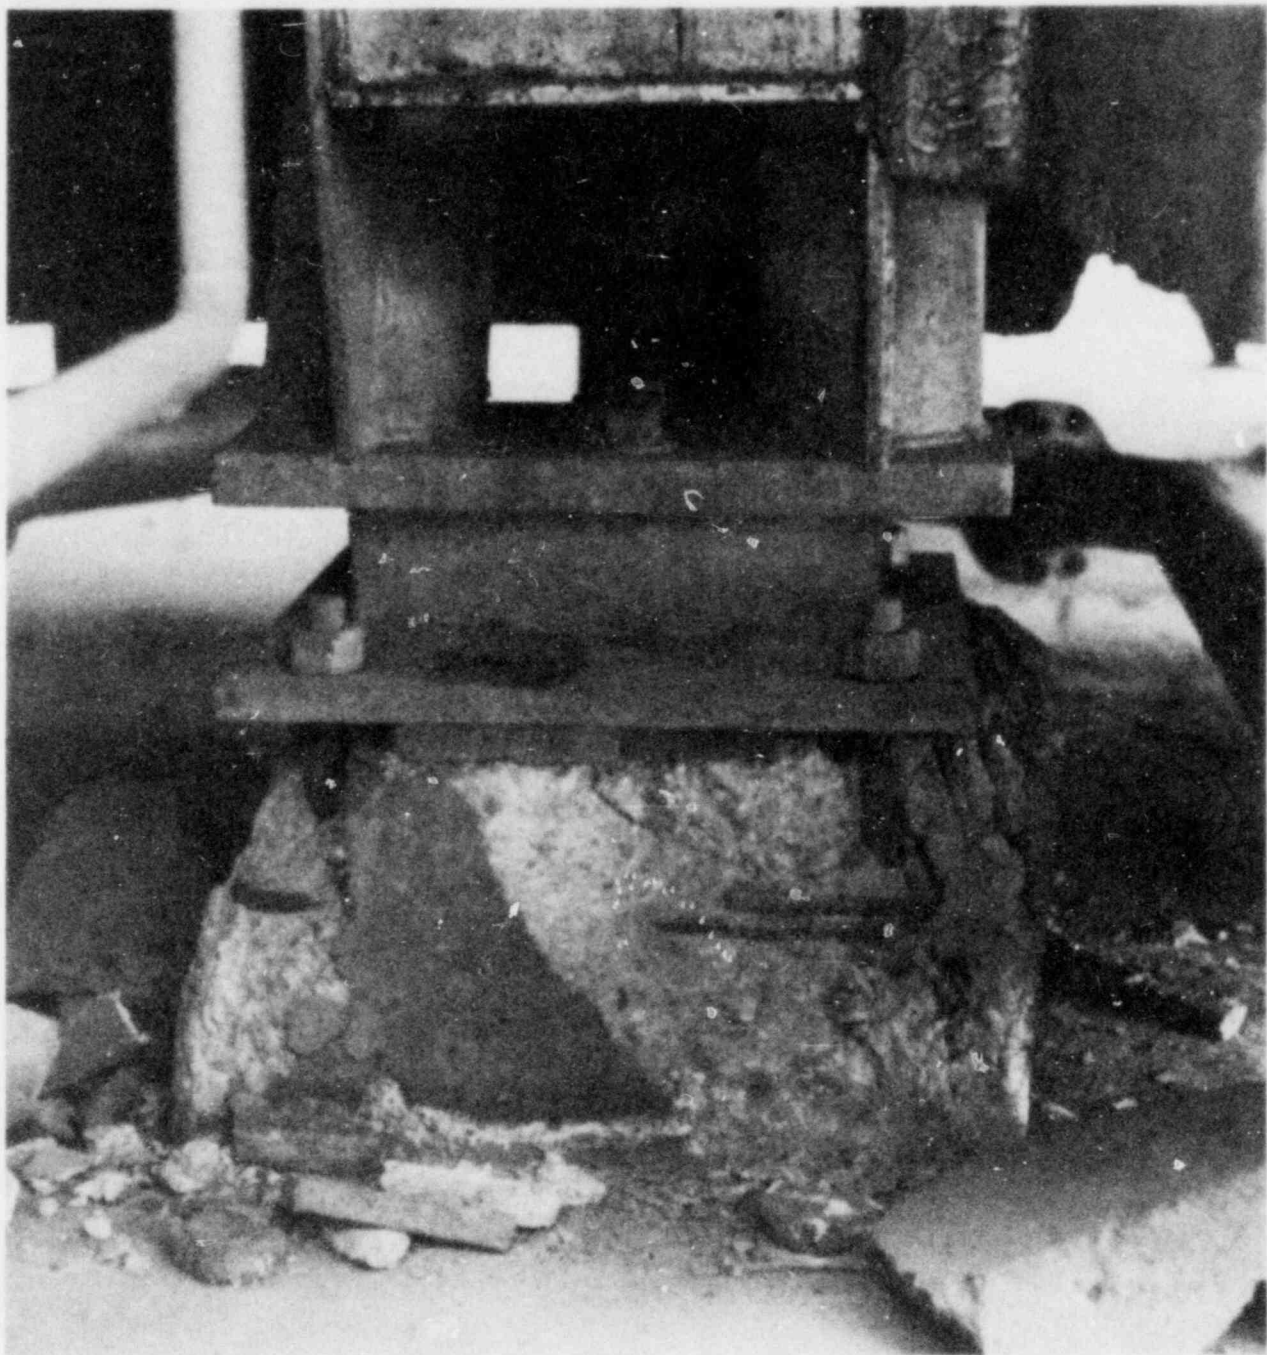
Unit 4 Air Preheater Foundation - One of the concrete foundation support pads had partially crushed but was still functional, and had not been replaced (Fig. 8).

Fig. 8. A concrete foundation support pad on the Unit 4 air preheater foundation was partially crushed but remained functional.

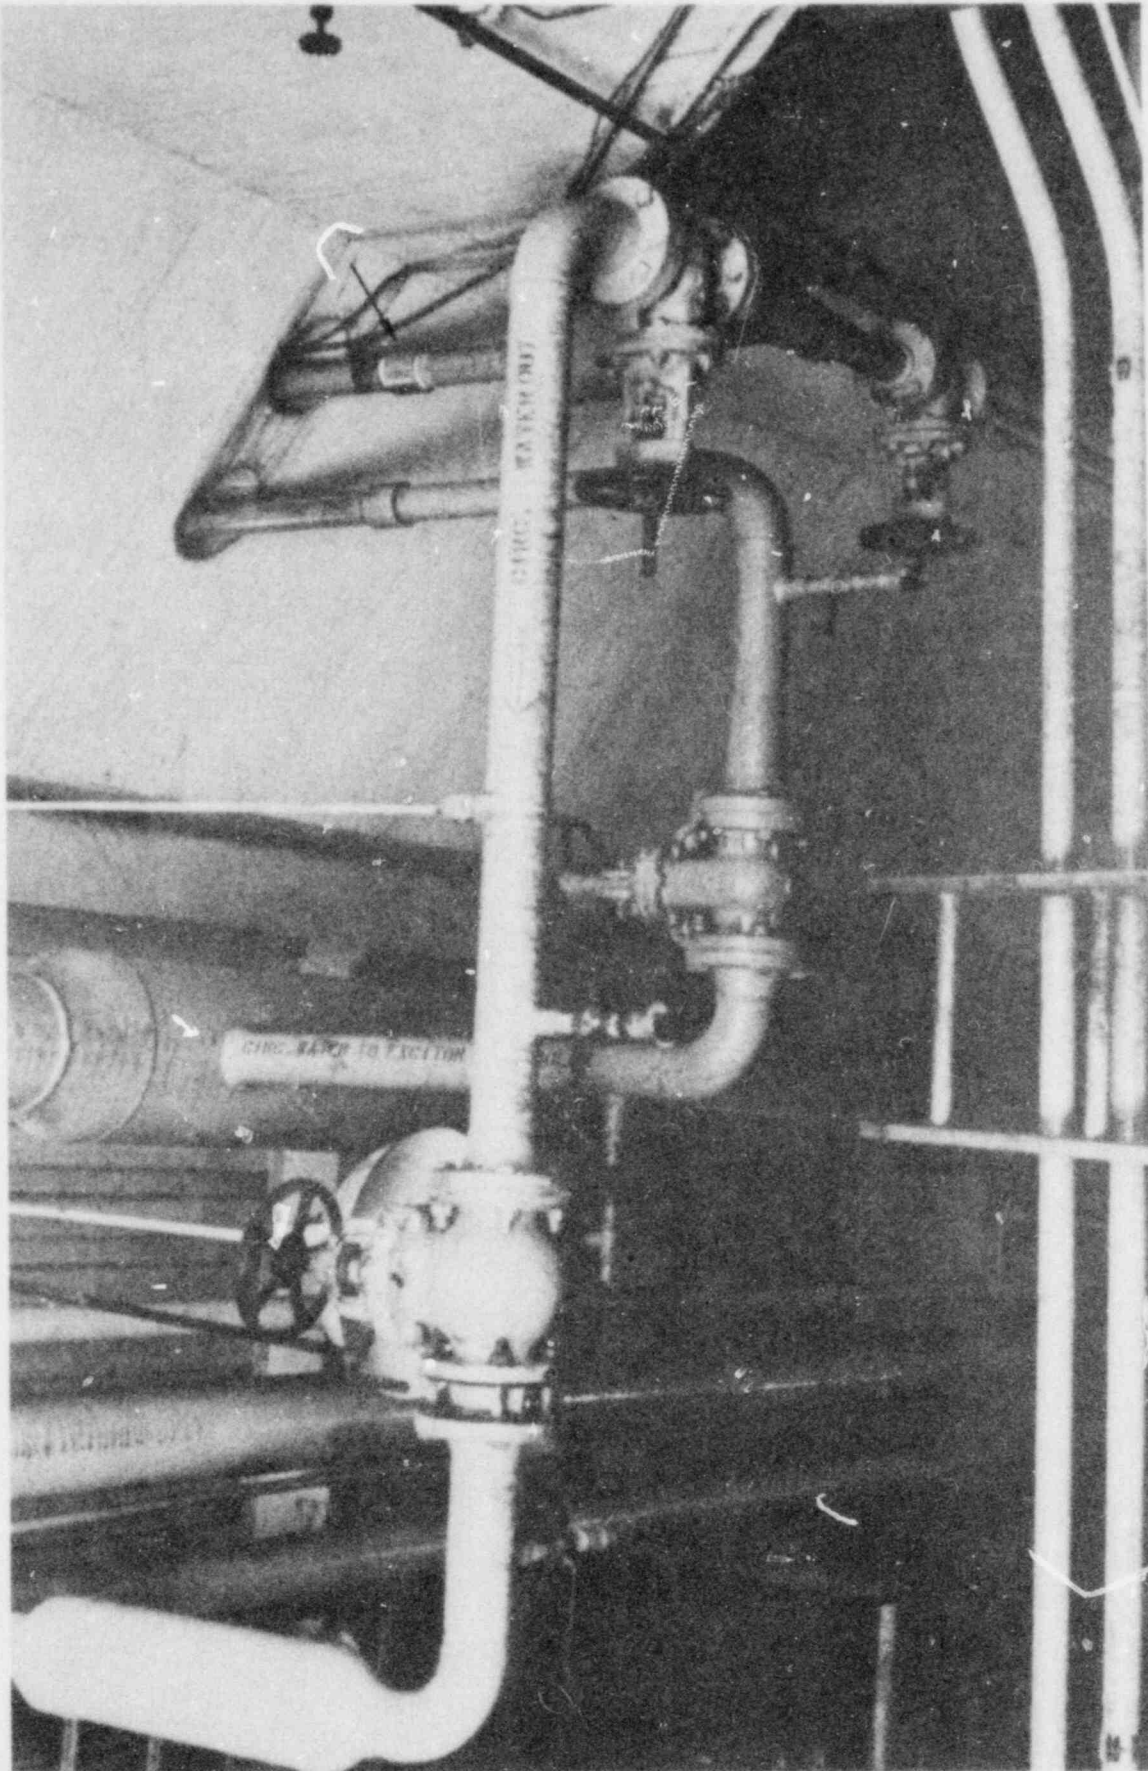
No high-temperature or high-pressure piping failed during the earthquake. However, a Victaulic coupling on a straight section of a 2-in.-diam cooling water line was damaged (Fig. 9). Additionally, 3- and 4-in.-diam water treatment and hydrogen cooling water lines in Units 3 and 4 failed in straight runs in areas which had been either weld repaired or excessively corroded. Circumferential cracks in these corroded lines, apparently caused by the earthquake, were observed; however, leakage was minimal since the cracks were later found to be essentially closed.

Fig. 9. Unit 4 developed leaks in the cooling water piping for the exciter cooler, shown here. Leaks occurred in locations weakened by corrosion. Arrow points to new Victaulic coupling.

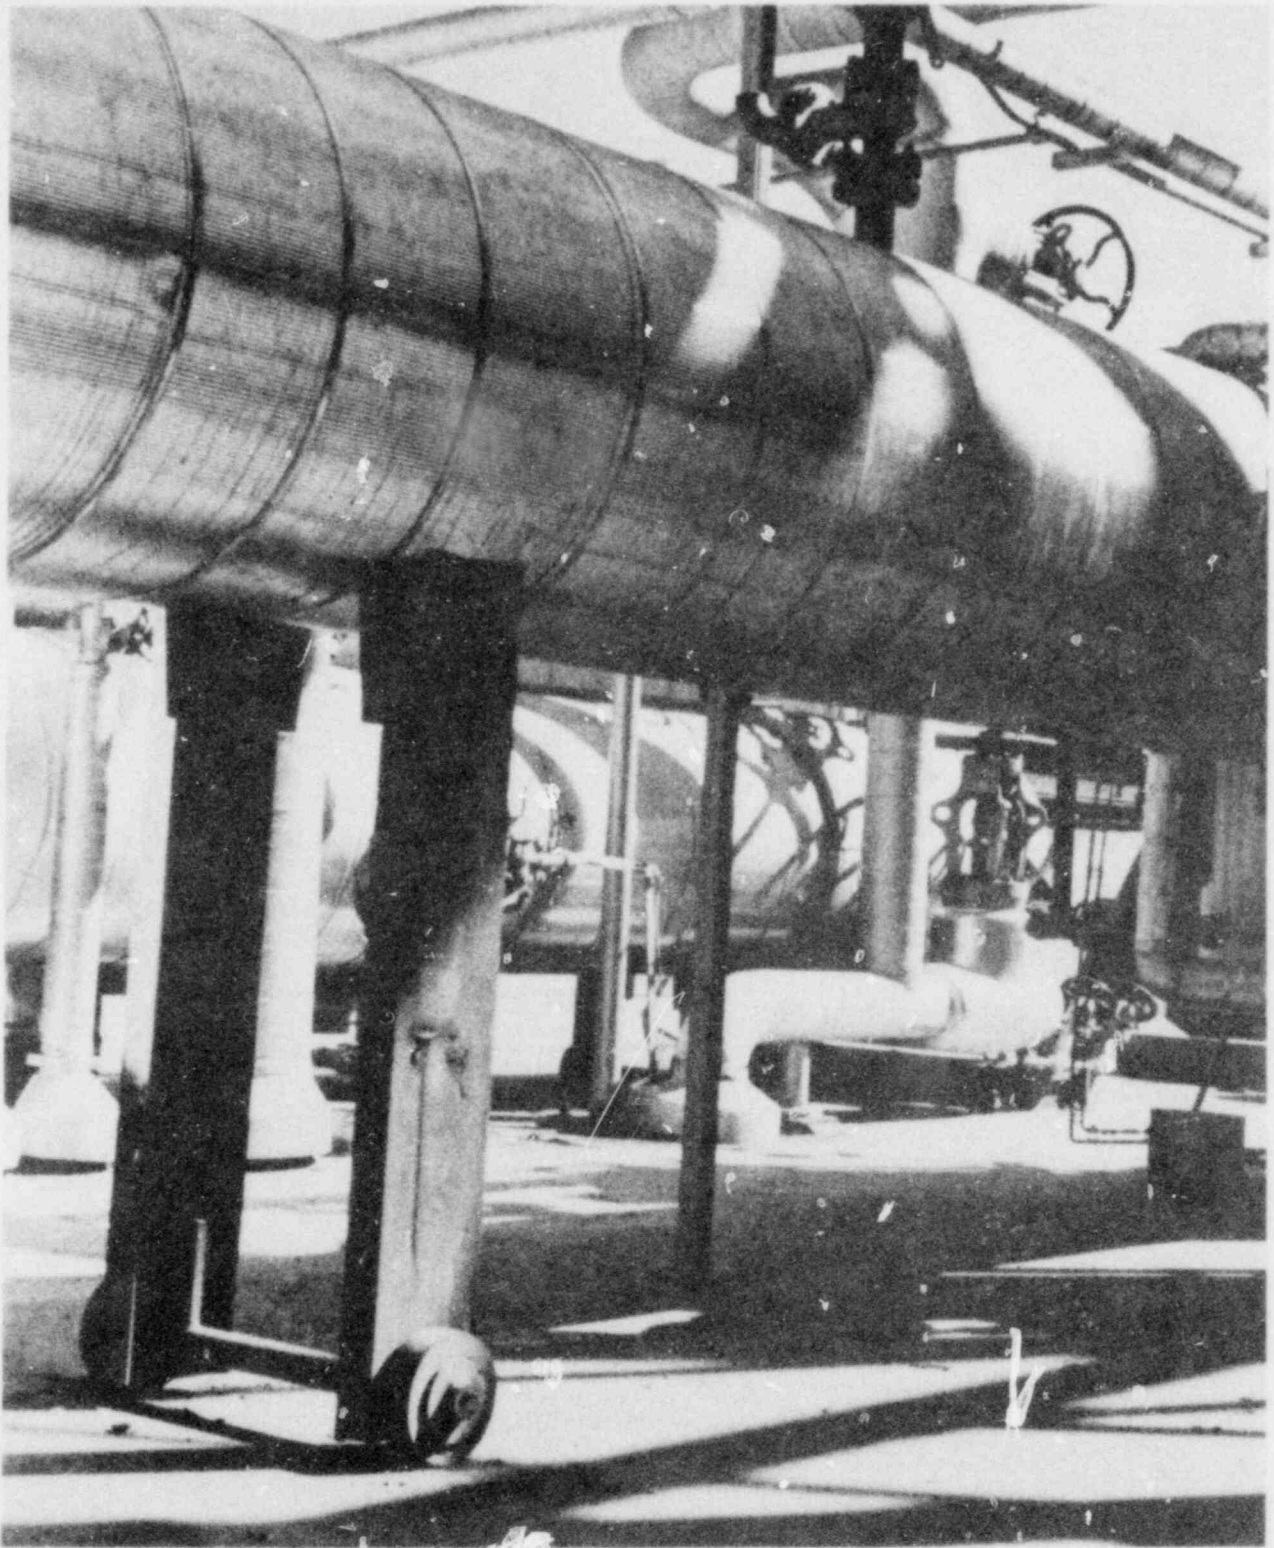
Two items in Unit 3 were not securely anchored and moved during the earthquake. The turbine oil cooler was not anchored to its support pedestal and moved about 1/4 in. The feedwater heater, located on the roof was anchored on one end only with rollers on the opposite end. The unanchored roller supports appeared to have slid laterally (E-W) about 3-5 in. (Fig. 10). Apparently these deflections were adequately tolerated by the attached piping since no evidence of cracking was observed at the nozzles or other discontinuities in the piping. A lateral support has since been added.

Fig. 10. A feedwater heater on the roof of Unit 3 was anchored on one end, but the unanchored end shown moved about 4 in. laterally. Note: wheels are about 6 to 8 in. in diameter.

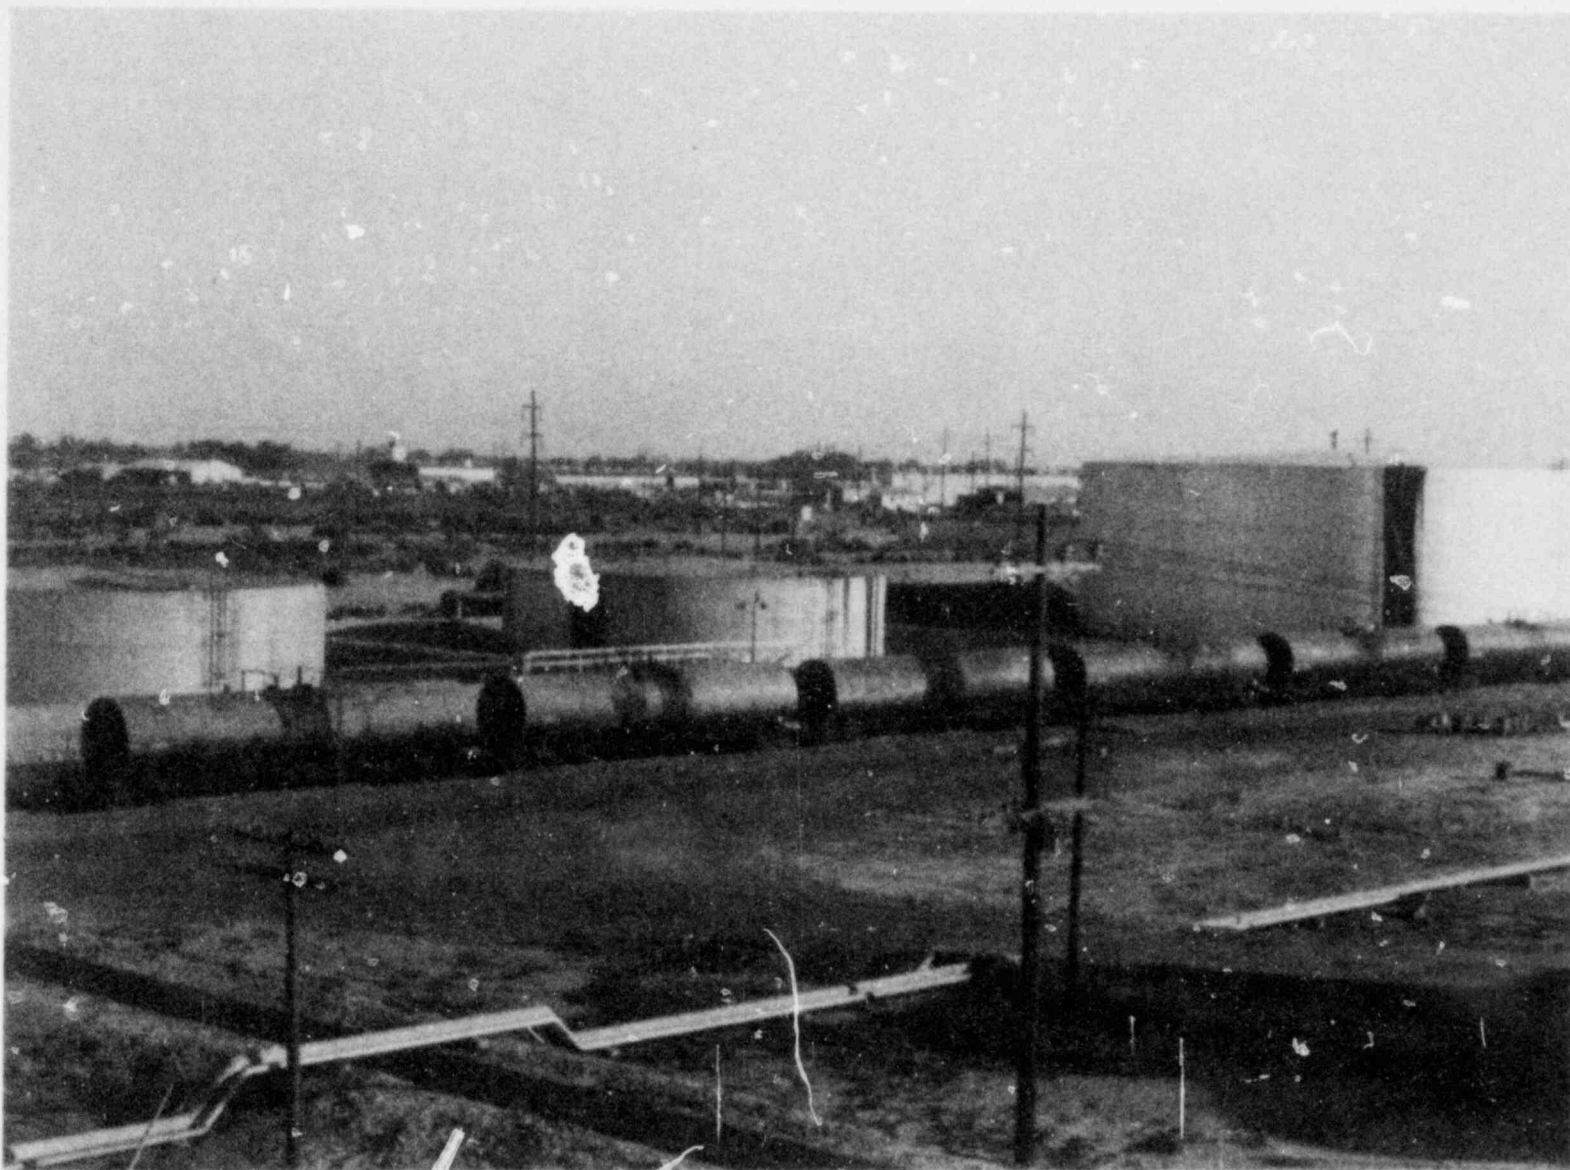
Fig.11. All oil storage tanks except No. 4 were damaged at the roof and leaked oil from the top (from Ref. 6).

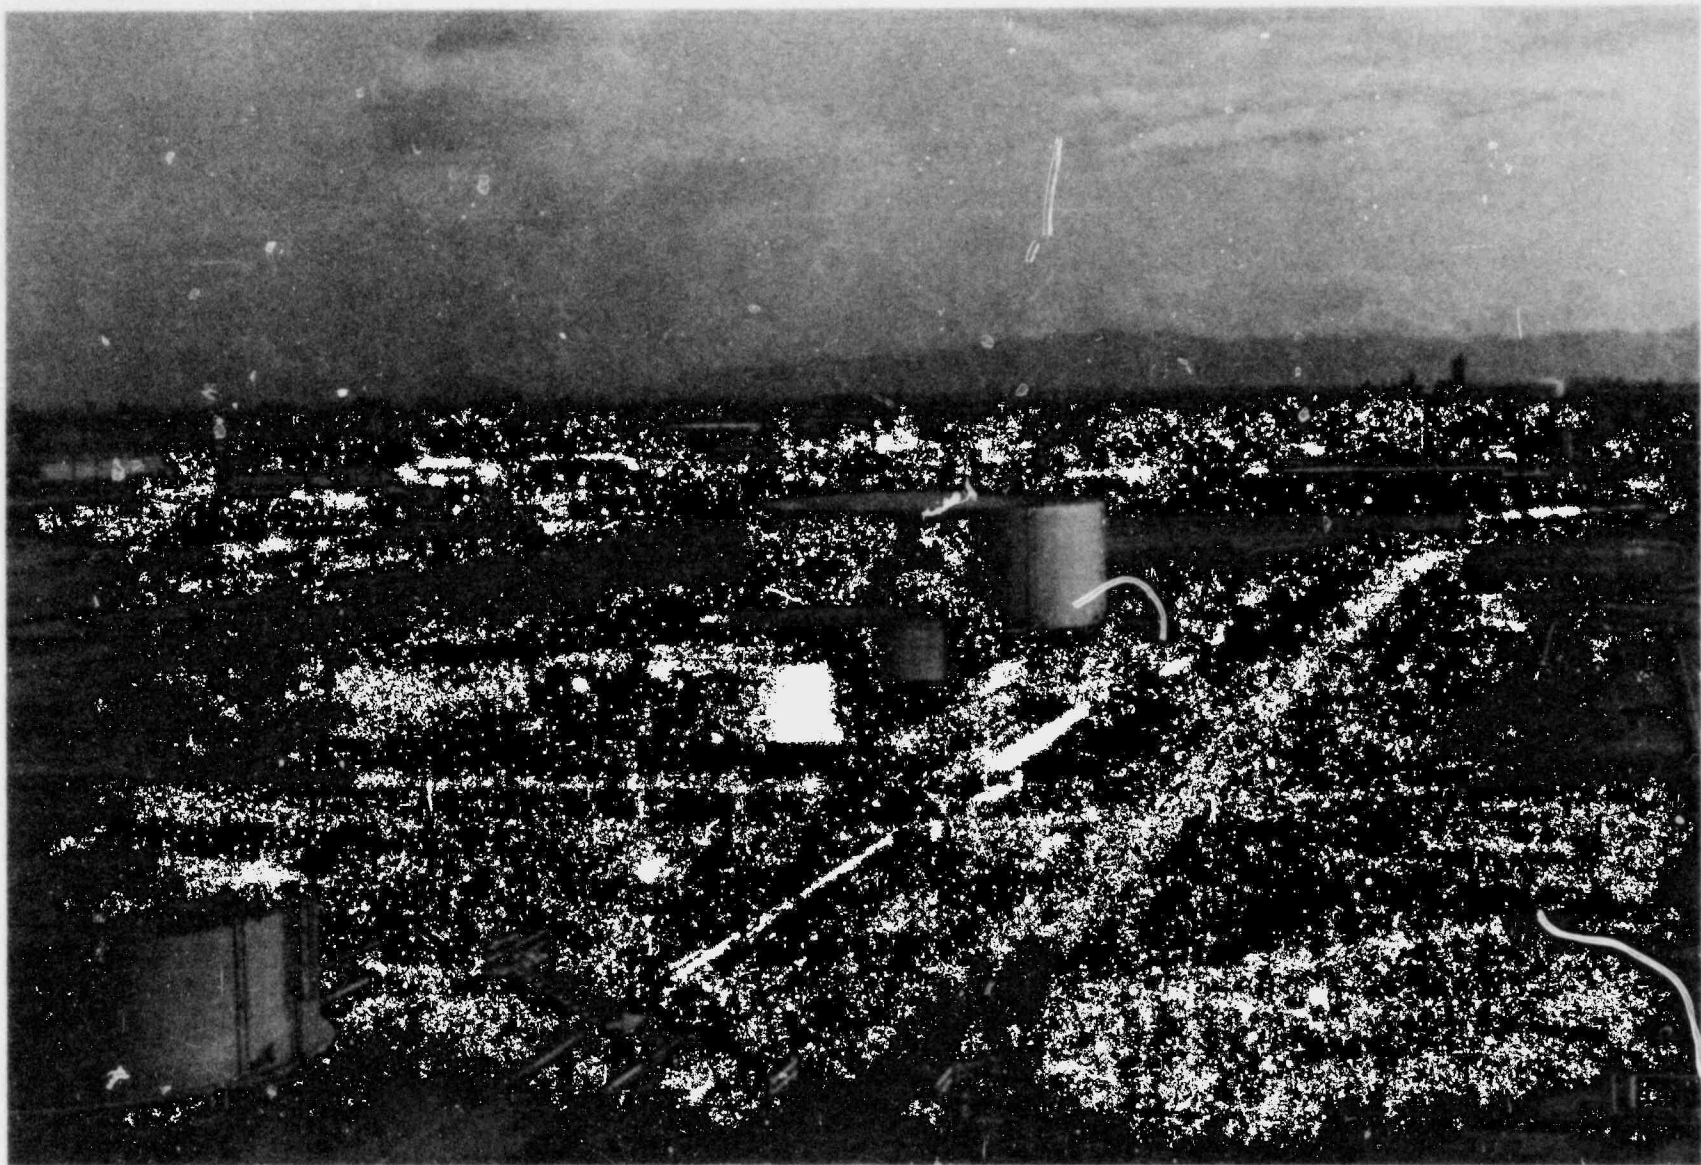
Fig. 12. The large 135-ft-diam tank No. 6 was the most badly damaged.

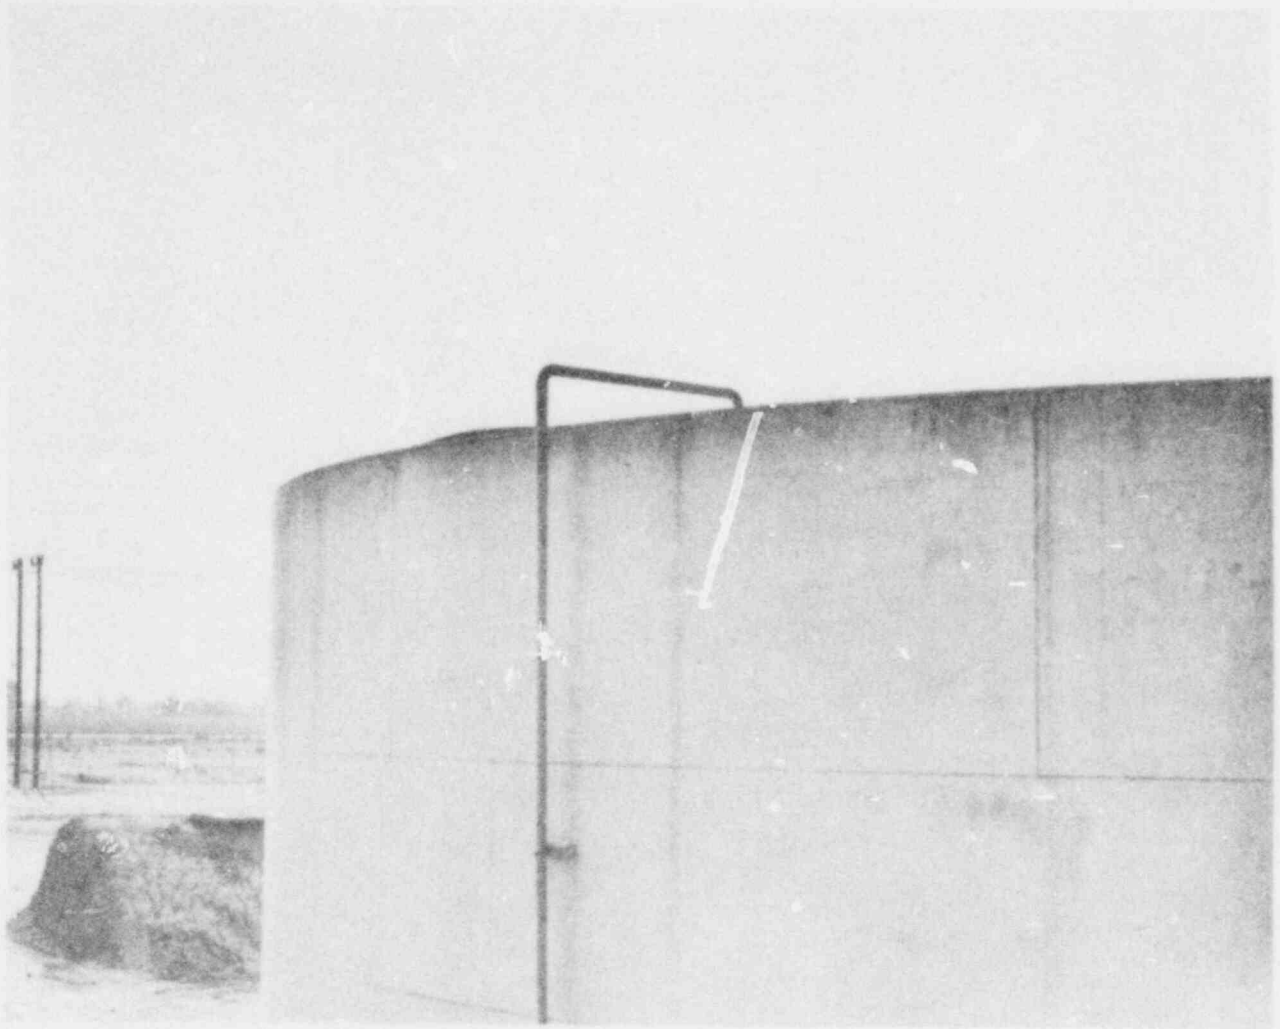
Fig. 13. Tank No. 3 was drained and entry was made during the August site visit. Of the 5 columns supporting the roof, one was badly buckled, causing the roof to sag locally. At about  $90^{\circ}$  from the buckled column, the roof-to-tank wall weld joint had failed, opening up a crack several feet long where fuel oil sloshed out.

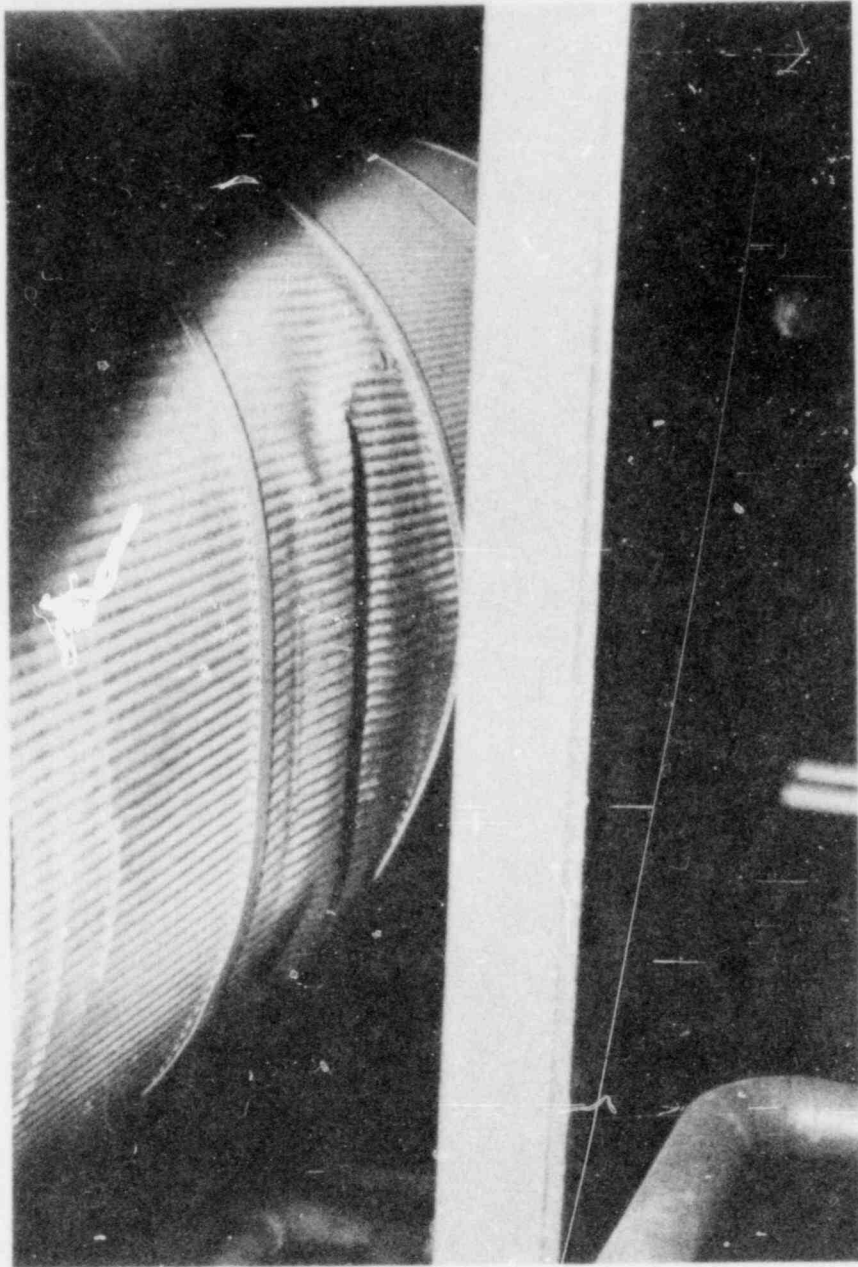
General observations indicate that the piping systems are hung in a more flexible manner than that which would be required by current NRC criteria. For example, the Unit 4 main steam line moved about 1.5 in., impacting a structural steel member and denting its insulation. In most cases, the piping is supported in a similar manner to older operating nuclear power plants, and it may be inferred that the seismic response would be similar. These observations are, on the surface, encouraging since in all cases the circumstances leading to failure are dissimilar to nuclear applications in that damage occurred at weld repaired areas of past corrosive attack or at nonwelded pipe joints.

Fig. 14. The Unit 4 main steam line moved about 1.5 in., hitting a structural member and denting insulation.
