# Characterization of Existing Surface Conditions at Sheffield Low-Level Waste Disposal Facility

Sheffield, Illinois  
Final Report  
July 10 - July 31, 1980

Prepared by  
G. E. Heim, M. V. Machalinski

Harding-Lawson Associates  
125 Windsor Drive  
Oak Brook, IL 60521

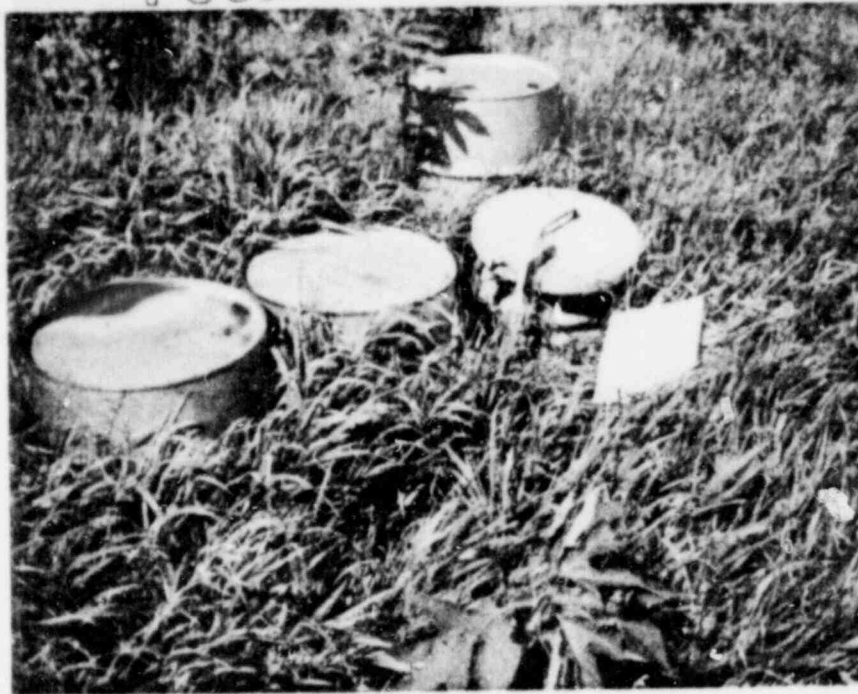
- 1) Three corrugated metal pipe piles capped with concrete lids and covered by steel drums were encountered at 12347N/14470E in the vicinity of Trench 1 (see Fig. 3).

FIGURE 3: Three corrugated metal pipe piles, capped with concrete lids and covered by steel drums; located near 12347N/14470E.

It is recommended that wells and steel pipes desined for abandonment have casings cut-off two feet below ground surface, be backfilled with concrete using the tremie method, capped, backfilled above the cap with six inches of concrete which extends a minimum of two feet from the well or pipe, place a six inch layer of tamped bentonite over the concrete, and place one foot of reworked loess in the remaining portion of the hole to bring the excavation back to grade level. The area should then be fertilized and seeded.

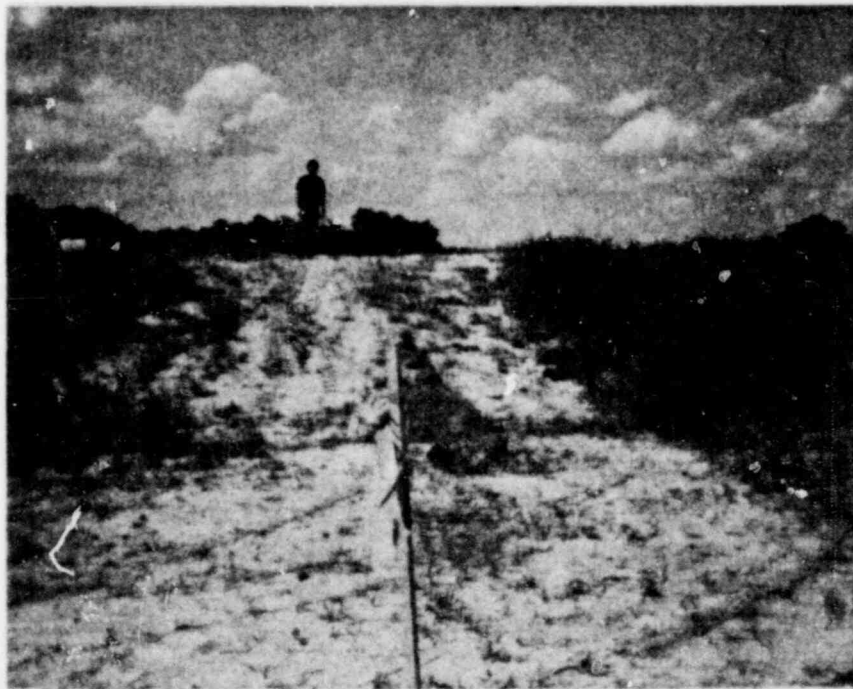
- 1) The roadway leading to the center of the site from the east is located at least partially within the north boundary of Trench 2. This roadway crosses Trench 2 near 14400E (see Fig. 5).

FIGURE 5: Roadway crossing of Trench 2; looking northeast from 12200N/14350E.

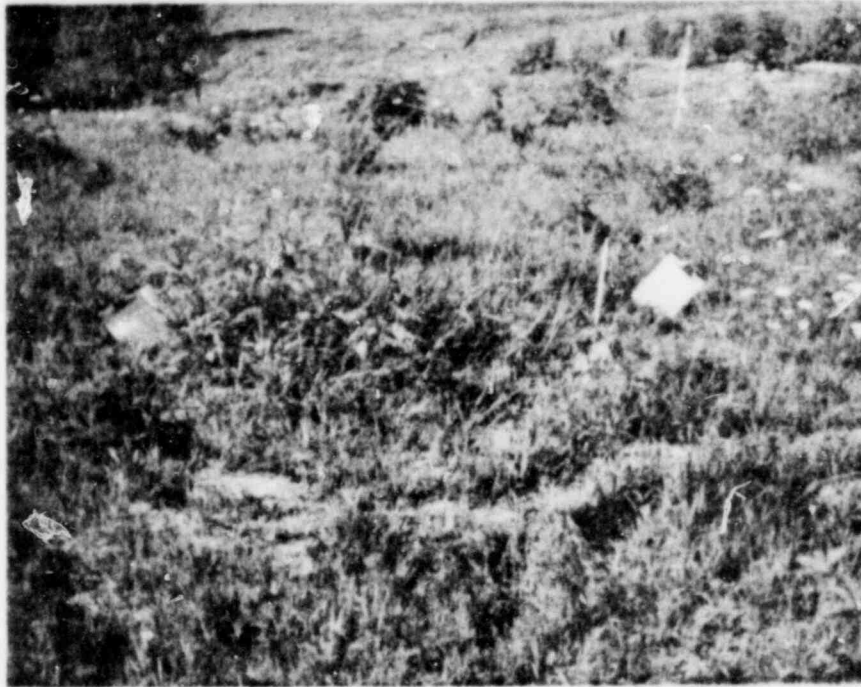
- 1) PCI-1 collapse structure encountered 12216N/14470E. It is 6 feet in diameter and a maximum of 16 inches deep at its western end (see Fig. 8 and 9).

FIGURE 8: PCI-1; clipboards mark the collapse structure limits.

Backfilling requirements for the excavation will depend upon the observations made during excavation. As a minimum it is recommended that a layer of bentonite at least one foot thick after tamping be placed at the base of the excavations. The material overlying the bentonite should also be tamped. Another one foot thick tamped layer of bentonite should be placed two feet below grade elevation. The upper two feet should then be backfilled with reworked loess.

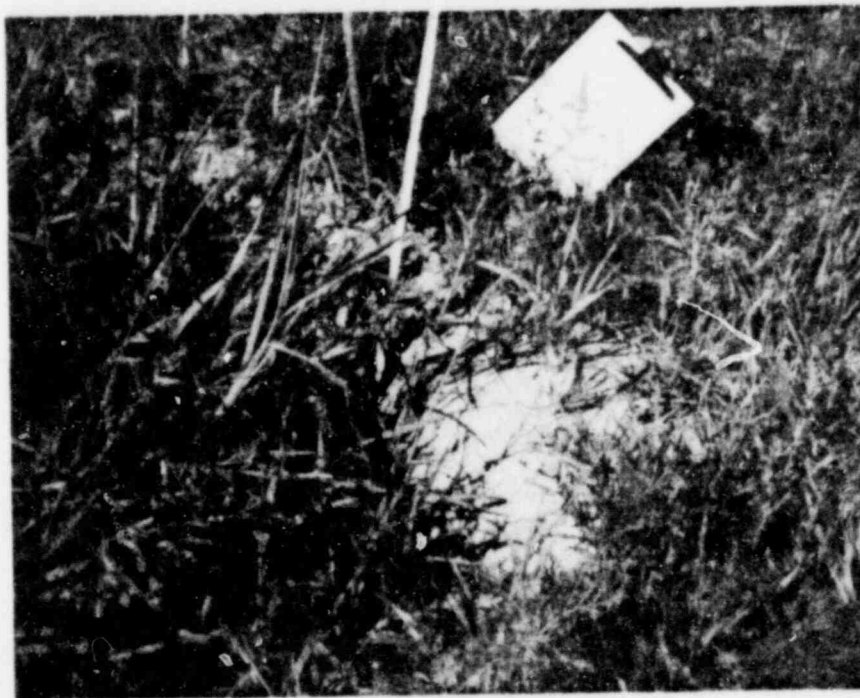
FIGURE 9: PCI-1, western end; the folding ruler was stuck in the deepest part of the collapse structure.

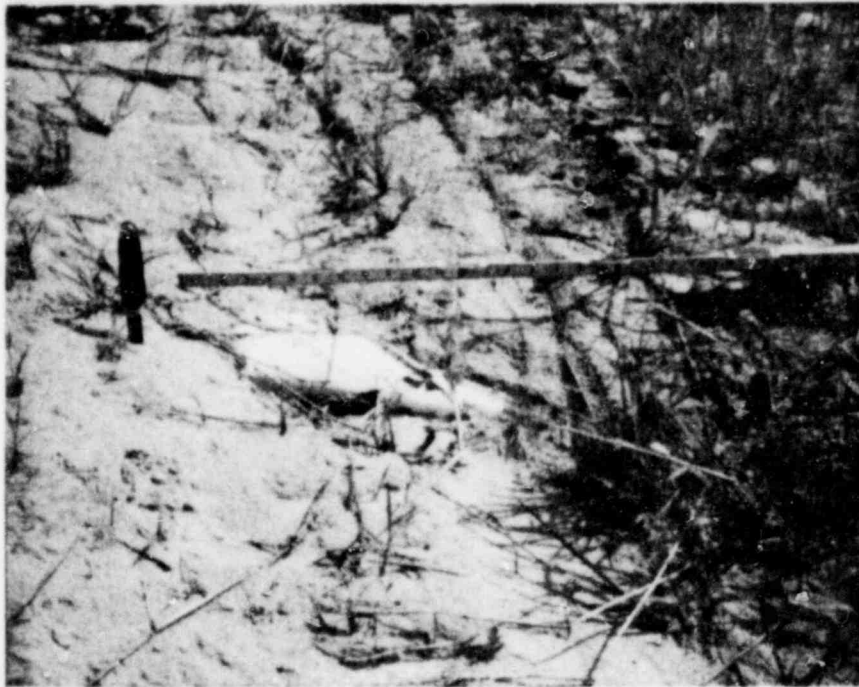
- 1) Plastic sacks were exposed at 12375N/14341E and 12370N/14342E (see Figs. 12 and 13 respectively).

FIGURE 12: Exposed plastic bag; 12375N/14341E.

The area where plastic is exposed at the surface should be hand excavated to determine if this plastic is a container of low level radio active waste. If it is found that the plastic is a low level waste container then the loess cover on this trench should be removed and the trench cap should be reconstructed in accordance with specifications. If the plastic does not represent a storage container, it should be removed so vegetation will grow in this area.

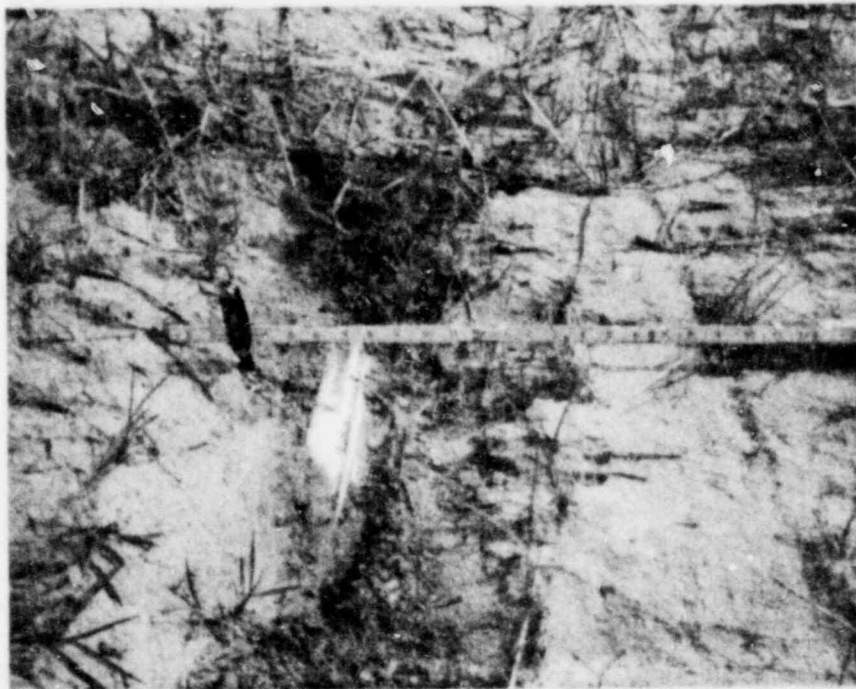
FIGURE 13: Exposed plastic bag; 123470N/14342E.

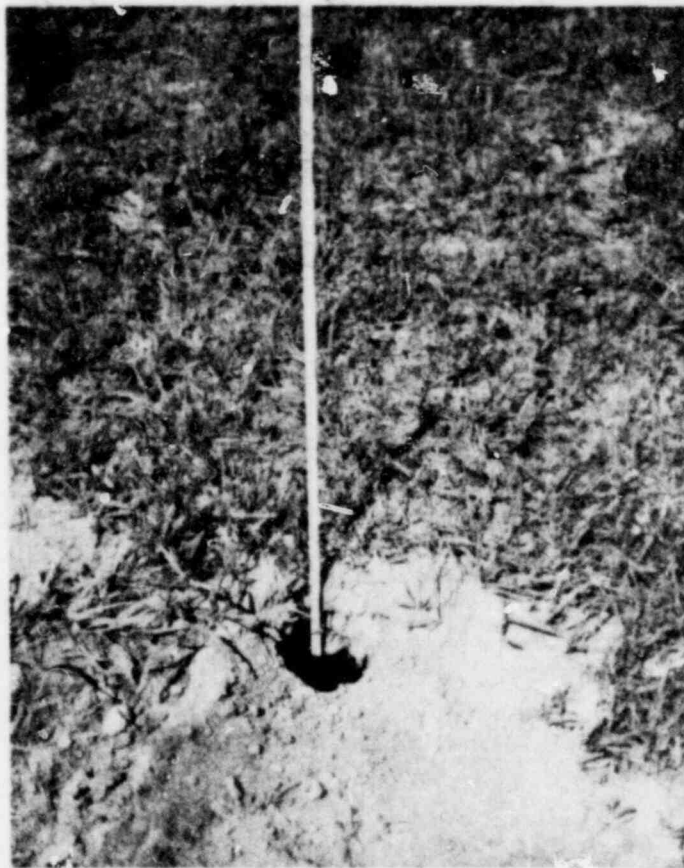
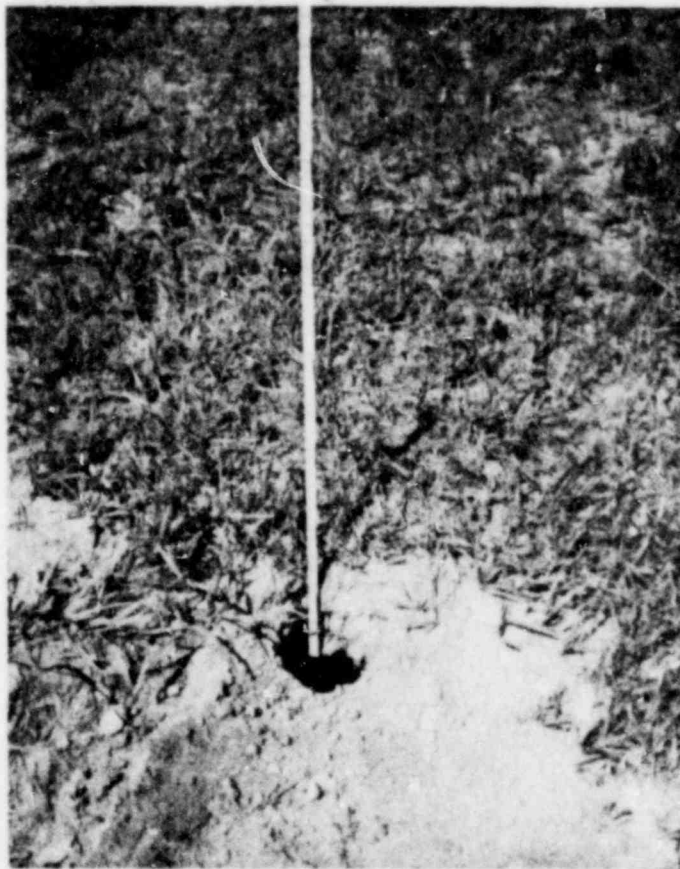
- 1) PCI-2, 9 inch diameter by 20 inch deep animal burrow; located at 11908N/14057E.

FIGURE 17: PCI-2; animal burrow located at 11908N/14057E.

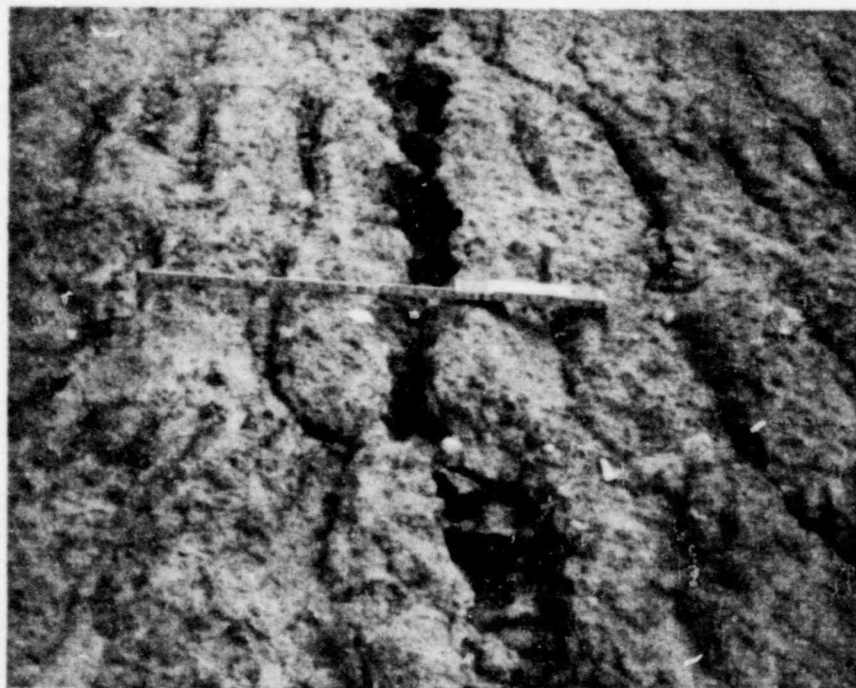
FIGURE 20: Gullying west of Trenches 8A and 8B on slope trending towards the drainage diversion channels.

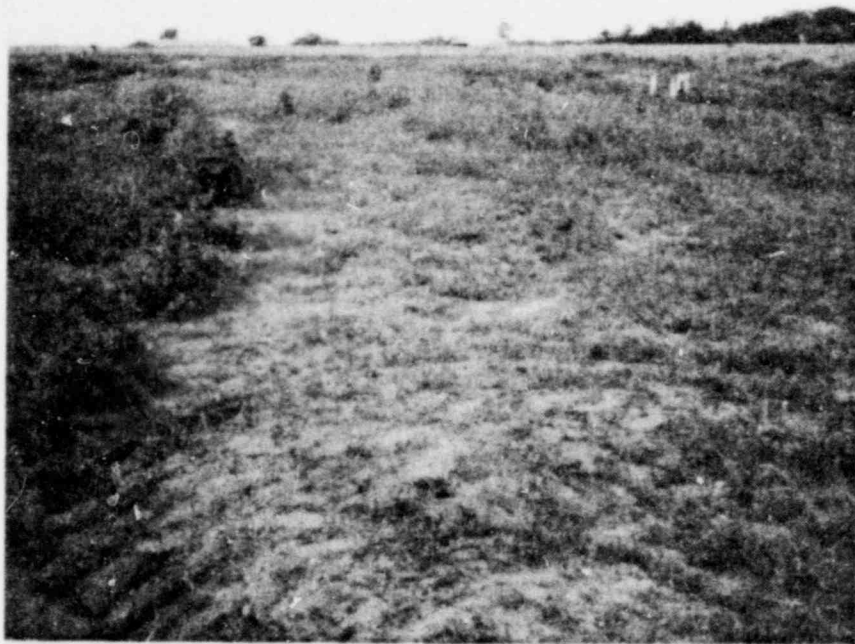
FIGURE 22: Trench 10; looking southeast from its northwest end; typical rilling.

Rills are the result of initial channellization of surface runoff. Areas that are heavily rilled should be regraded by a vehicle that can drag a chain mat to remove any impressions caused by the vehicle wheels or tracks. Grading should be along the contour. Areas that are regraded should be fertilized, seeded, and mulched as quickly as possible.

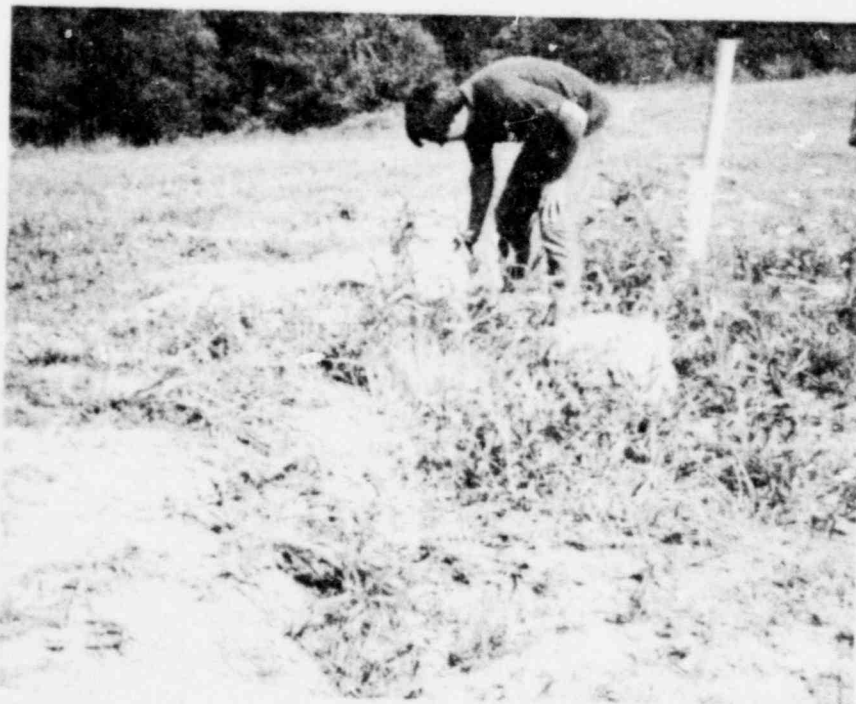
- 1) Northeast side -- gullying; 2 to 3 inches deep; 2 to 4 foot spacings; trending east.
- 2) Southwest side, north half -- minor rilling.
- 3) Southwest side, south half -- G-8 consists of a 4 inch deep gully which passes near the center of Trench 10 at its southeast end. Minor rilling leads to this gully.

FIGURE 23: G-8 at the southeast end of Trench 10.

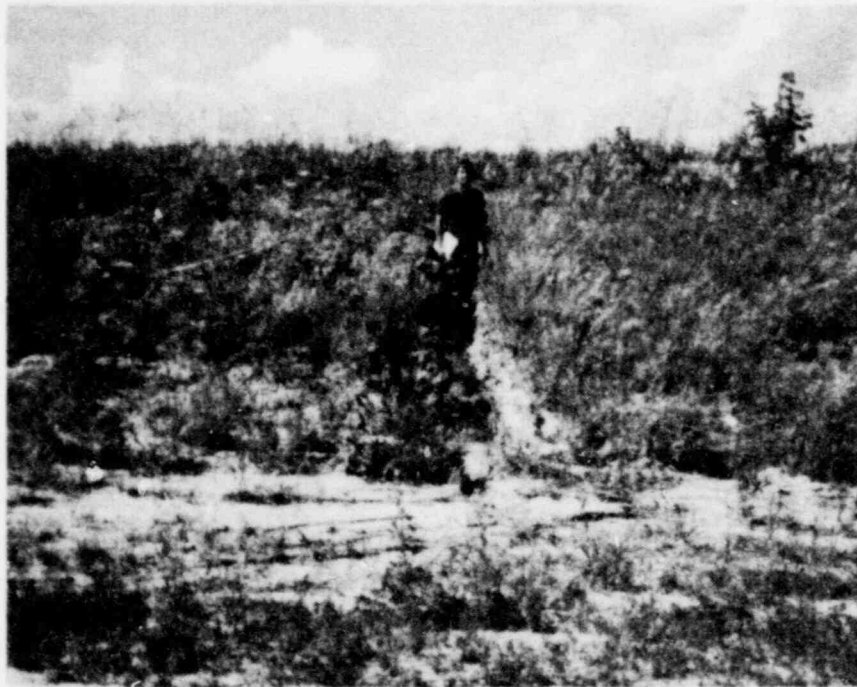
FIGURE 26: G-5; looking north at the transition slope south of the east end of Trench 14.

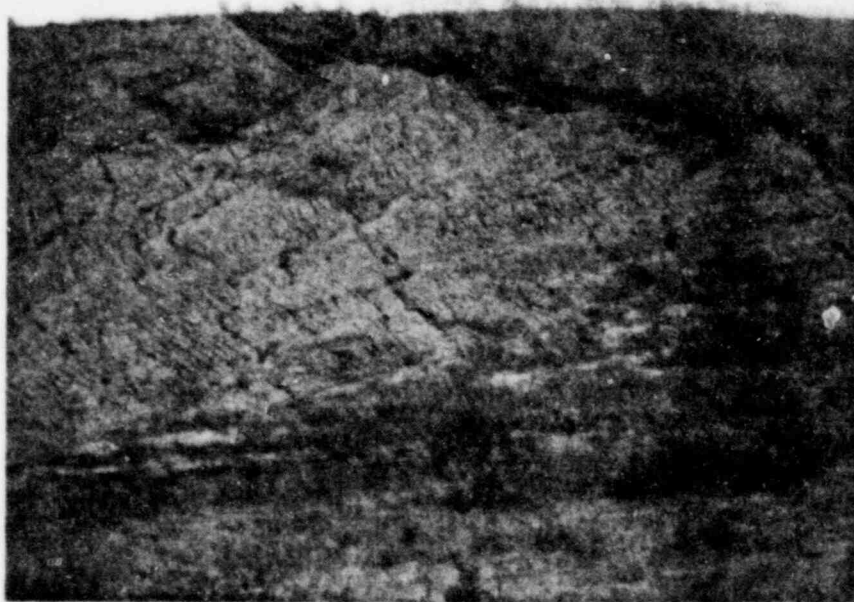
- 4) Major gullies and a crack noted on the transition slope north of Trench 14A:
  - a) G-2, 13880E, 6 inches wide and 36 inches deep.
  - b) G-3, 13967E, several 12 inch deep gullies.
  - c) G-4, at bend in transition slope, two 36 inch wide by 30 inch deep gullies trending northwest meet at 12400N/14200E.
  - d) PCI-3, thin vertical crack at the top of the slope extends from 13862E to 13967E.

FIGURE 28: Transition slope, north bend, near 12600N; gullying in bare area typical of this slope.

It is recommended that these slopes either be regraded or backfilled and regraded so that the final slope is 4:1. Final slopes should be fertilized, seeded, and mulched.

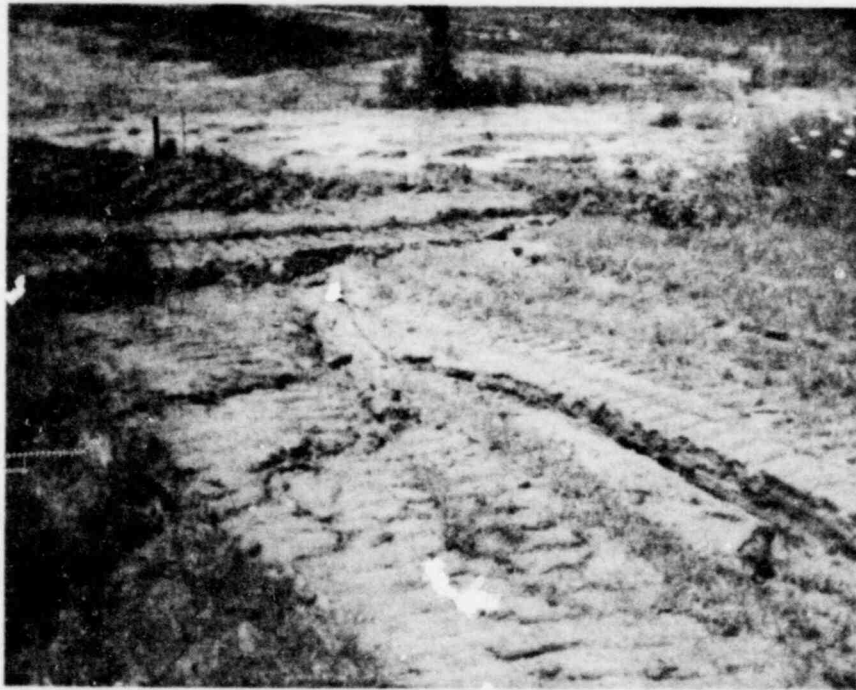
FIGURE 32: G-1; looking northwest from the west end of Trench 23.

Gullies G-1, G-6, G-7, and G-9 appear to be fairly well defined drainageways that have developed at the site. We recommend that these gullies be hand cleaned, removing irregularities and any vegetation that may be present. The gully floor should then be tamped and backfilled with crushed rock. The thickness of crushed rock should equal the depth of the gully.

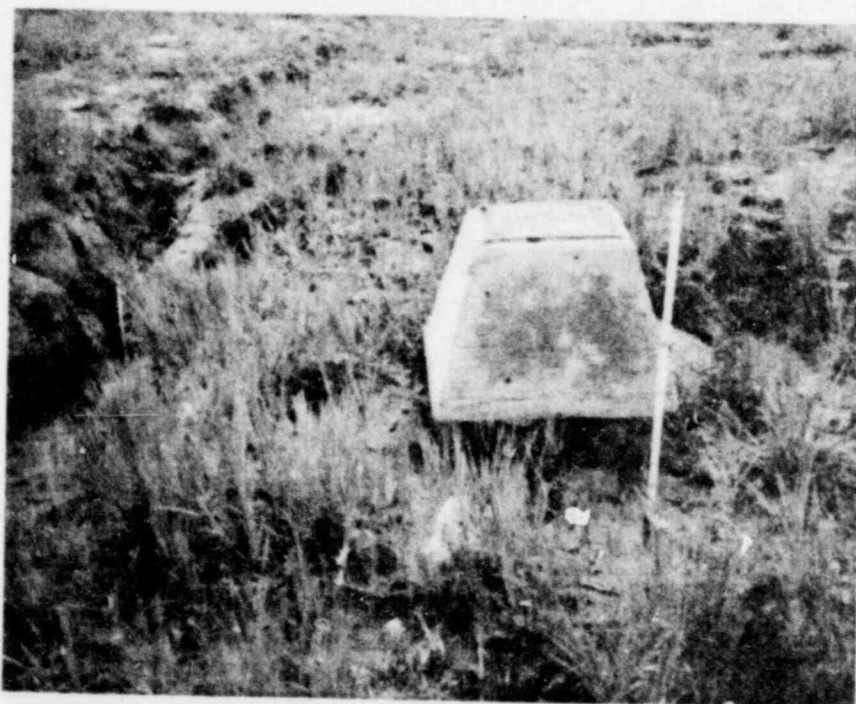
FIGURE 34: Erosion at Trench 24 west monument.

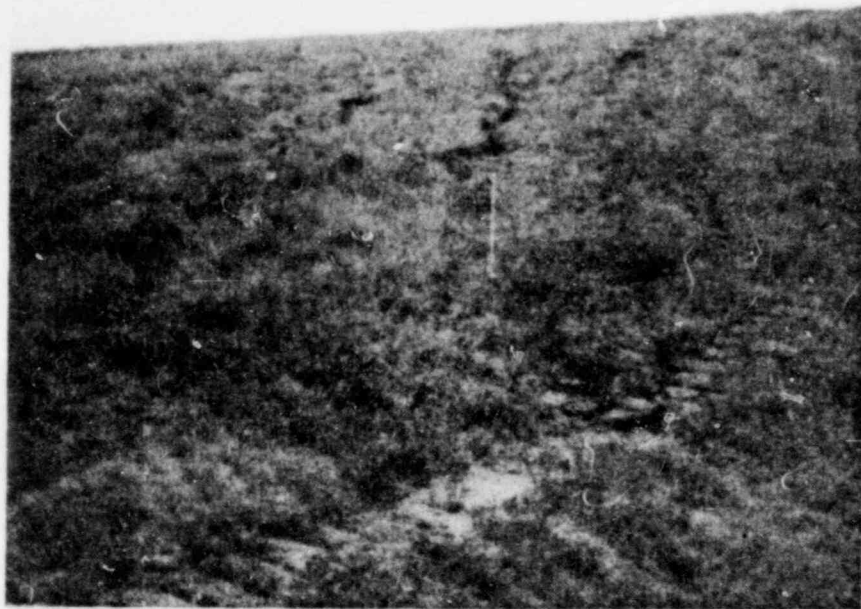
- 2) 14420E to 14600E -- gullying from the middle to the north end of the trench; 4 inches deep; 2 to 3 foot spacing; north trending.
- 3) 14600E to east end -- densely rilled and gullied from S-3 north; 2 to 4 inches deep; 0.5 to 1 foot spacing; north trending (see Fig. 35).

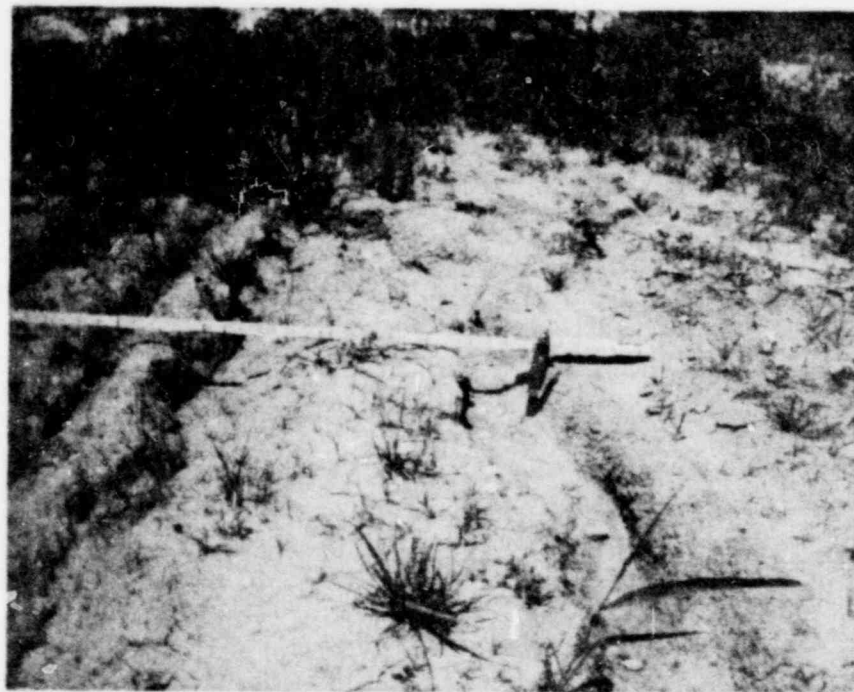
FIGURE 36: Trench 24; rilling and gullying at its northeast corner.

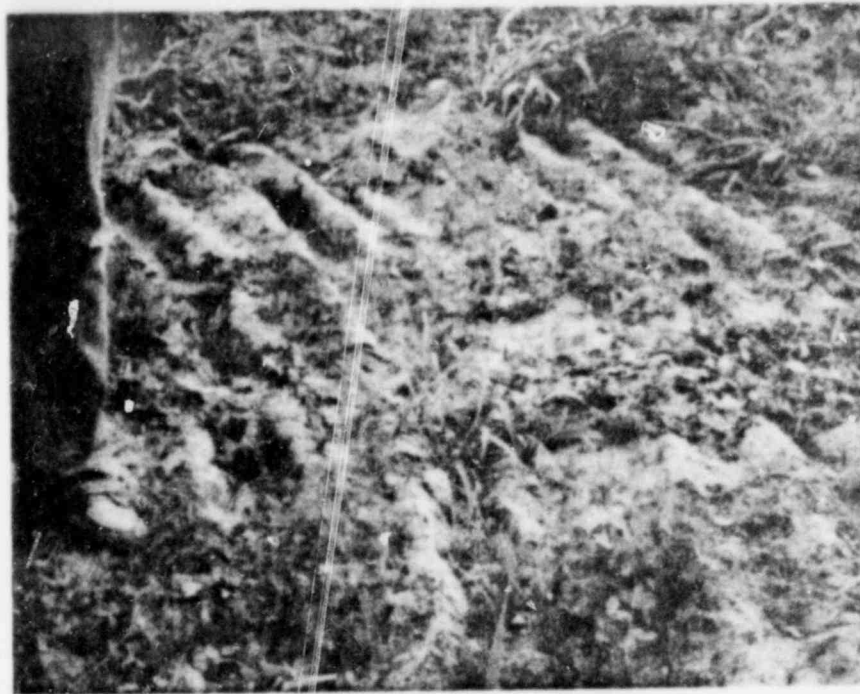
FIGURE 41: Trench 26; rills and gullies in its northeast corner.

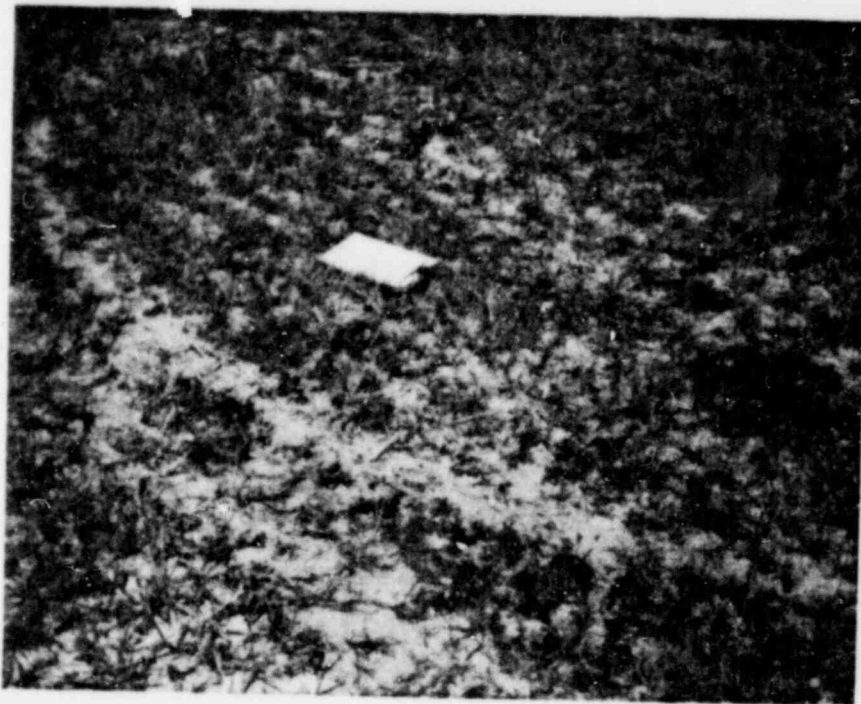
There is a mowing program in effect at the site and the mowing is done on a periodic basis. Vegetation is cut to a height of approximately four inches. It was noted during the mowing operation that the blade of the mowing machine often cut into local high spots leaving them devoid of vegetation. Also, when the tractor pulling the mowing machine turns, the tires cut into the soft surface soil and the vegetation is often destroyed in the tractor track (Fig. 42).

FIGURE 42: Tractor tire tracks located north of the northwest corner of Trench 5.

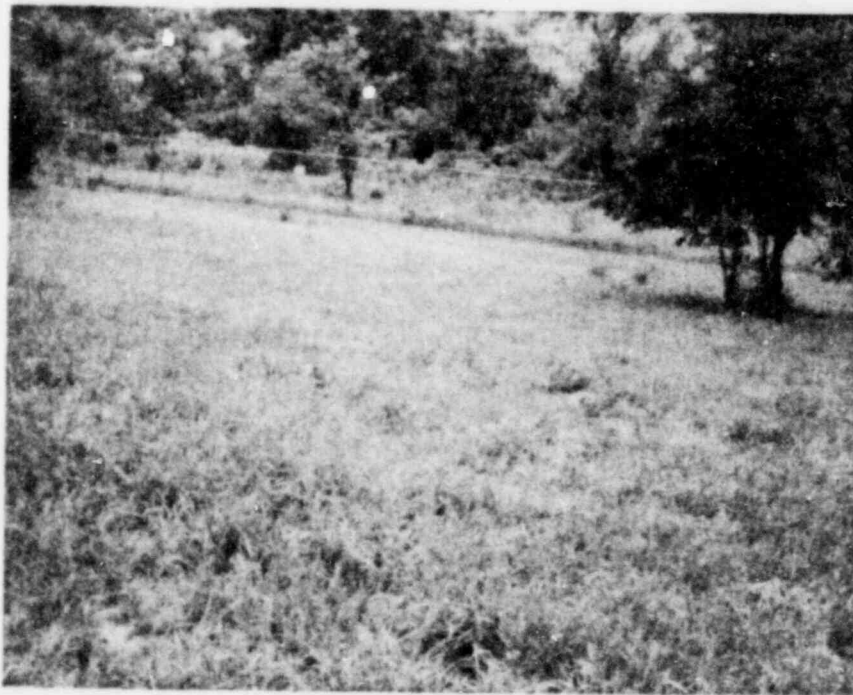
Figure 43 shows the area located south of Trench 7. This southwest trending  $10^{\circ}$  slope is covered by a thick, grass vegetative cover, and has only minor rilling and occasional gullying. The trees shown are located outside the trench limits.

FIGURE 43: Slope at site southwest corner; looking southeast from the west end of Trench 7.

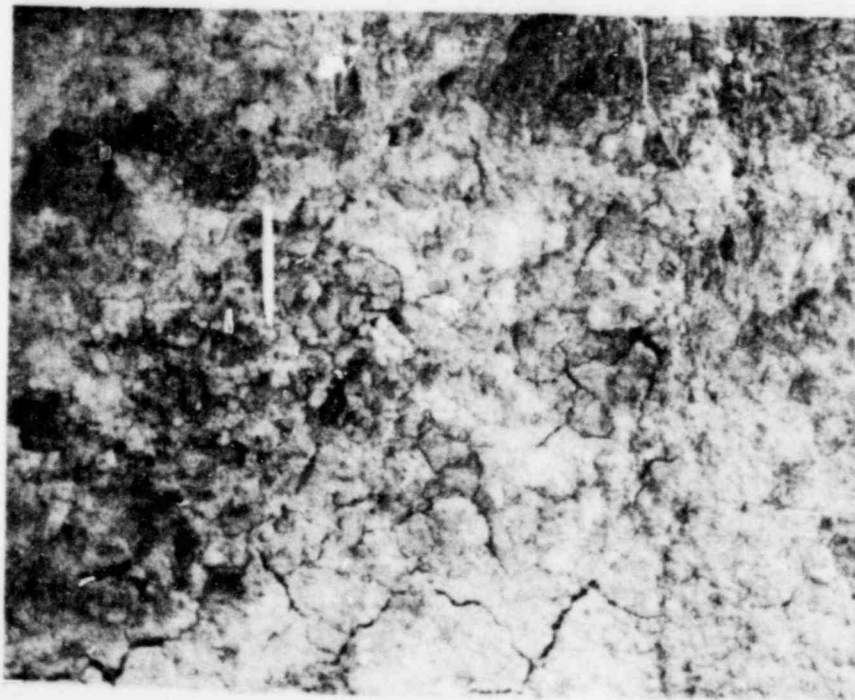
During our site investigation a drainage diversion channel (DDC-1) was being formed to drain the center of the site to the north. This channel runs from 12200N/14300E to the southwest corner of the wooded area located in the site's northeast corner. It is 4 feet wide at the bottom with sloped sides (see Figures 48 through 50). Material exposed in its cuts consisted primarily of silty soils with some clay (see Fig. 51).

FIGURE 51: Cut face in DDC-1; east slope at 12570N/14300E; redder materials are clay soils.

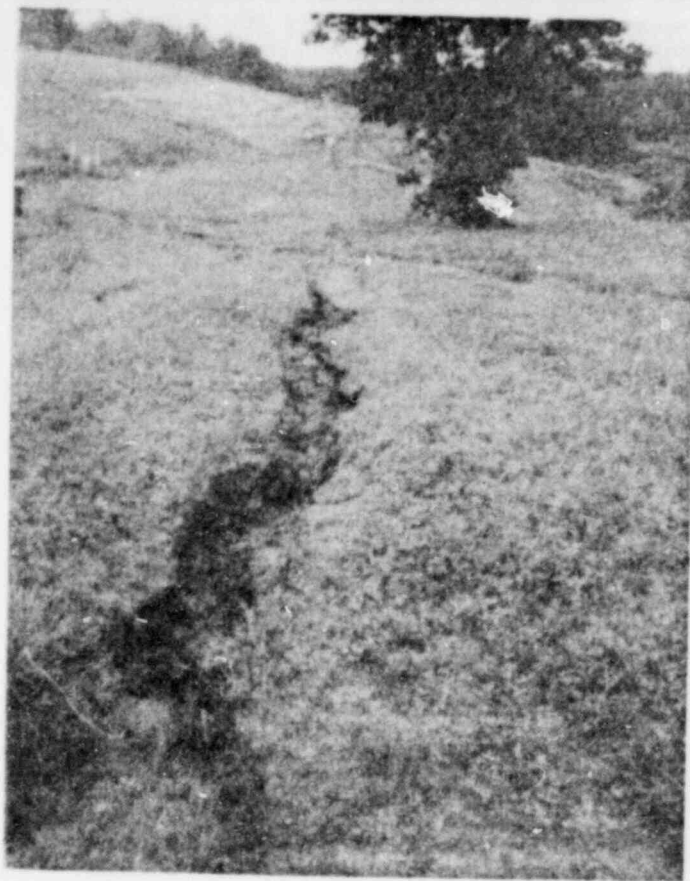
G-9 extends from the southern limit of Trench 3 to the head of DC-2. Its north half is generally 24 inches deep and passes immediately west of Trench 11 (see Fig. 54). Its southern half is lined with 1 to 4 inch diameter gravel for a depth of 1 to 4 inches and a width of 17 feet (see Fig. 55, background). This gravel lined portion has an eroded channel 12 inches deep and 36 inches wide (Fig. 56).

FIGURE 54: G-9; looking south from 12155N/14440E.

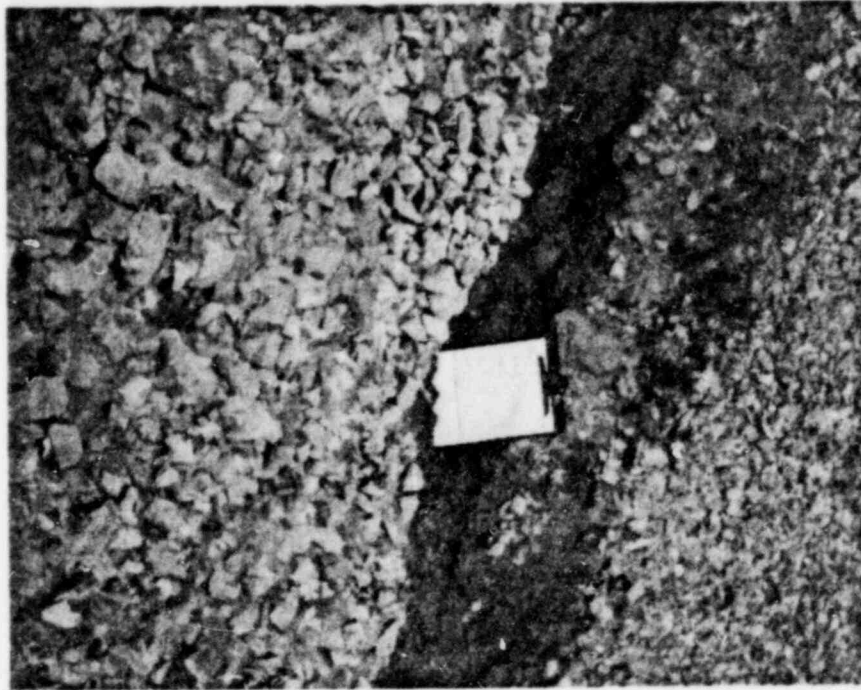
Several gullies which are over one foot deep are indicated on Plate 4 and were sketched in from field observations. Several gullies on the transition slope north of Trench 14A disappear into a subsurface channel on the side slope and reappear at a lower elevation. A repair of the lower portion gully G-9 was attempted by placement of crushed limestone along the gully (Fig. 55). The thickness of crushed stone ranges from one inch to four inches. Erosion subsequent to the placement of the stone has resulted in the formation of a one foot deep gully within the broader gully area (Fig. 56).

FIGURE 56: G-9; eroded gully in gravel lined section.

Severe gullying is occurring along the natural slope at the south end of the site adjacent to DC-2. It is recommended that a gravel lined drain be constructed near the crest of the slope to intercept surface water. The drain should be graded to lead into DC-2. The interception will reduce the rate of development of the gullies.
