UNIVERSITY OF MISSOURI RESEARCH REACTOR FACILITY

TEST REPORT

TESTING OF A RADIO-ACTIVE MATERIAL SHIPPING
CONTAINER TO THE REQUIREMENTS OF THE ATOMIC
ENERGY COMMISSION REGULATION 10CFR, PART 71

September 29, 1966

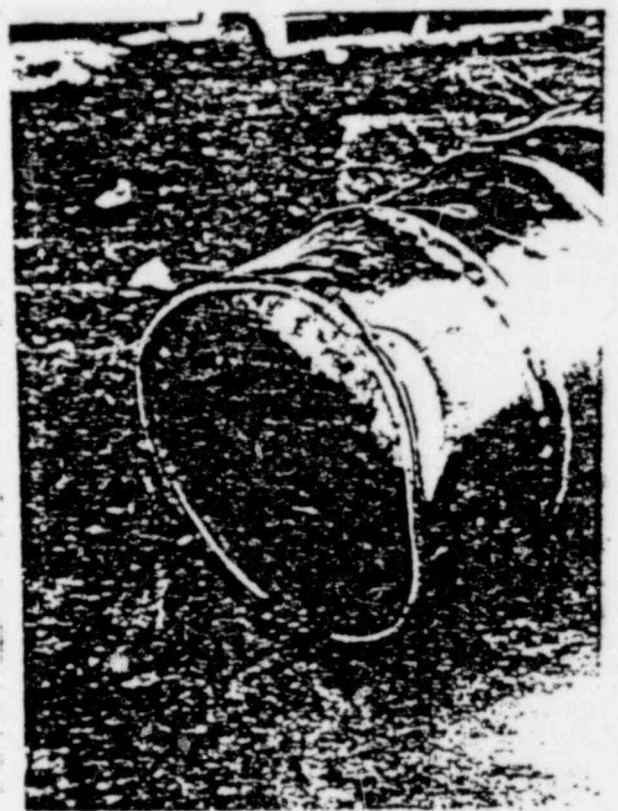
As shown by Plate #4, we lifted the barrel with a fork lift and a rope, on an angle, and cut the rope to drop the barrel free. The corner was dented in approximately three inches for a nineteen inch span as is evident from the photographs in Plate #4. We consider it significant that the screening over the drain hole did not tear loose in this test but remained in position and retained the vermiculite in the annular area. Examination of the barrel and contents externally and internally revealed no further damage.

FIG. 8 DAMAGE CAUSED BY
DROP

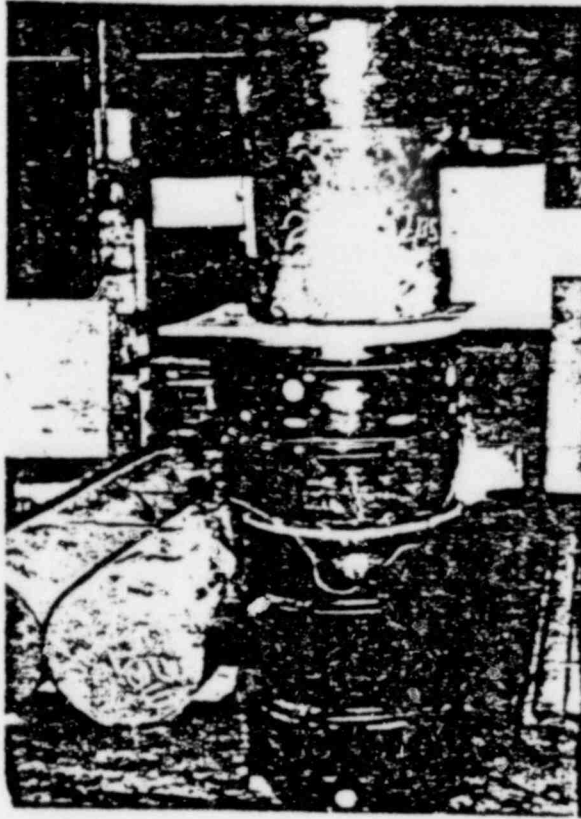
PLATE V COMPRESSION TEST

Plate #5 shows the barrel during the compression test which we maintained for seventy-two hours. As anticipated, no change whatsoever occurred.

FIG. 9 COPPER CRUCIBLES USED FOR WEIGHTS

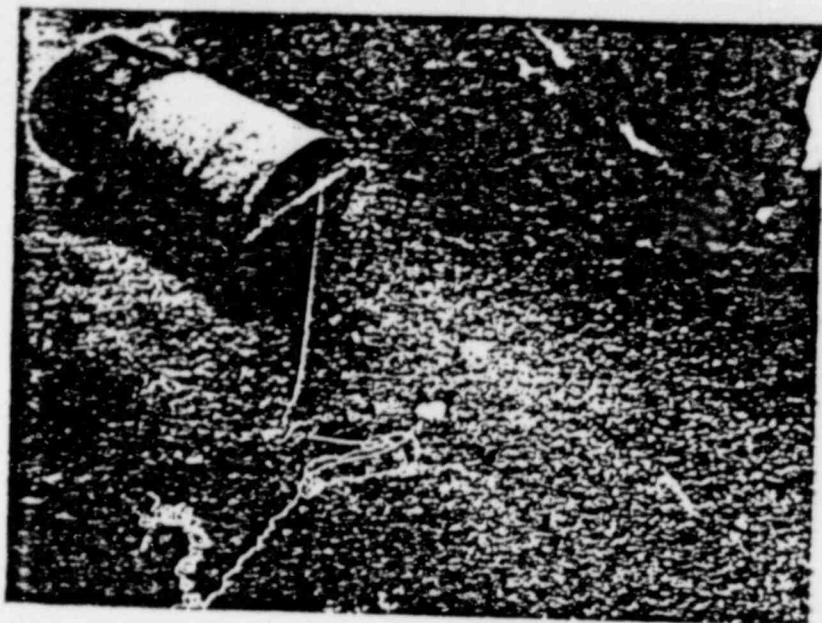
The top of the barrel, as anticipated, came partially off of the barrel. It is believed that the strap prevented the top from falling off until the top and barrel were sufficiently crushed together so that they were essentially one unit and could not be separated by normal means. A small amount of vermiculite flew out of the barrel on impact as a fine spray for about ten feet. Loss of vermiculite by this effect was small and when the barrel was stood up, the vermiculite still

FIG. 12 BARREL AS IT LANDED.
NOTE FINE SPRAY OF VERMICULITE
AND LACK OF MAJOR VERMICULITE
LOSS.

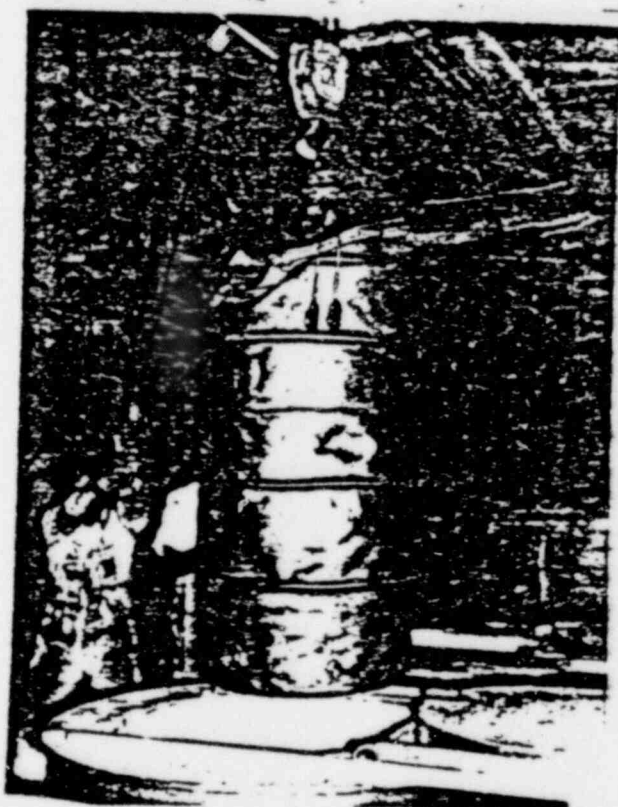
This test was conducted by placing the barrel in a large furnace. A thermocouple was located in the inner barrel by means of a Conax fitting through the barrel lid. Plate #9 shows the barrel as it was being removed from the furnace. It can be noted in this plate that handling hooks were welded on the outside of the barrel for this test. For one hour from initiation of test, that is thirty minutes after removal from the furnace, there was absolutely no temperature change. Over the next two-hour period, the temperature gradually rose to a maximum of 185°F because of the large quantity of vermiculite involved. Fifteen hours later, the temperature was still 160°F in the center. Examination of the contents indicated absolutely no damage to the inner container or its contents, including the polyethylene wrapping on the dummy fuel elements and the cardboard tubes. Plate #10 shows the internal and external barrels after this test. (See Appendix A for repeat of this test with vermiculite removed from top of container.)

FIG. 18 BARREL BEING REMOVED.
PICTURE DOES NOT SHOW THAT IT
WAS CHERRY RED.

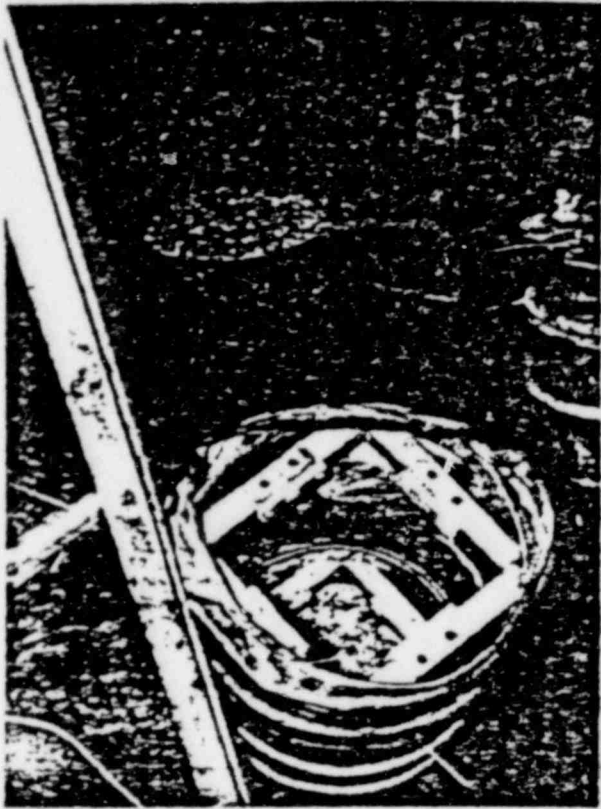
FIG. 19 INTERIOR OF EXTERNAL BARREL. NOTE COMPLETE LACK OF SIGNIFICANT DAMAGE.

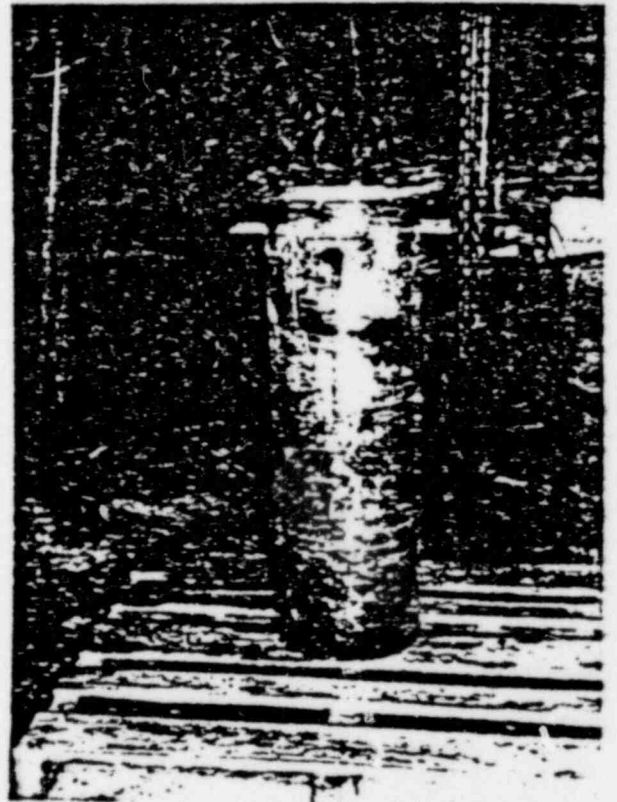
FIG. 20 INTERNAL BARREL. NO VISIBLE DAMAGE OR DIMENSIONAL CHANGE.

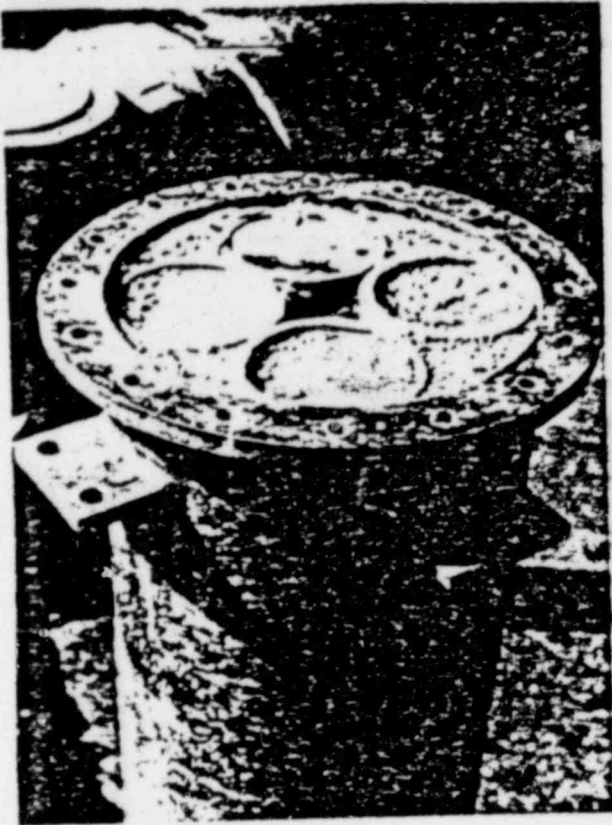
FIG. 23 CONTAINER OPENED
SHOWING VERMICULITE AND
CARDBOARD TUBES.
