Subj: Water in IA

SUBJ: Water in Service air & hot air

Subject: WATER IN THE INSTRUMENT AIR LINES AT THE CONDENSATE POLISHER CONTROL PANEL AND REGENERATION SKID RESULTING IN A LOSS OF FEEDWATER CONDITION IN UNIT #2 ON OCTOBER 19, 1977  
Location TMI Nuclear Station  
Middletown, PA 17057  
Date November 14, 1977

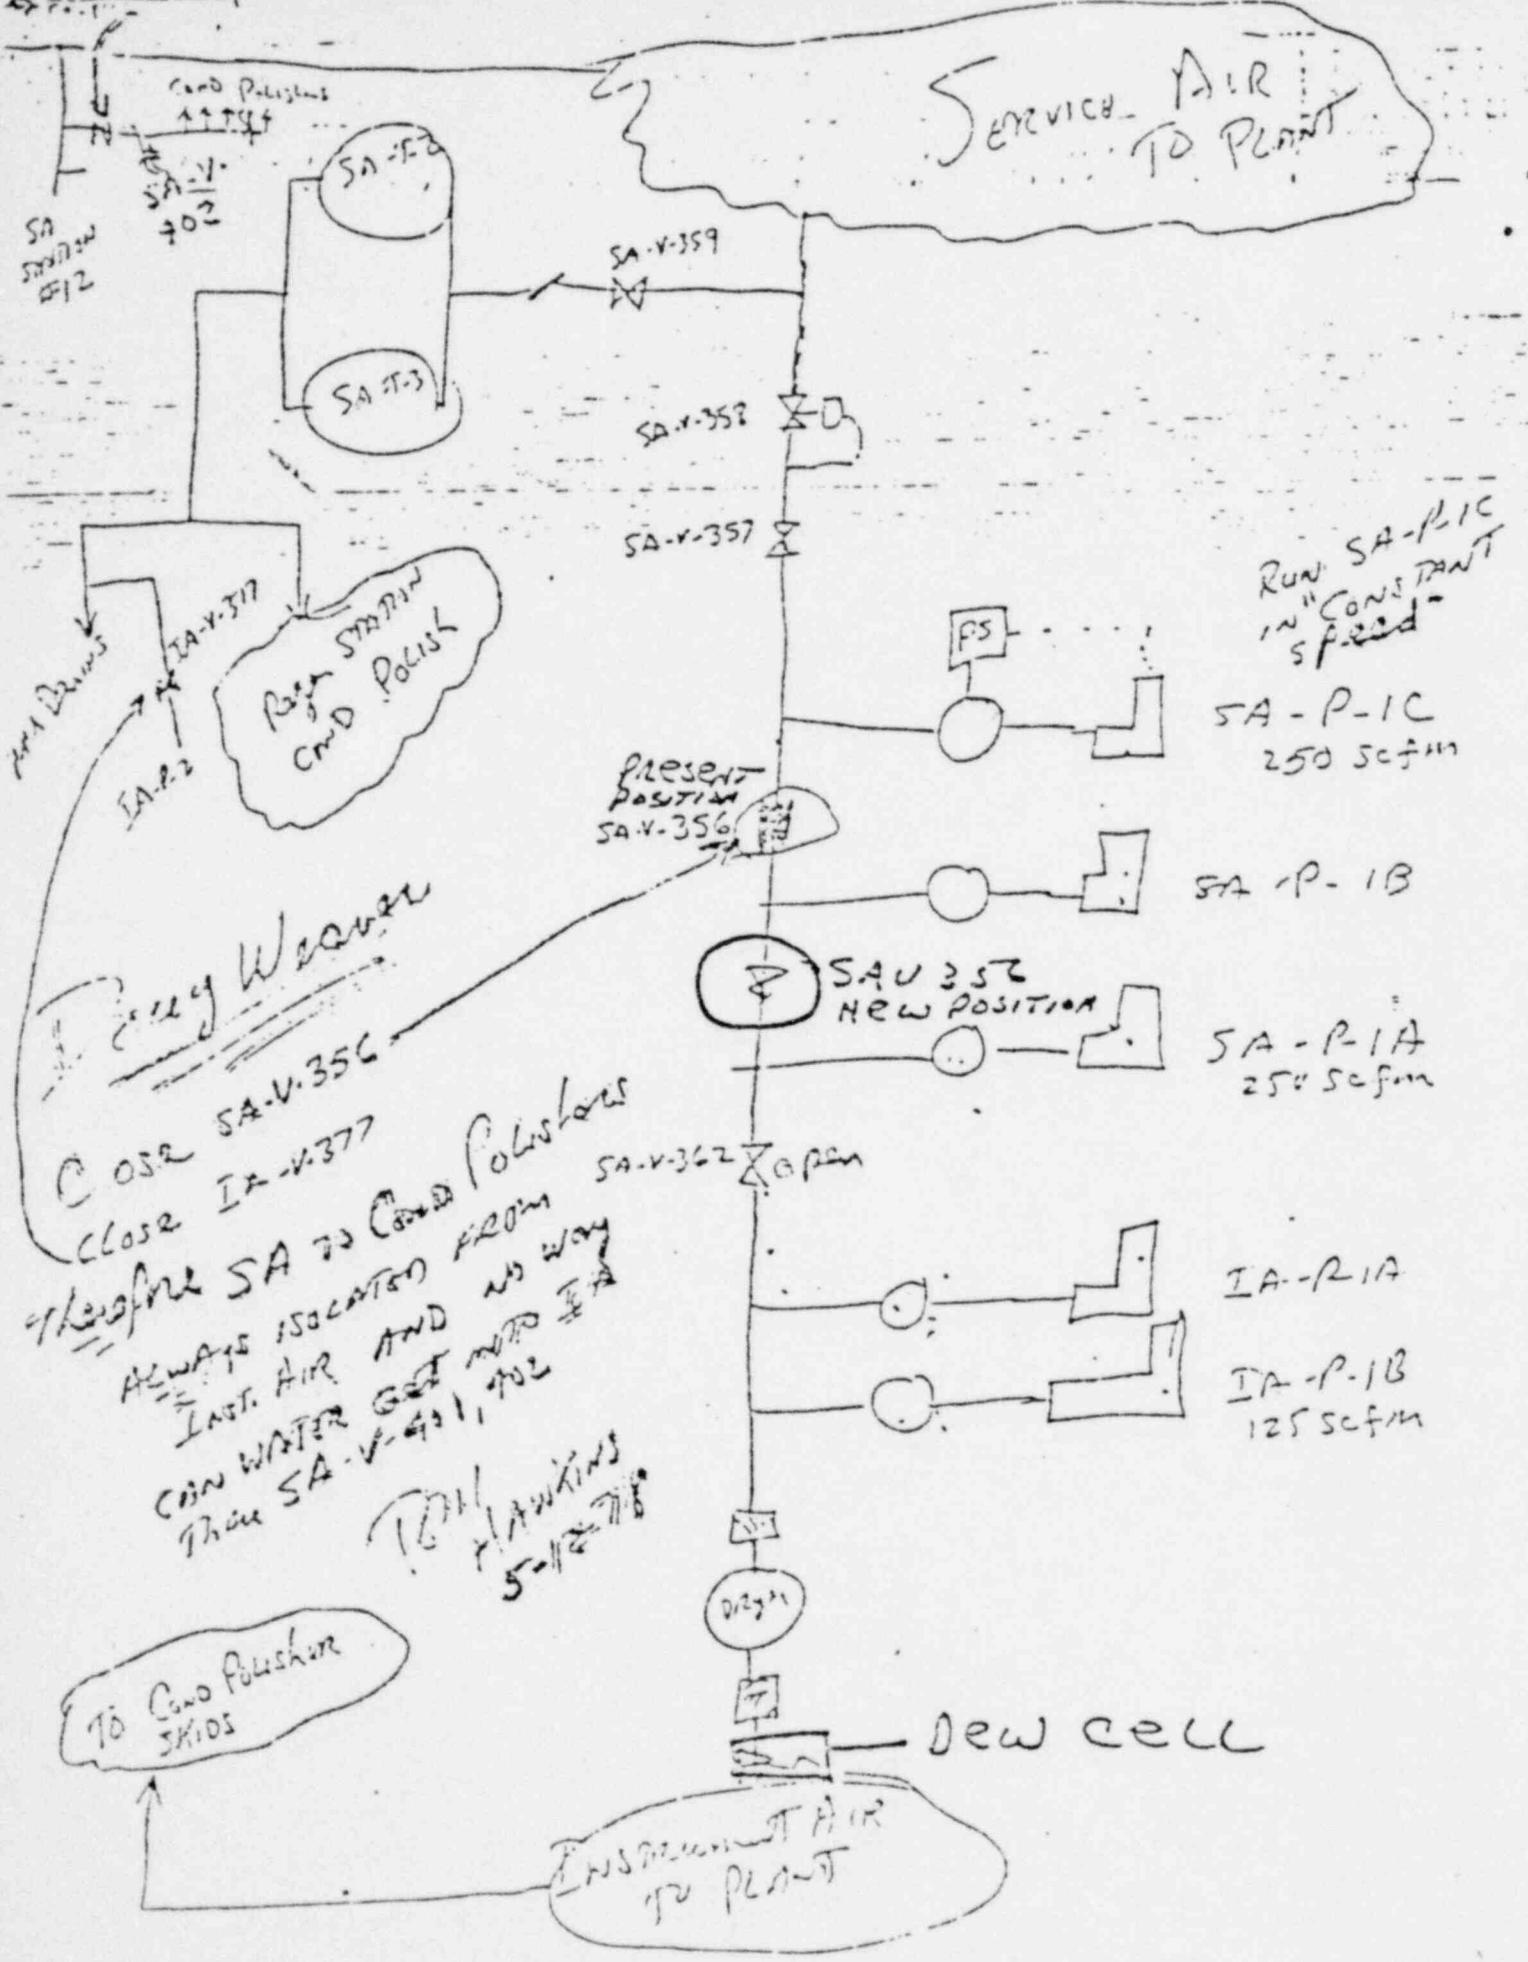
It's time to really do something on this problem before a very serious accident occurs. If the Polisters take themselves off line at any high power level the resultant damage could be very significant.

1. CDV12 - must be made an automatic valve that ~~opens~~ on High Polister OP  
OPENS
2. SAV 356 - Move valve to between SA-P-12 and SA-P-1A. Keep this valve shut at all times to isolate SA. + I.A.
3. Install inline Dew cell instrument downstream of air dryer. This should be made to alarm and record.

Close SA-V-356  
Close IA-V-377  
Therefore SA to COND POLISH  
ALWAYS ISOLATED FROM  
INST. AIR AND NO WAY  
CAN WATER GET INTO IA  
THRU SA-V-401, 402  
TOTAL PLANNING  
5-11-78

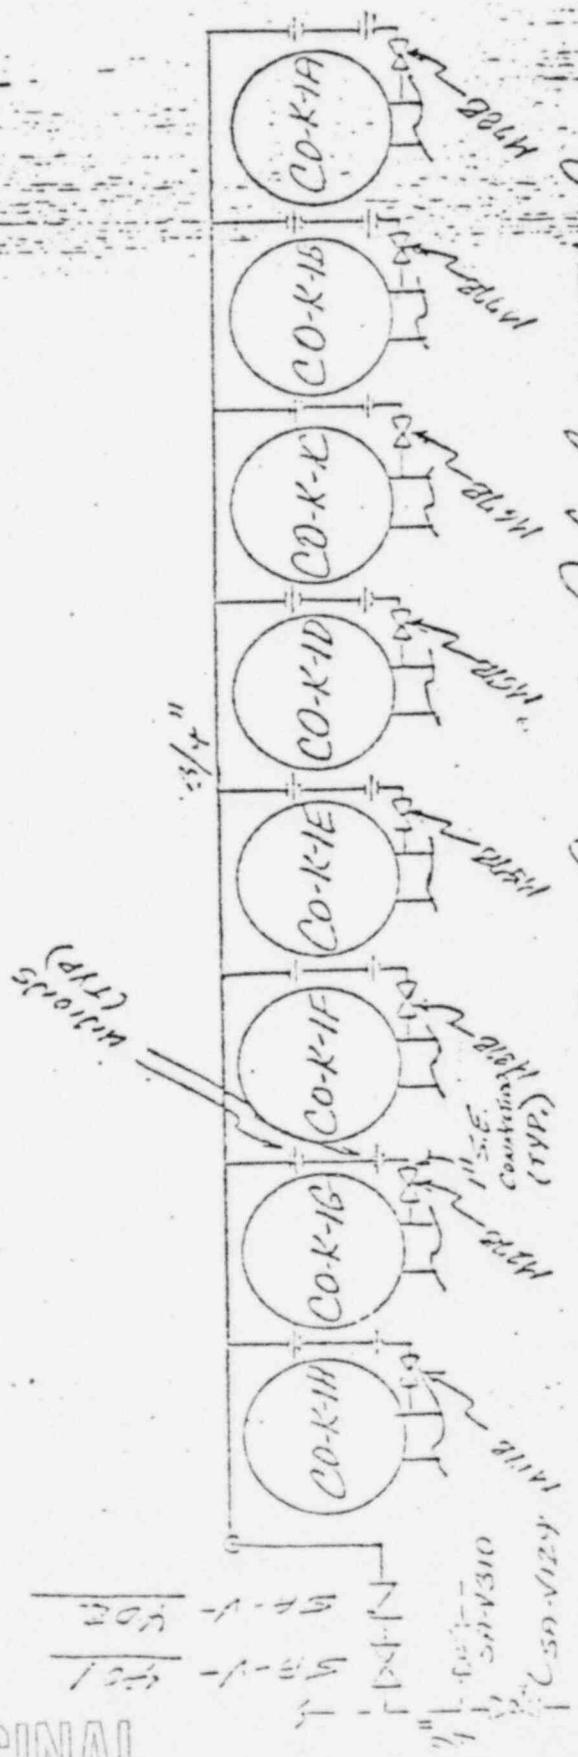
Attachment 1 of 2  
 ECM No. S-4512

GPU Request to provide permanent S.A. supply to the bottom of each Condensate Polisher to lift & fluff resins prior to sluicing to Regeneration Station.

UEC START-UP TO CONNECT 3/4" Line spec. 150-1, piping at S.A. STA. NO. 12 and field route to a 3/4" C.S. gate valve and check valve. From the check valve field run the header and branch lines to each Condensate Polisher valve M17B then M97B. (see attachments 1 and 2 of 2).

All Piping To Be 3/4" 450-1  
 And Field Run By MEC STARTUP
