UNITED STATES
NUCLEAR REGULATORY COMMISSION
OFFICE OF INSPECTION AND ENFORCEMENT
WASHINGTON, D.C. 20555

July 31, 1980

IE Bulletin No. 80-20

FAILURES OF WESTINGHOUSE TYPE W-2 SPRING RETURN TO NEUTRAL CONTROL SWITCHES

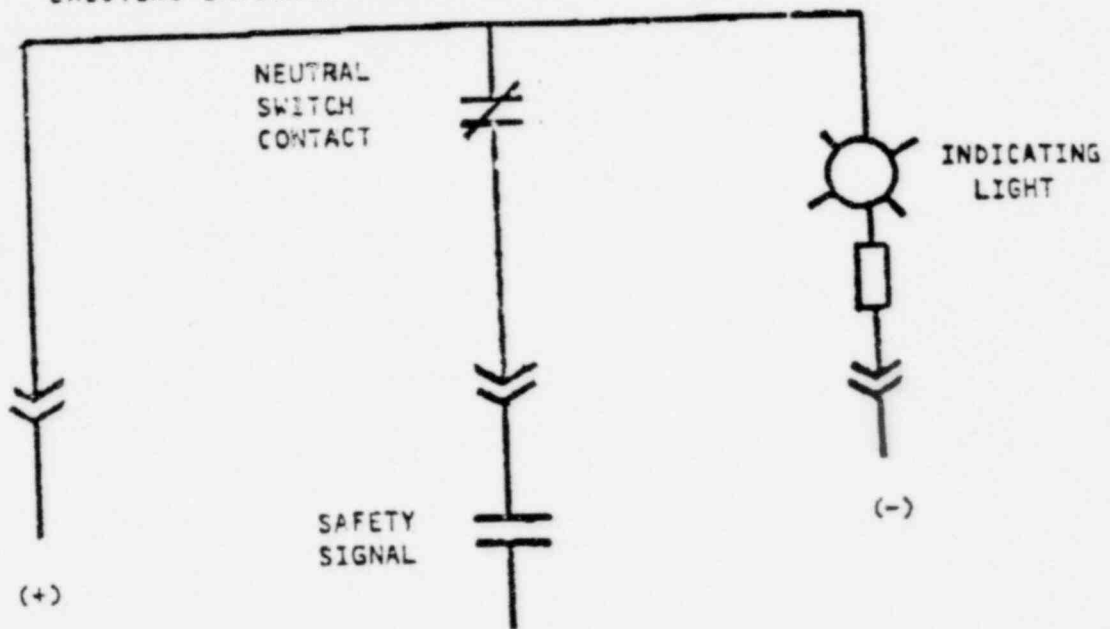
EXISTING INDICATING LIGHT CIRCUIT (TYPICAL)

A review of this matter by Westinghouse led to the issuance of NSD Technical Bulletin No. NSD-TB-80-9 to the utility owners of all Westinghouse operating plants. The recommendations contained in the Westinghouse technical bulletin include: (i) testing the neutral position contacts of the subject W-2 switches for continuity, and (ii) rewiring of the indicating light circuit to permit the early detection of a neutral contact failure as shown in Figure 1.

Depending on how the indicating light circuit is wired, loss of continuity thru the neutral position contact of a W-2 switch could remain undetected until the equipment associated with the switch were called upon to operate. Since such a failure would be equivalent to by-passing the system associated with the switch, consideration should be given to rewiring the switches used in safety-related applications as shown in Figure 1. Such rewiring would provide an acceptable means for detecting contact failure, provided the indicating light is in the control room and readily visible by the operator. If the indicating light is not so located, consideration should be given to annunciating the neutral position contact failures at the control room to alert the operator of the inoperable status of a safety-related system. In addition, consideration should be given to adding redundant contacts to the W-2 switches or to replacing the W-2 switches with others having a more positive contact wiping action.

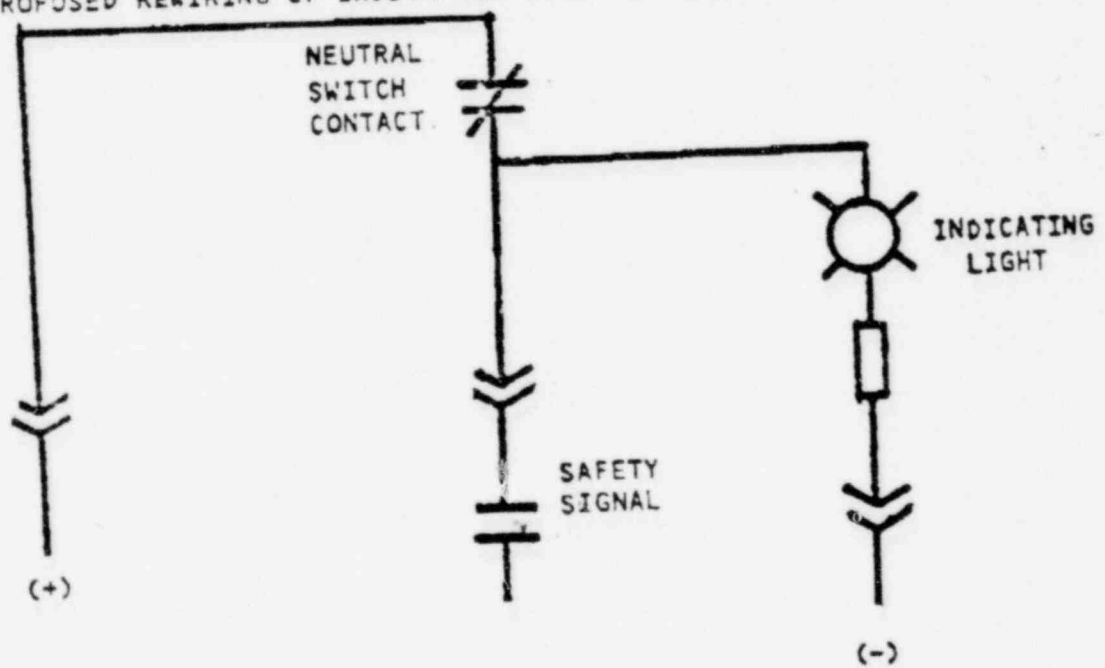
PROPOSED REWIRING OF INDICATING LIGHT CIRCUIT (TYPICAL)

REWIRING OF INDICATING LIGHT CIRCUIT OF W-2 SWITCHES
AS RECOMMENDED BY WESTINGHOUSE TECHNICAL BULLETIN NSD-TB-80-9

3. Licensees of operating plants and holders of construction permits shall describe the longer term corrective measures planned and the date by which such measures will be implemented by actual installation or by design change, as appropriate. As a minimum, the longer term corrective measures should include rewiring the indicating light as shown in Figure 1 provided the light is readily visible to the control room operator. If not, failures of the neutral position contacts should be annunciated in the control room.
