UNITED STATES
NUCLEAR REGULATORY COMMISSION
OFFICE OF INSPECTION AND ENFORCEMENT
WASHINGTON, D.C. 20555

IE Bulletin No. 80-20

FAILURES OF WESTINGHOUSE TYPE W-2 SPRING RETURN TO NEUTRAL CONTROL SWITCHES

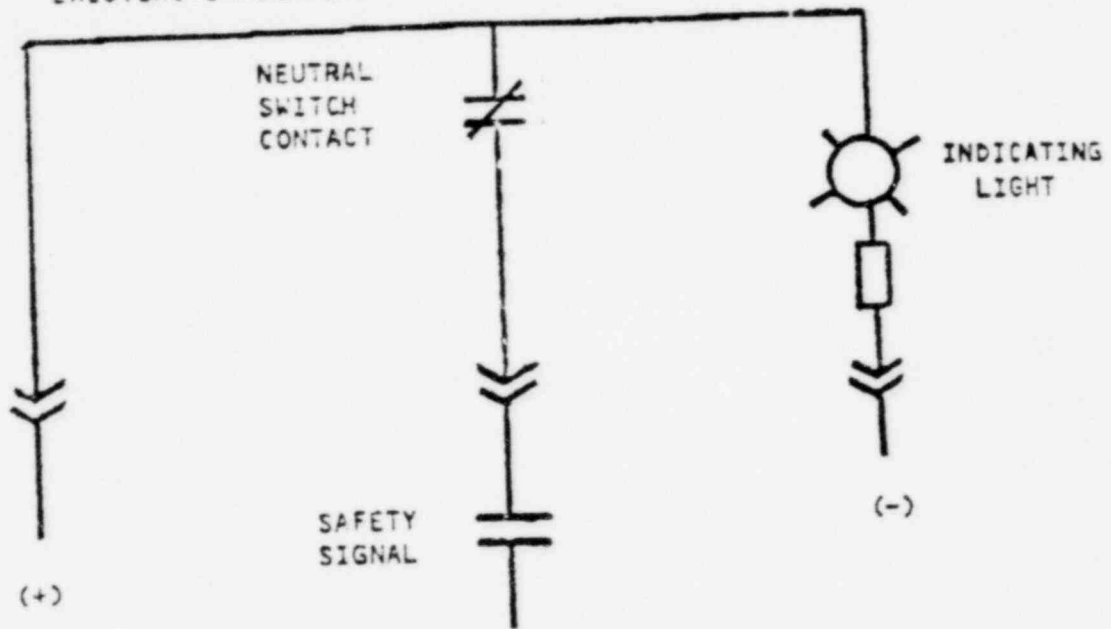
EXISTING INDICATING LIGHT CIRCUIT (TYPICAL)

Depending on how the indicating light circuit is wired, loss of continuity thru the neutral position contact of a W-2 switch could remain undetected until the equipment associated with the switch were called upon to operate. Since such a failure would be equivalent to by-passing the system associated with the switch, consideration should be given to rewiring the switches used in safety-related applications as shown in Figure 1. Such rewiring would provide an acceptable means for detecting contact failure, provided the indicating light is in the control room and readily visible by the operator. If the indicating light is not so located, consideration should be given to annunciating the neutral position contact failures at the control room to alert the operator of the inoperable status of a safety-related system. In addition, consideration should be given to adding redundant contacts to the W-2 switches or to replacing the W-2 switches with others having a more positive contact wiping action.

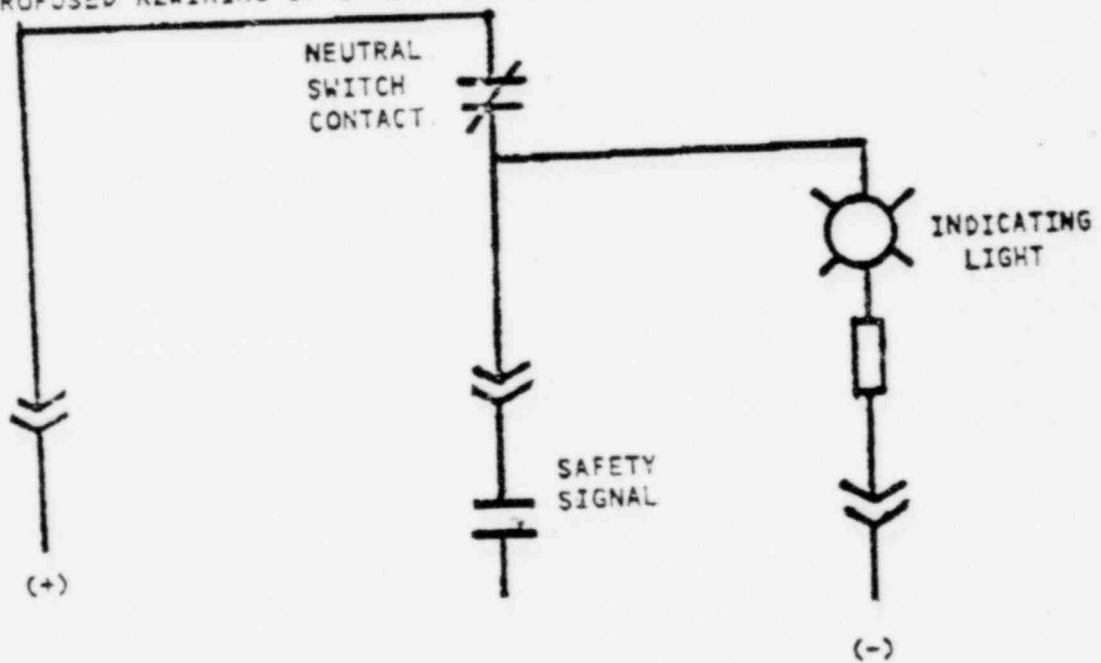
PROPOSED REWIRING OF INDICATING LIGHT CIRCUIT (TYPICAL)

REWIRING OF INDICATING LIGHT CIRCUIT OF W-2 SWITCHES
AS RECOMMENDED BY WESTINGHOUSE TECHNICAL BULLETIN NSD-TB-80-9

A review of this matter by Westinghouse led to the issuance of NSD Technical Bulletin No. NSD-TB-80-9 to the utility owners of all Westinghouse operating plants. The recommendations contained in the Westinghouse technical bulletin include: (i) testing the neutral position contacts of the subject W-2 switches for continuity, and (ii) rewiring of the indicating light circuit to permit the early detection of a neutral contact failure as shown in Figure 1.

3. Licensees of operating plants and holders of construction permits shall describe the longer term corrective measures planned and the date by which such measures will be implemented by actual installation or by design change, as appropriate. As a minimum, the longer term corrective measures should include rewiring the indicating light as shown in Figure 1 provided the light is readily visible to the control room operator. If not, failures of the neutral position contacts should be annunciated in the control room.
