UNITED STATES
NUCLEAR REGULATORY COMMISSION
OFFICE OF INSPECTION AND ENFORCEMENT
WASHINGTON, D. C. 20555

July 31, 1980

IE Bulletin No. 80-20

FAILURES OF WESTINGHOUSE TYPE W-2 SPRING RETURN TO NEUTRAL CONTROL SWITCHES

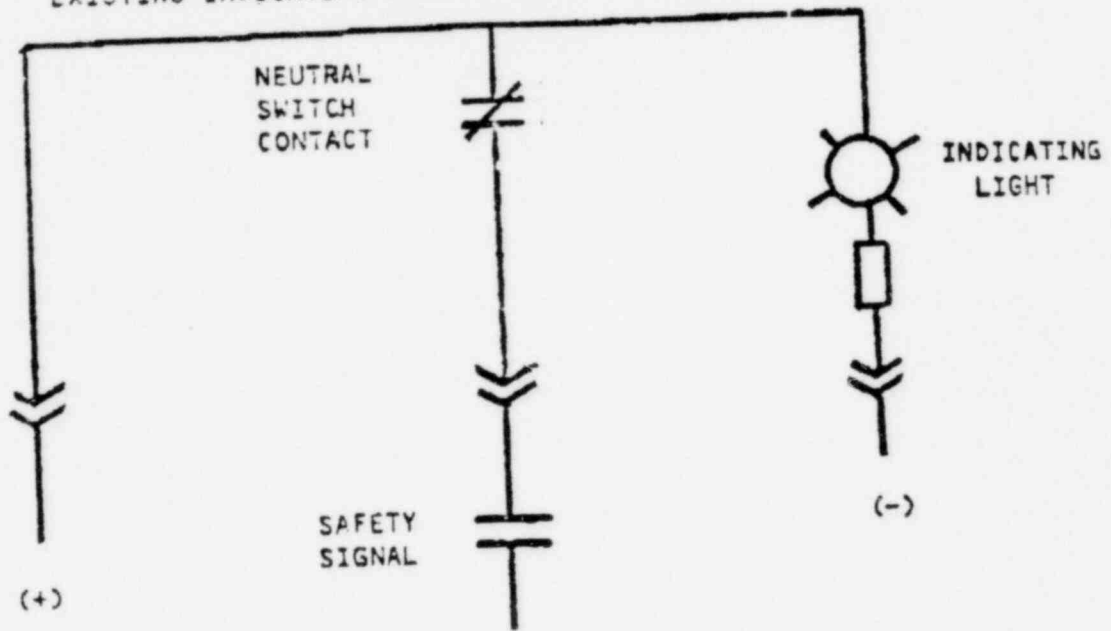
EXISTING INDICATING LIGHT CIRCUIT (TYPICAL)

Depending on how the indicating light circuit is wired, loss of continuity thru the neutral position contact of a W-2 switch could remain undetected until the equipment associated with the switch were called upon to operate. Since such a failure would be equivalent to by-passing the system associated with the switch, consideration should be given to rewiring the switches used in safety-related applications as shown in Figure 1. Such rewiring would provide an acceptable means for detecting contact failure, provided the indicating light is in the control room and readily visible by the operator. If the indicating light is not so located, consideration should be given to annunciating the neutral position contact failures at the control room to alert the operator of the inoperable status of a safety-related system. In addition, consideration should be given to adding redundant contacts to the W-2 switches or to replacing the W-2 switches with others having a more positive contact wiping action.

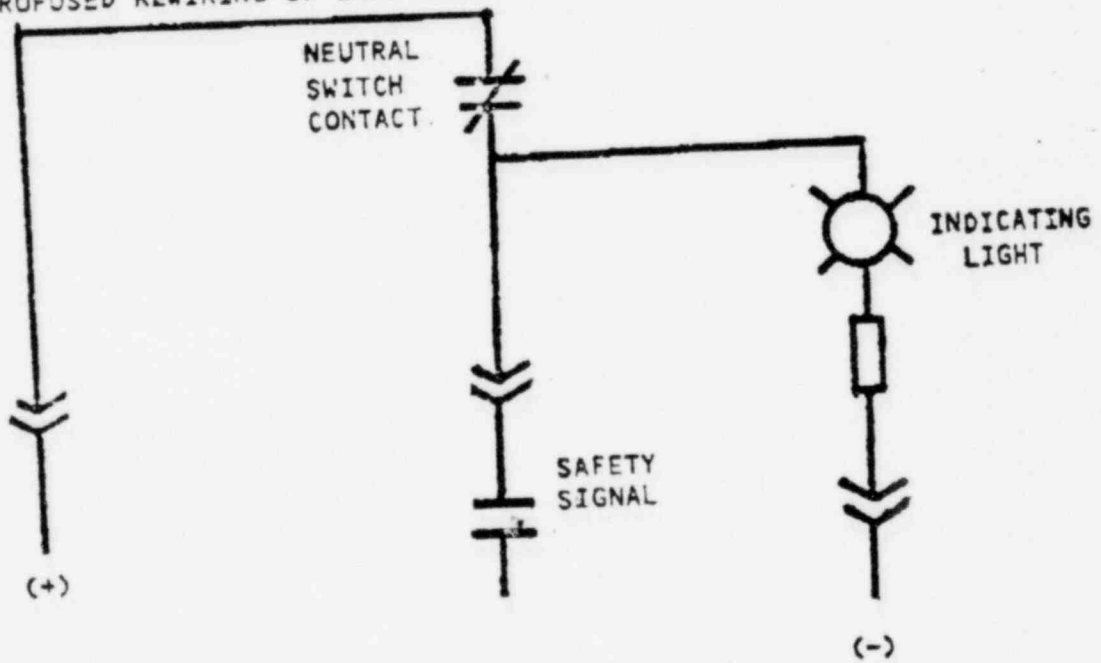
PROPOSED REWIRING OF INDICATING LIGHT CIRCUIT (TYPICAL)

REWIRING OF INDICATING LIGHT CIRCUIT OF W-2 SWITCHES
AS RECOMMENDED BY WESTINGHOUSE TECHNICAL BULLETIN NSD-TB-80-9

A review of this matter by Westinghouse led to the issuance of NSD Technical Bulletin No. NSD-TB-80-9 to the utility owners of all Westinghouse operating plants. The recommendations contained in the Westinghouse technical bulletin include: (i) testing the neutral position contacts of the subject W-2 switches for continuity, and (ii) rewiring of the indicating light circuit to permit the early detection of a neutral contact failure as shown in Figure 1.

3. Licensees of operating plants and holders of construction permits shall describe the longer term corrective measures planned and the date by which such measures will be implemented by actual installation or by design change, as appropriate. As a minimum, the longer term corrective measures should include rewiring the indicating light as shown in Figure 1 provided the light is readily visible to the control room operator. If not, failures of the neutral position contacts should be annunciated in the control room.
