Docket No. 50-329
Docket No. 50-330

IE Bulletin No. 80-20

FAILURES OF WESTINGHOUSE TYPE W-2 SPRING RETURN TO NEUTRAL CONTROL SWITCHES

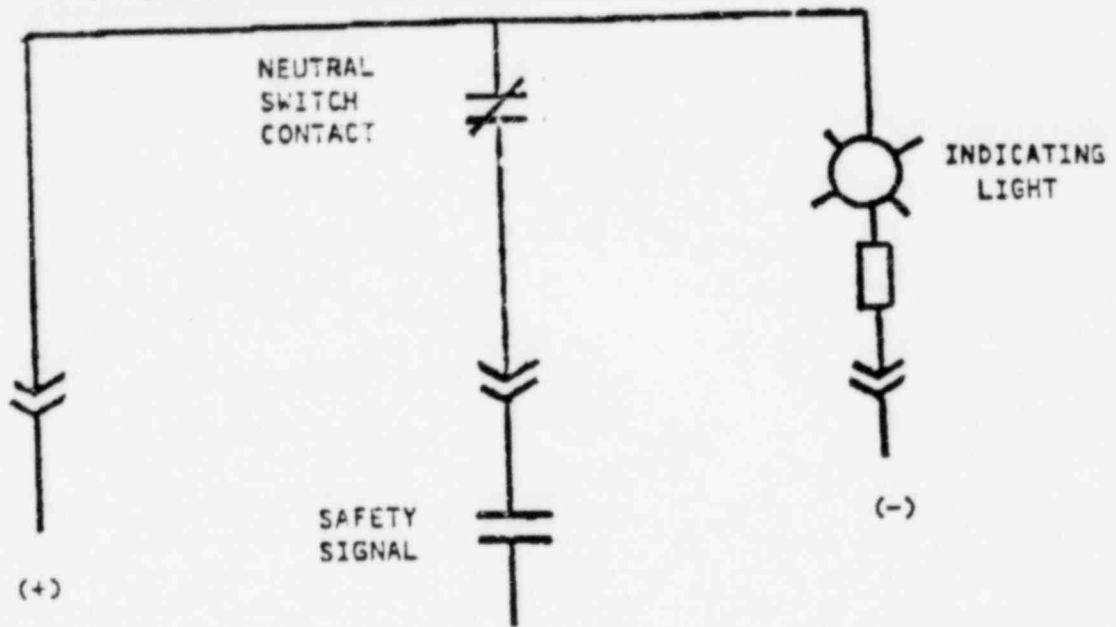
EXISTING INDICATING LIGHT CIRCUIT (TYPICAL)

Depending on how the indicating light circuit is wired, loss of continuity thru the neutral position contact of a W-2 switch could remain undetected until the equipment associated with the switch were called upon to operate. Since such a failure would be equivalent to by-passing the system associated with the switch, consideration should be given to rewiring the switches used in safety-related applications as shown in Figure 1. Such rewiring would provide an acceptable means for detecting contact failure, provided the indicating light is in the control room and readily visible by the operator. If the indicating light is not so located, consideration should be given to annunciating the neutral position contact failures at the control room to alert the operator of the inoperable status of a safety-related system. In addition, consideration should be given to adding redundant contacts to the W-2 switches or to replacing the W-2 switches with others having a more positive contact wiping action.

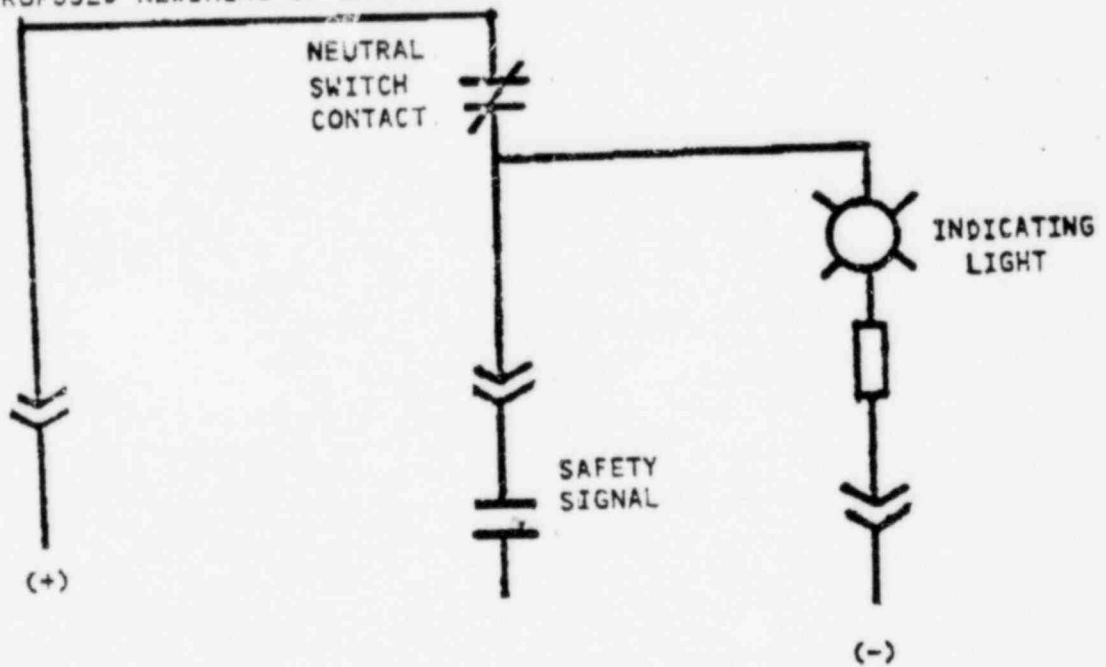
PROPOSED REWIRING OF INDICATING LIGHT CIRCUIT (TYPICAL)

REWIRING OF INDICATING LIGHT CIRCUIT OF W-2 SWITCHES
AS RECOMMENDED BY WESTINGHOUSE TECHNICAL BULLETIN NSD-TB-80-9

A review of this matter by Westinghouse led to the issuance of NSD Technical Bulletin No. NSD-TB-80-9 to the utility owners of all Westinghouse operating plants. The recommendations contained in the Westinghouse technical bulletin include: (i) testing the neutral position contacts of the subject W-2 switches for continuity, and (ii) rewiring of the indicating light circuit to permit the early detection of a neutral contact failure as shown in Figure 1.

3. Licensees of operating plants and holders of construction permits shall describe the longer term corrective measures planned and the date by which such measures will be implemented by actual installation or by design change, as appropriate. As a minimum, the longer term corrective measures should include rewiring the indicating light as shown in Figure 1 provided the light is readily visible to the control room operator. If not, failures of the neutral position contacts should be annunciated in the control room.
