July 31, 1980

IE Bulletin No. 80-20

FAILURES OF WESTINGHOUSE TYPE W-2 SPRING RETURN TO NEUTRAL CONTROL SWITCHES

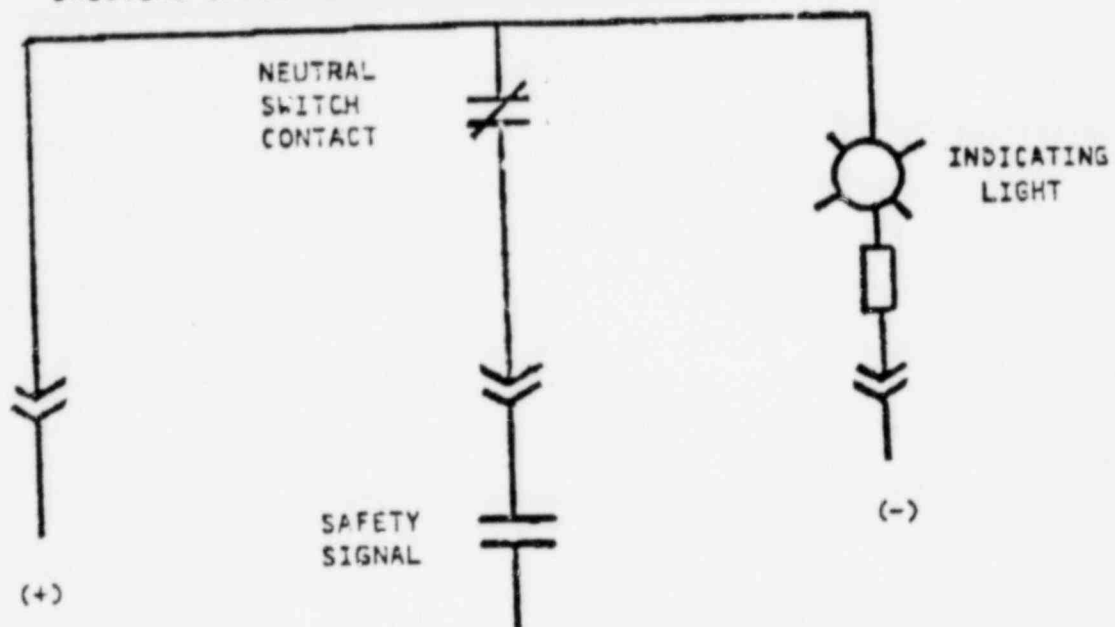
EXISTING INDICATING LIGHT CIRCUIT (TYPICAL)

By letter dated June 18, 1980, Commonwealth Edison Company submitted Licensee Event Report No. LER 50-295/80-24 to the NRC describing a malfunction of a Westinghouse Type W-2 control switch at the Zion Generating Station, Unit 1. The malfunctioning switch is a three position spring return to neutral switch. Although the switch was in its proper neutral position when it malfunctioned, its neutral contacts failed to close properly thereby preventing the automatic start of 1A Service Water Pump.

Subsequent tests conducted on the malfunctioning switch revealed that contact closure was intermittent with the switch in the neutral (or "Auto Start") position. Other tests conducted on identical switches from spares and from Unit 2 equipment disclosed two additional switches with a tendency for intermittent contact closure.

Depending on how the indicating light circuit is wired, loss of continuity thru the neutral position contact of a W-2 switch could remain undetected until the equipment associated with the switch were called upon to operate. Since such a failure would be equivalent to by-passing the system associated with the switch, consideration should be given to rewiring the switches used in safety-related applications as shown in Figure 1. Such rewiring would provide an acceptable means for detecting contact failure, provided the indicating light is in the control room and readily visible by the operator. If the indicating light is not so located, consideration should be given to annunciating the neutral position contact failures at the control room to alert the operator of the inoperable status of a safety-related system. In addition, consideration should be given to adding redundant contacts to the W-2 switches or to replacing the W-2 switches with others having a more positive contact wiping action.

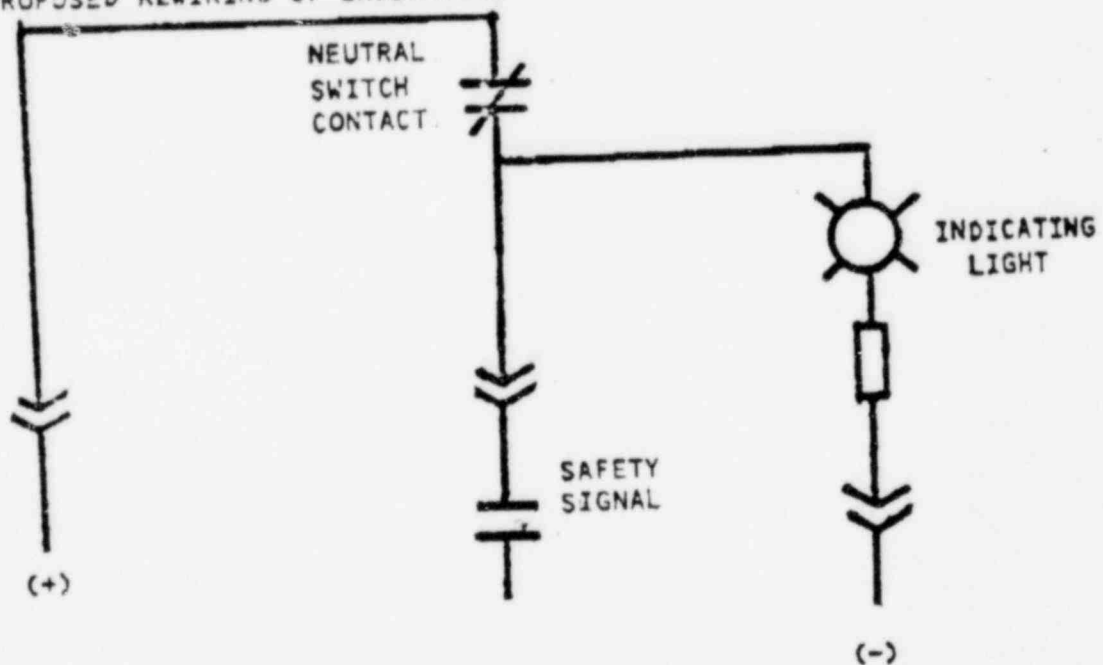
PROPOSED REWIRING OF INDICATING LIGHT CIRCUIT (TYPICAL)

REWIRING OF INDICATING LIGHT CIRCUIT OF W-2 SWITCHES  
AS RECOMMENDED BY WESTINGHOUSE TECHNICAL BULLETIN NSD-TB-80-9

A review of this matter by Westinghouse led to the issuance of NSD Technical Bulletin No. NSD-TB-80-9 to the utility owners of all Westinghouse operating plants. The recommendations contained in the Westinghouse technical bulletin include: (i) testing the neutral position contacts of the subject W-2 switches for continuity, and (ii) rewiring of the indicating light circuit to permit the early detection of a neutral contact failure as shown in Figure 1.

3. Licensees of operating plants and holders of construction permits shall describe the longer term corrective measures planned and the date by which such measures will be implemented by actual installation or by design change, as appropriate. As a minimum, the longer term corrective measures should include rewiring the indicating light as shown in Figure 1 provided the light is readily visible to the control room operator. If not, failures of the neutral position contacts should be annunciated in the control room.
